KAMA CREEK CULVERT RESTORATION:
AN ASSESSMENT OF LONG-TERM REMEDIATION SUCCESS

Brent Straughan

April 2018

An Undergraduate Thesis Submitted in
Partial Fulfillment of the Requirements for the
Degree of Honours Bachelor of Environmental Management

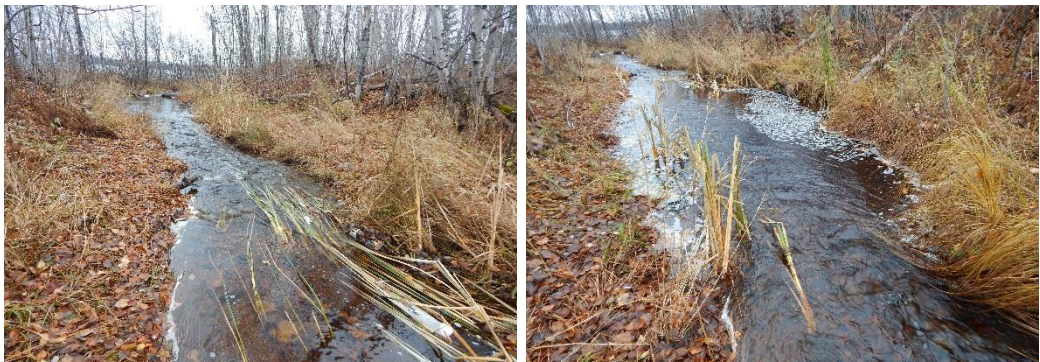
Source: Field Data
Figure 2: Downstream views of riffle-pool sequence in reach 2 within 40m of stream mouth.

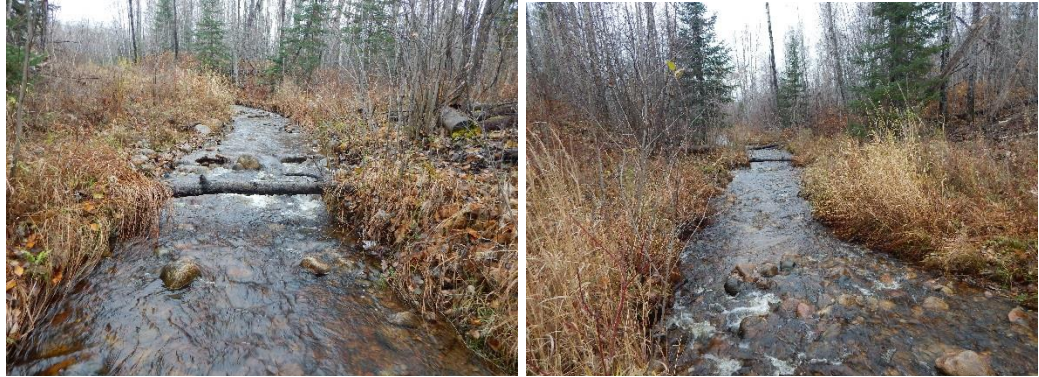
Figure 3: Upstream view and downstream view of step-pool sequence in reach 2, 40m upstream.

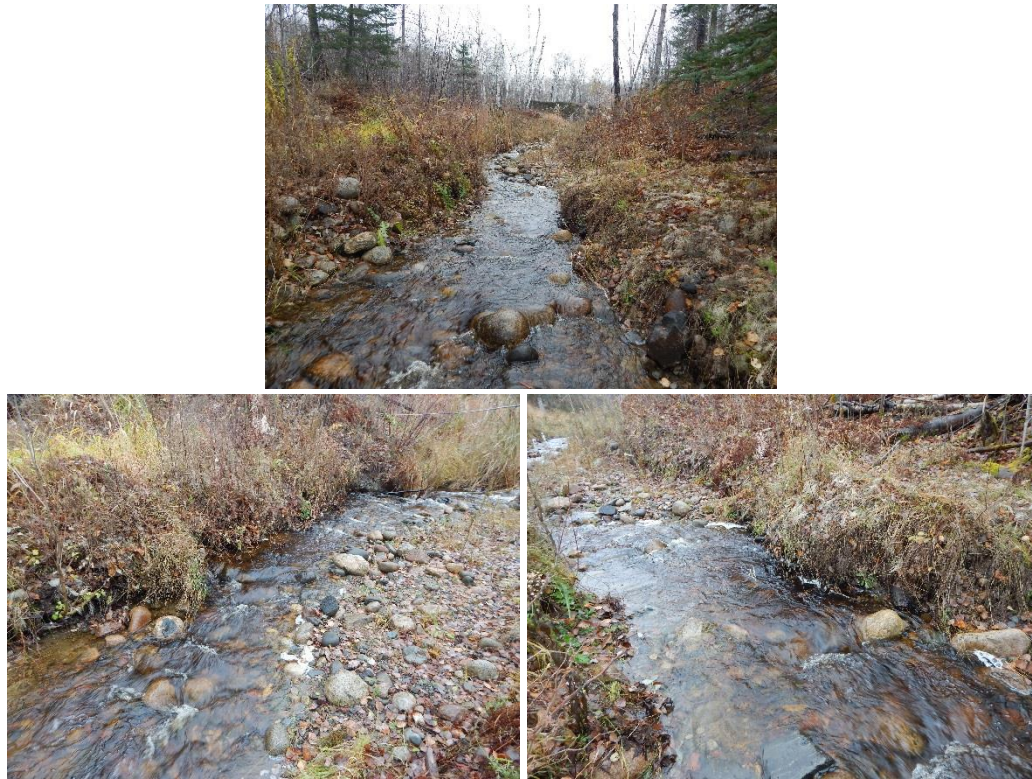
In terms of providing suitable brook trout habitat and restoration attempts to improve such habitat, the most prominent issue with Kama Creek was the concern with erosion and sediment deposition (Cox, 2015; Kaurin, 2015). The upper portion of reach 2 had the most signs of sediment removal and deposition over the full stretch downstream of the culvert. Fast flowing shallow water moved sediments from their originally placed position of the restoration, to various places downstream. As stated in Lakehead University’s request for proposal Kama Creek restoration (2011), sediments were embedded between 25 and 50% of the particles size. The flow of Kama moved

smaller cobbles and gravels downstream while many larger cobbles and boulders stayed in place. After years of flows through the channel, smaller sediments were concentrated within 40m of the stream mouth, as well as, forming a depositional fan in Kama Bay itself. The upper portion of reach 2 had a high ratio of large to small sediments that lead to infilled pools and hard-bottomed shallow runs. Which in turn created a system of fast flowing water with low sinuosity. Figure 4 shows a notable 10-meter section of the straightened, fast flowing water with a large point bar and undercuts on both the stream banks.

Figure 4: Sediment deposition and undercut banks in reach 2. Top, upstream view of point bar on right side of stream. Bottom left, upstream view of right bank showing point bar and undercut bank. Bottom right, upstream view of left bank showing point bar and undercut bank.

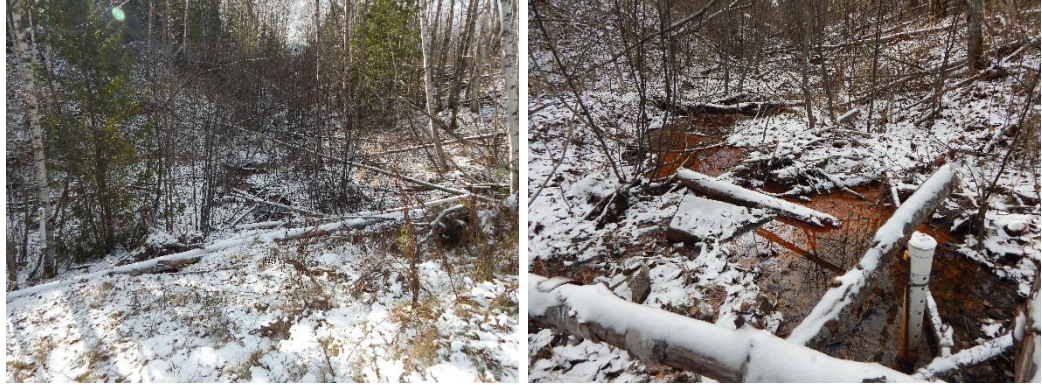
Discharge was examined in both reach 1 and reach 2 but was only calculated at two sites within reach 2. There was some concern of water seeping through the constructed embankment into reach 1 (Cox, 2015). The flow in reach 1 was so low that velocity was immeasurable with the water meter, therefore, was less than the devices minimal measurement of 0.05m/s. This left photo documentation to best represent the extent of seepage in reach 1 and is shown in Figure 6.

Figure 6: Downstream views of pre-restoration Kama Creek (reach 1)

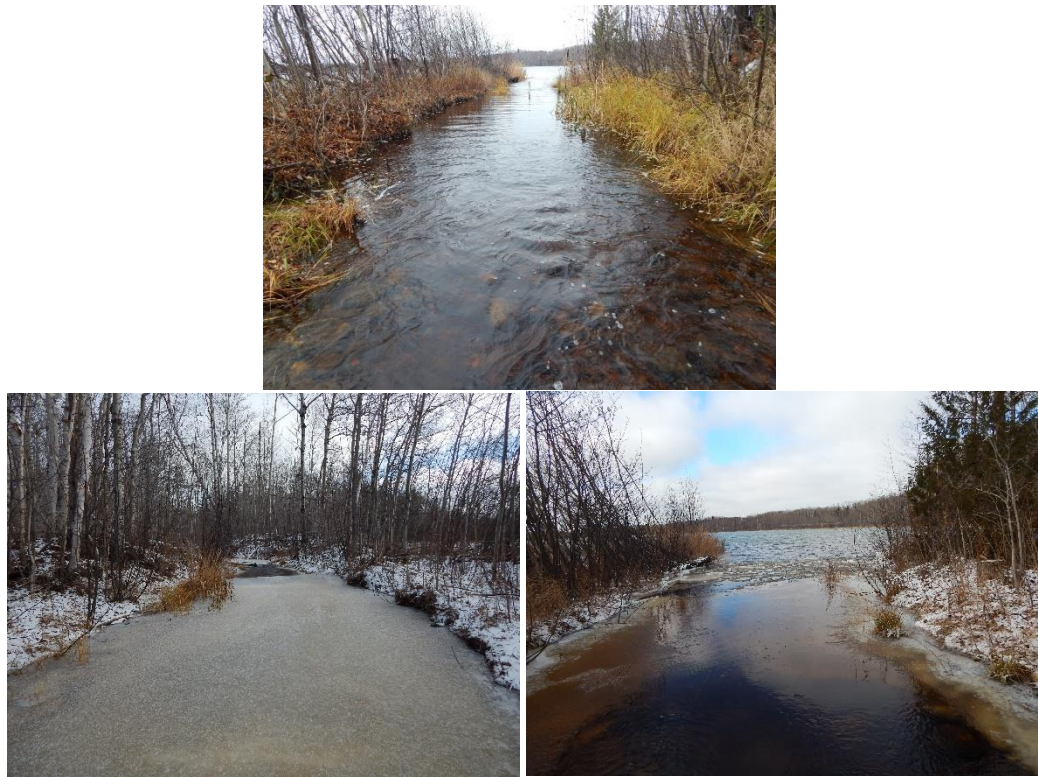
The discharge calculation from Kama 1 site near the mouth of Kama Creek revealed stream discharge to be $0.1214\text{m}^3/\text{s}$. Kama 1 was a deep slow pool with fine sediments and woody riparian vegetation on the banks. Onsite conditions of this site are shown in Figure 7.

Figure 7: Discharge assessment site from reach 2, Kama 1 Top, downstream view of Kama 1 site. Bottom left, upstream view from Kama 1. Bottom right, downstream view from Kama

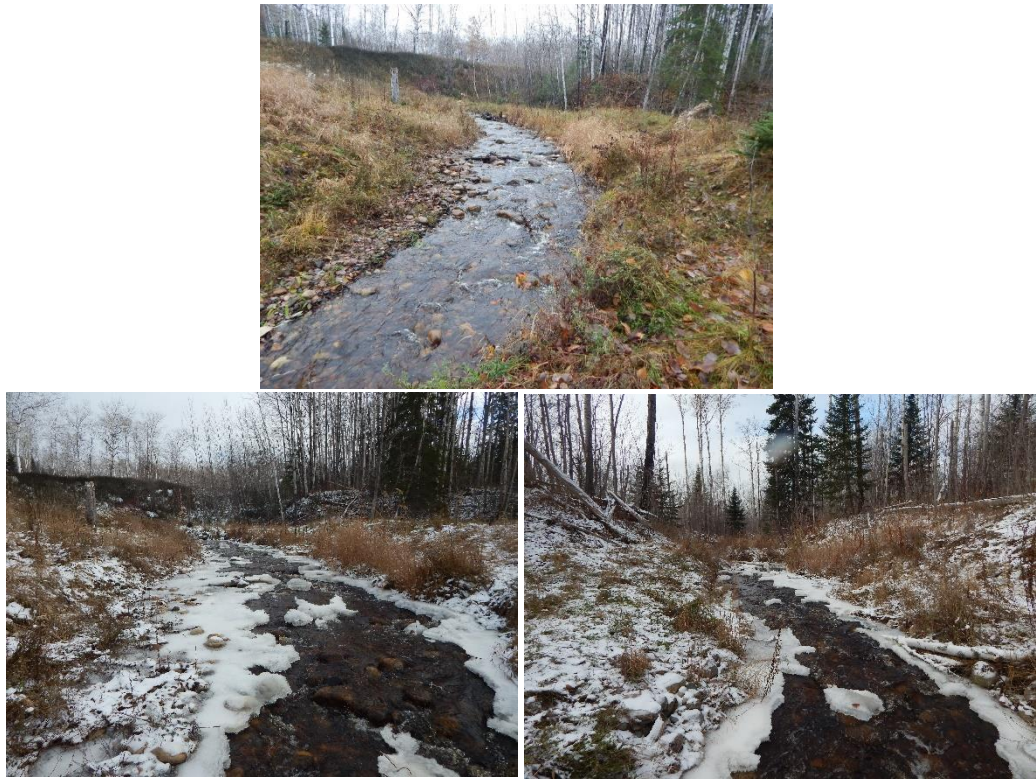
The discharge calculation from Kama 2 site close to the culvert revealed stream discharge to be $0.1183\text{m}^3/\text{s}$. Kama 2 was a remediation constructed pool that has been partly infilled with larger sediments, resulting in a shallow pool with a developed point bar connected to the left bank. Onsite conditions of this site are shown in Figure 8.

Figure 8: Discharge assessment site from reach 2, Kama 2. Top, upstream view of Kama 2 site. Bottom left, upstream view from Kama 2. Bottom right, downstream view from Kama 2.

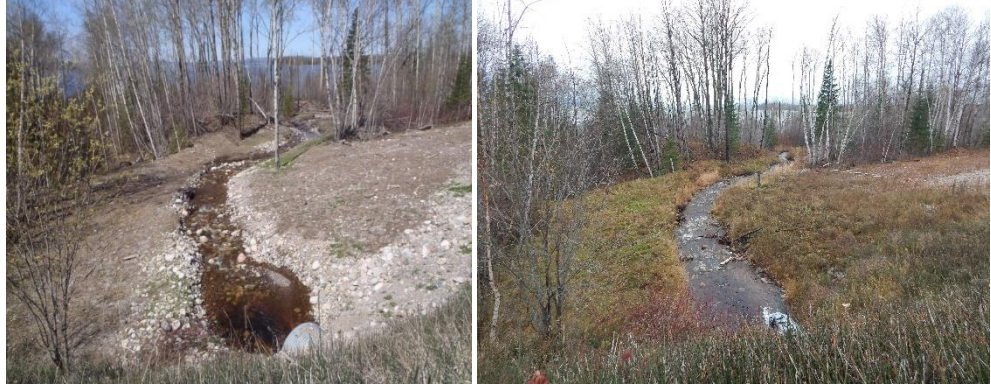
In Figure 9, the general changes seen from 2012 to 2018 are shown. As previously mentioned, the vegetative recovery over the six years was the most significant improvement. With well-developed, non-woody species dominating stream banks and open areas the woody shrub and tree species had colonized the riparian zone. Some sedimentation can be seen, but the amount of change from this, shown in Figure 9, is minimal.

Source: Left, Kaurin (2015). Right, Field Data
 Figure 9: Comparison of Kama Creek from 2012 and 2018. Left, downstream view from culvert in 2012. Right, downstream view from culvert in 2018.

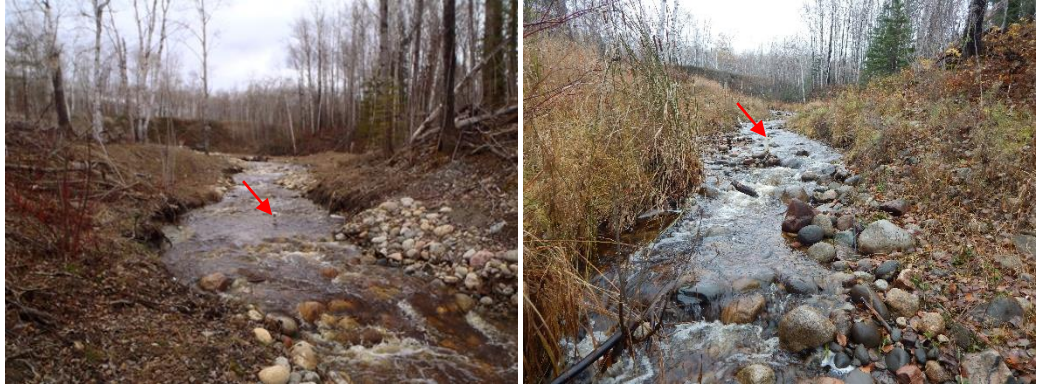
Figure 10 is a representative section of reach 2, demonstrating morphological change. A level-logger in the stream was used as a reference and (red arrows) and indicates the development of the step-pool sequence over the originally dug out riffle-pool found in reach 2. In general, a riffle-pool stream has an even slope with distinct sections of slow, deep, and flat water separated by narrower stretches of larger sediments with fast, shallow, and white water (Rosgen, 1994). Step-pool systems, on the other hand, follow a staircase like form of uniform width with shallow, and flat water sections separated by a build-up of sediments that cause an abrupt drop in elevation (Laronne and Carson, 1976; Wooldridge and Hickin, 2002).

Source: Left, Kaurin (2015). Right, Field Data
 Figure 100: Comparison of a stream section from 2012 and 2018. Left, upstream view of stream section site in 2012. Right, upstream view of stream section in 2018. Red arrows, showing level logger for reference.

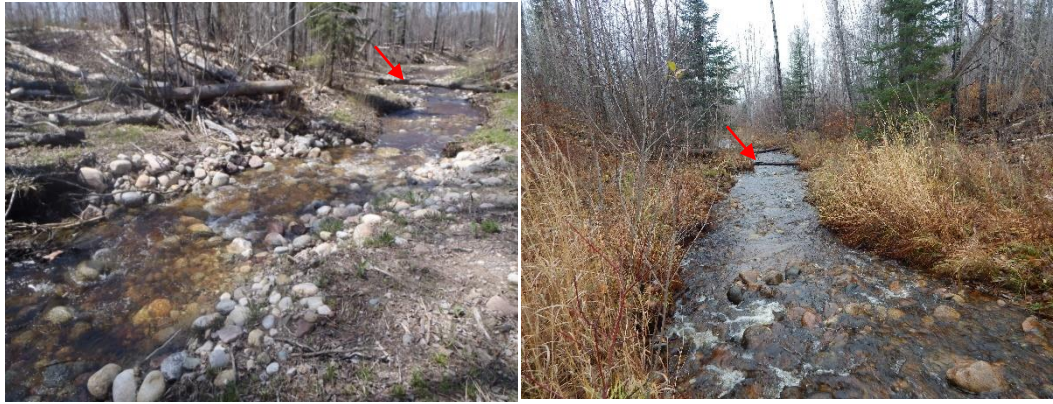
The most representative comparison of the 2018 condition with the 2012 condition is shown in Figure 11. Below is the same section of reach 2 with a downed log for reference. In 2012, the riffle-pool sequences are clearly visible and distinct, whereas in 2018, the sequencing became blurred due to larger riffle sediments flushed into downstream pools. During the onsite data collection, the riffle-pool sequences that existed in 2012 were no longer distinct but some evidence of previous pool locations was distinguishable. Wider widths, the presence of smaller sediments placed in pool sections, and steep banks were characteristic of the proposed pool designs (Lakehead University, 2011).

Source: Left, Kaurin (2015). Right, Field Data
 Figure 111: Comparison of a stream section from 2012 and 2018. Left, downstream view of stream section site in 2012. Right, downstream view of stream section in 2018. Red arrows, showing downed tree for reference.

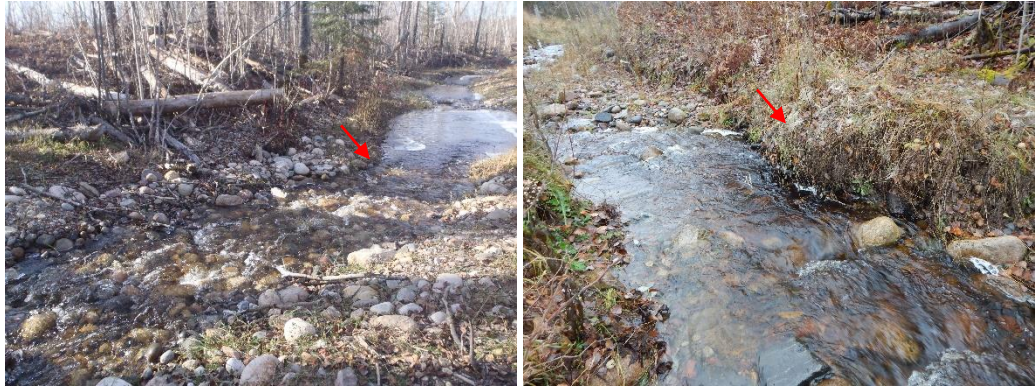
As with the past comparisons, 2012 conditions mirrored that of the proposed design and constructed channel bed, but in 2018, sedimentation altered the channel. Figure 12 below shows the effects sedimentation caused to Kama Creek over time; such as, point bar development, constricted flow, and undercut banks. The 2012 channel contained a functional riffle section composed of large cobbles and boulders, while the following pool was wide and deep (Kaurin, 2015). In 2018, the same section of reach 2 had lost functionality of the riffle section and the pool had become filled with large cobbles and boulders. Evidence of decreased riffle functionality was the developed point bar causing constricted flow, undercut banks, and channel incision (Lakehead University, 2011).

Source: Left, Kaurin (2015). Right, Field Data
 Figure 12: Comparison of a stream section from 2012 and 2018. Left, downstream view of stream section site in 2012. Right, upstream view of stream section in 2018. Red arrows, showing point on right bank for reference.
