**Experimental Fire Testing of Damaged Glulam Beam Connections
Retrofitted Using Self-Tapping Screws**

submitted to the Faculty of Graduate Studies
in partial fulfillment of the requirements for the
Degree of Master of Science

Civil Engineering

Lakehead University

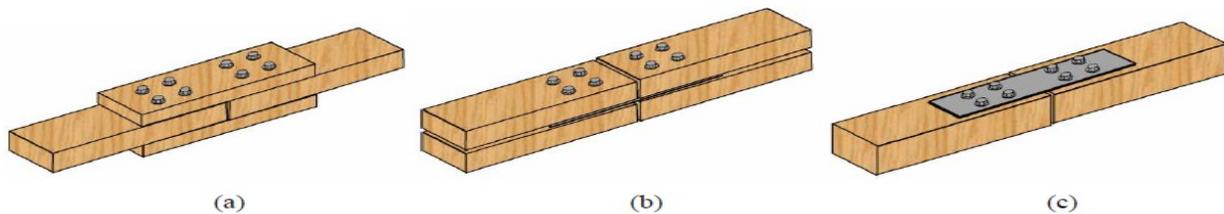
Figure 2.3 Double shear hybrid connection in timber structures, (a) WWW, (b) WSW, (c) SWS
(Adapted from Peng et al., 2011).

plate. Hybrid SWS members have steel plates on each side of the middle wood member. Figure 2.3 illustrates a schematic of the three different connection types. Bolts or dowels are utilized as connectors. WSW connections will be utilized in this research and hence the performance of these connections will be discussed throughout this chapter. Additionally, the failure modes of these connections will be provided in the sections below.

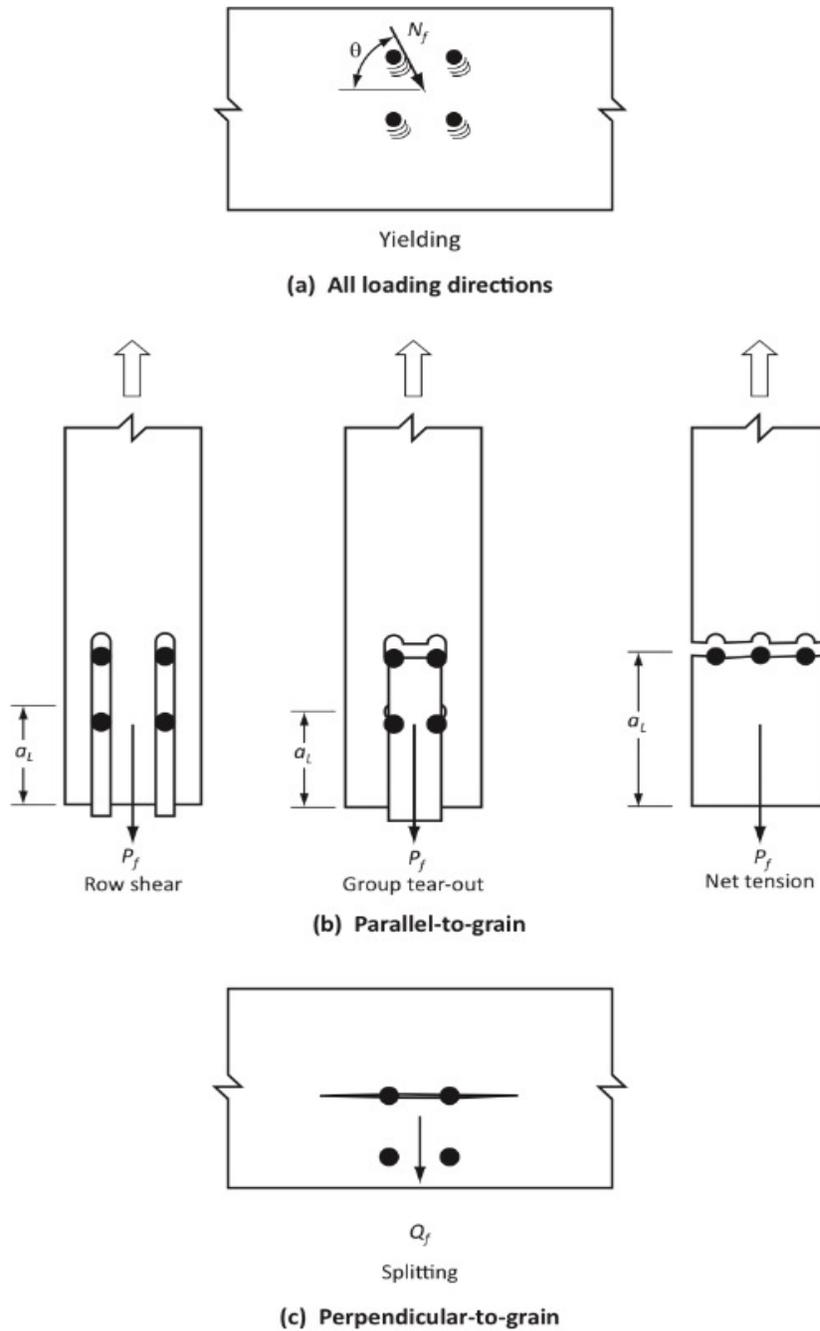
Figure 2.6 Failure modes for bolted wood connections (Adapted from the Canadian Wood Council, Wood Design Manual, 2020)

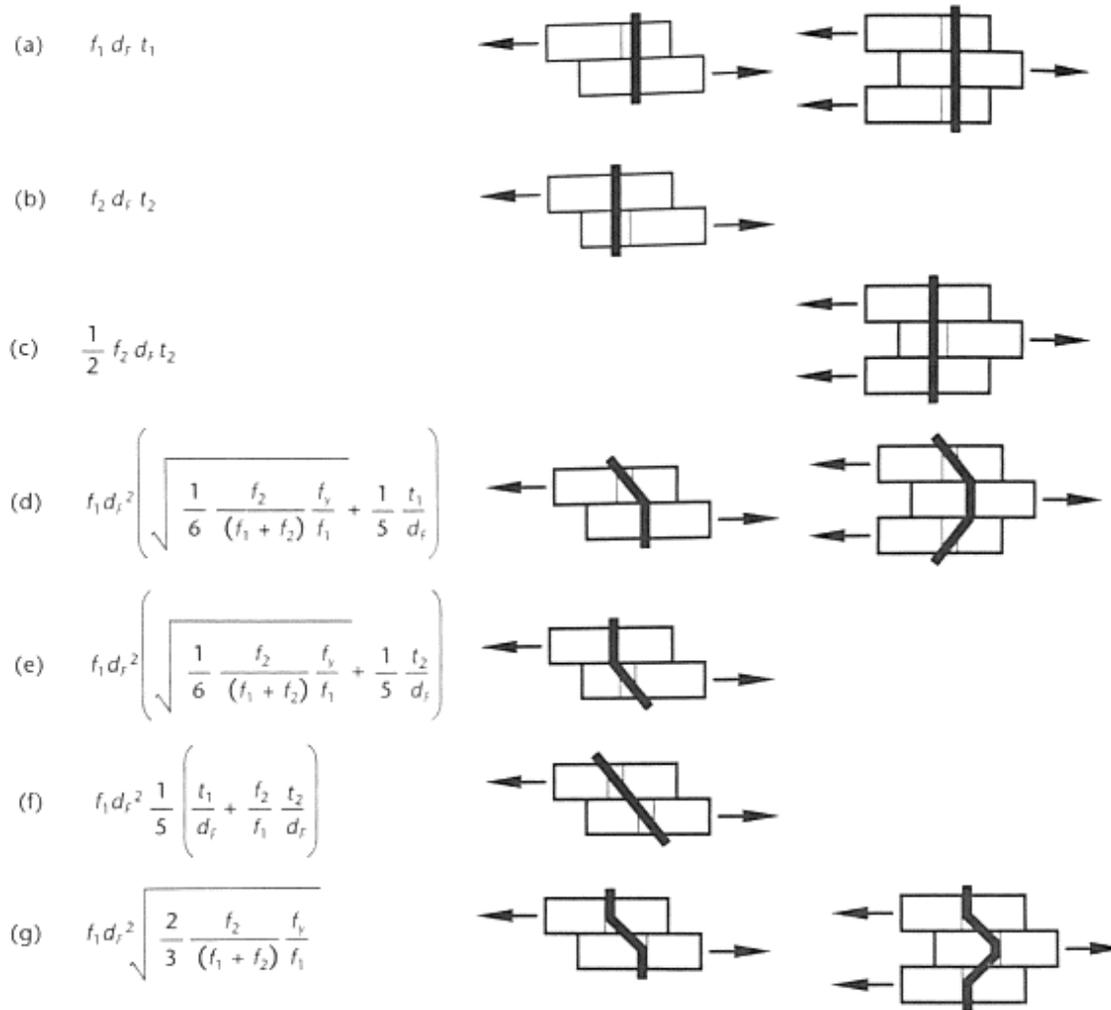
Figure 2.7 Ductile failure modes for wood connections (Adapted from the Canadian Wood Council, Wood Design Manual, 2020)

The unit lateral yielding resistance is dependent on the number of members in the connections, and the different modes a connection can fail in yielding. Figure 2.7 shows the variety of ways yielding can occur in timbers connections and the governing unit yielding resistance. The unit lateral yielding resistance, n_u , is taken as the least value from (a) to (g)

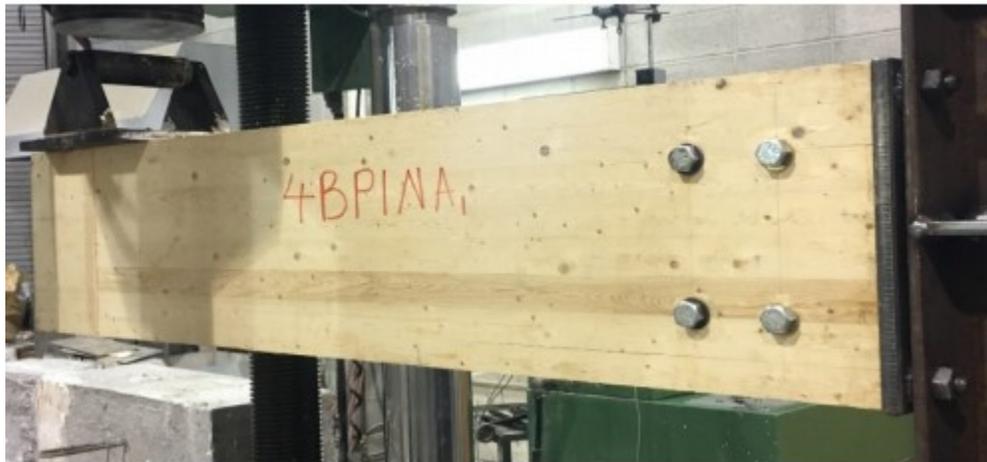
Figure 2.8 Ambient temperature test setup (Adapted from Owusu, 2019)

Connections are used to transfer load between members. They are also the weakest link in any wood assembly, and therefore it is critical to understand the behaviour of those connections when loaded. In a bolted connection subjected to a load perpendicular to the grain, the strength of the connection is governed by the type of wood, member thickness, number of bolts, and bolts arrangement (WDM, 2020). To study the performance of a bolted WSW connection under bending, Owusu (2019) investigated the effect of bolts arrangement and the number of bolts on the carrying capacity of a connection on a 184 x 362 x 1600 mm black spruce–pine, grade 24f-EX glulam beam. The beam was free on one end and fixed to a column on the other end. The load was applied at the free end until failure of the connection at a rate of 2.0 kN/minute. The beam was connected to the column using a concealed T-stub with a thickness of 12.7 mm and A325M, high strength bolts were used. The test set up is shown in Figure 2.8.

Upon test completion, it was observed that the 4-bolt connections failed by splitting along the top row of the connection; however, bolts arranged in the second pattern experienced some row shear-out failure. The row-shear out failure of pattern two was due to the yielding of the bottom bolts, which also resulted in the considerable increase in the moment resistance in pattern two, as the connection experienced more ductility. In terms of moment capacity, the placement of the bolts in the tensile zone (pattern two) resulted in a 92% increase in the moment resistance as compared to pattern one.

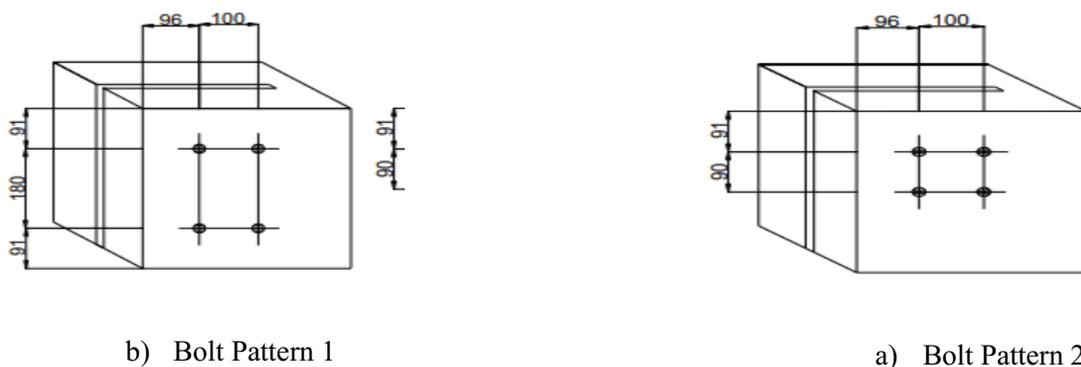
Figure 2.9 Details of bolts arrangement: (a) Bolts arrangements in Pattern 1; (b) Bolt arrangements in Pattern 2 (Adapted from Owusu, 2019)

When 6 bolts were used in the first pattern, the moment capacity was 44 kN.m. Therefore, this is a 66% increase compared to the 4 bolts configuration. It is worth noting that for the 6 bolts arrangement in position 2, the test was not completed due to the failure of the supporting column. The results of this test are summarized in Table 2.3.

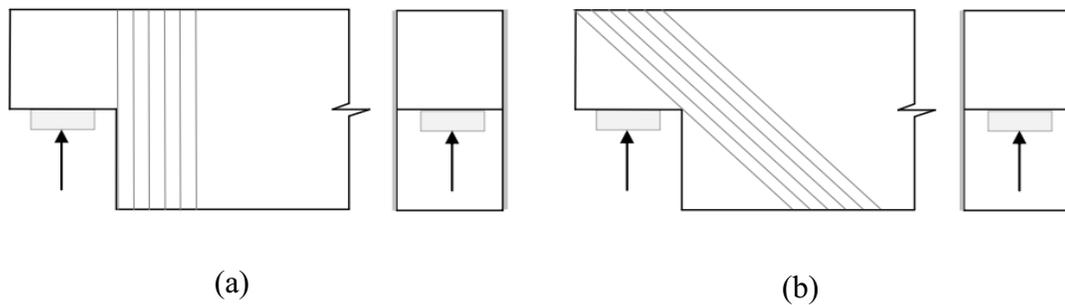
Figure 2.10 FRP-reinforced specimens' detail: (a) FRP Placed Perpendicular to grain; (b) FRP placed at 45° angle to grain (Adapted from Jockwer, 2015).

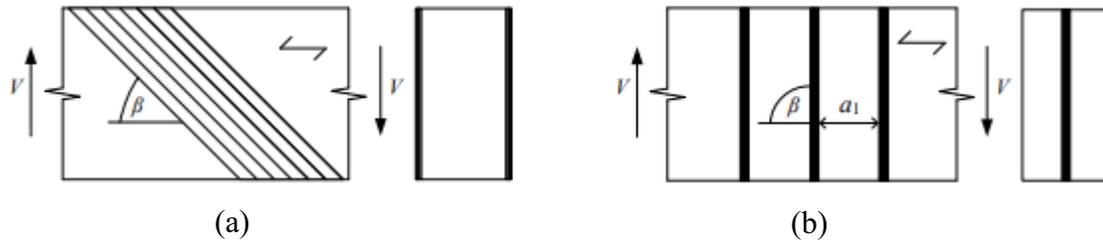
Figure 2.11 FRP-reinforced specimens' detail: (a) FRP placed at angle 45° to grain; (b) FRP placed at angle 90° to grain (Adapted from Widmann et al., 2012).

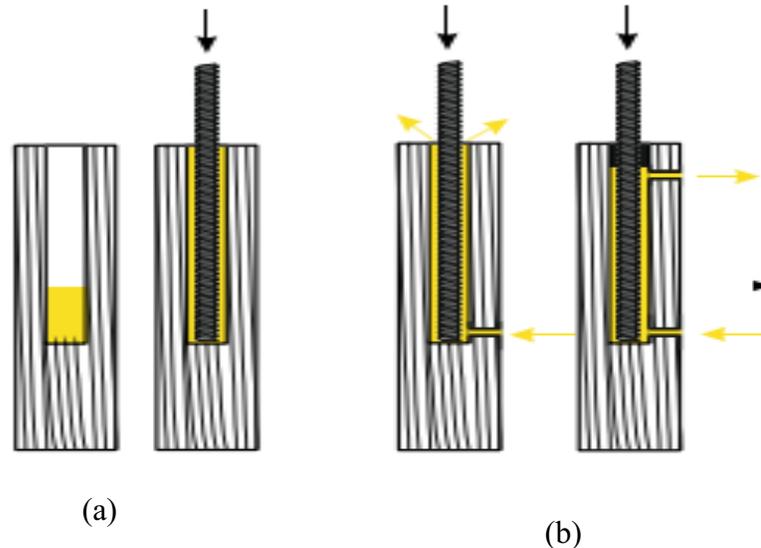
Figure 2.12 Variation of Placing GiR into Wood: (a) a hole is drilled vertically and glue is injected; (b) Glue is injected into a hole perpendicular to where the rod is to be placed (Adapted from Steiger et al., 2015).

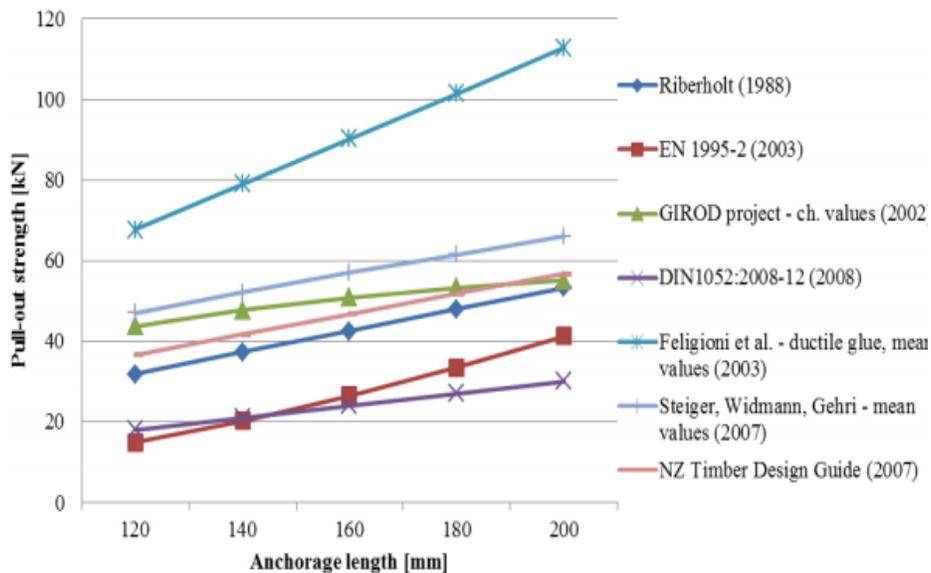
Figure 2.13 Anchorage length vs Pull-out strength for GiR connection from different studies

shown in Figures 2.13 and 2.14. As evident from Figures 2.13 and 2.14, pull-out strength increases linearly as the anchorage length, and the diameter of the rod is increased. Further, the effect of wood density on pull strength was investigated in studies by Riberholt (1988), EN 1995-2 (2003), GIROD project (2002), DIN1052:2008-12 (2008), and Feligioni et al., (2003). The conclusion of whether the density had any effect on the pull-out strength varied between studies. For instance, most studies including one by EN 1995-2 (2003) showed that density has no effect on the pull-out strength. Other studies conducted by Riberholt (1988), and Feligioni et al., (2003) showed that the pull-out strength increases linearly as density is increased. A summary of the findings of the different studies is shown in Figure 2.15.

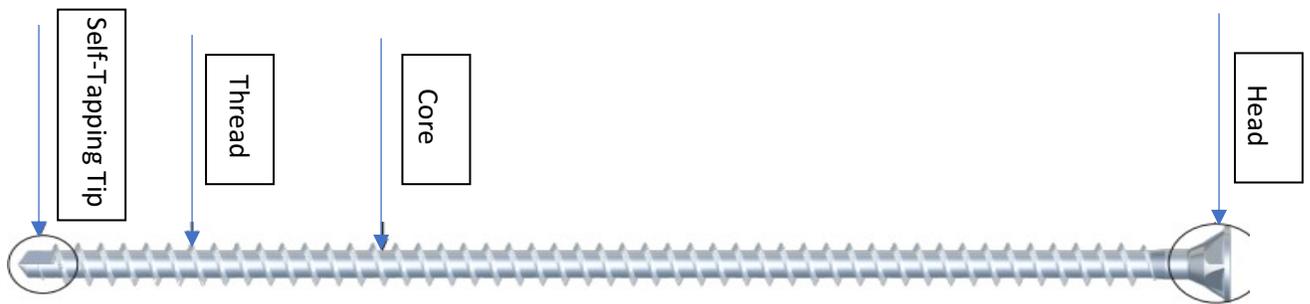
Figure 2.16 Fully threaded ASSY® VG STS (Adapted from MTC Solutions).

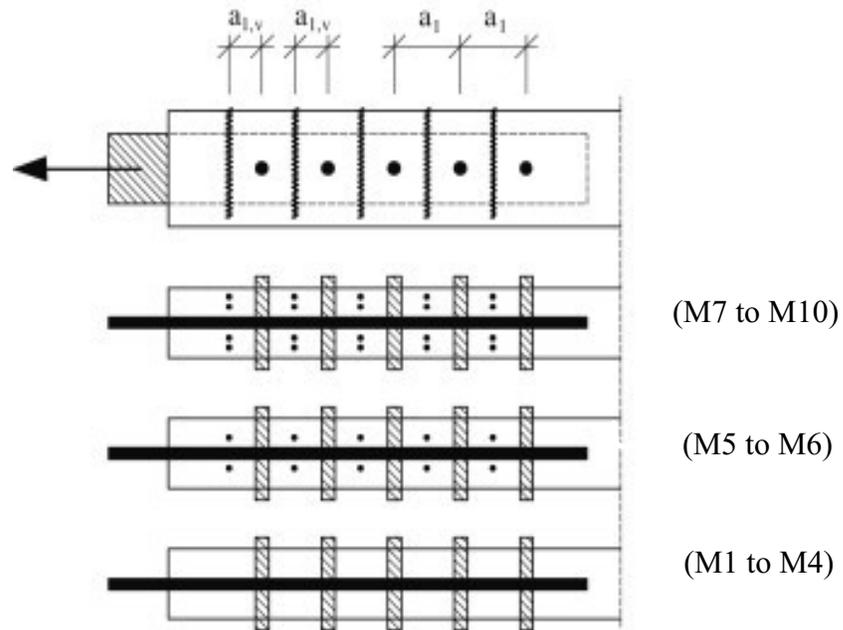
Figure 2.17 Geometry of specimens tested (M1 to M10), including the number of reinforcing STS (Adapted from Blaß and Schädle, 2011).

To understand the effect of STS on load carrying and ductility on wood members, Blaß and Schädle, (2011) conducted an experiment on a glulam beam with dowel-type connections reinforced with STS and subjected to tensile load applied parallel to the grain. Three different geometries of beams, with different numbers of bolts, were tested. In the first geometry, no STS reinforcement was used (M1 to M4); the second geometry (M5 to M6) consisted of ten STS, and the third variation consisted of twenty STS (M7 to M10). Figure 2.17 illustrates the three different variations. The results, including ductility and load-carrying capacity, were compared to that of an unreinforced beam. Figure 2.18 shows the load-displacement curve for the three different variations. From the graph, it is evident that the unreinforced beam (M1 to M4) experienced very little ductility. When ten STS were used (M5 to M6), the ductility of the specimen increased, but

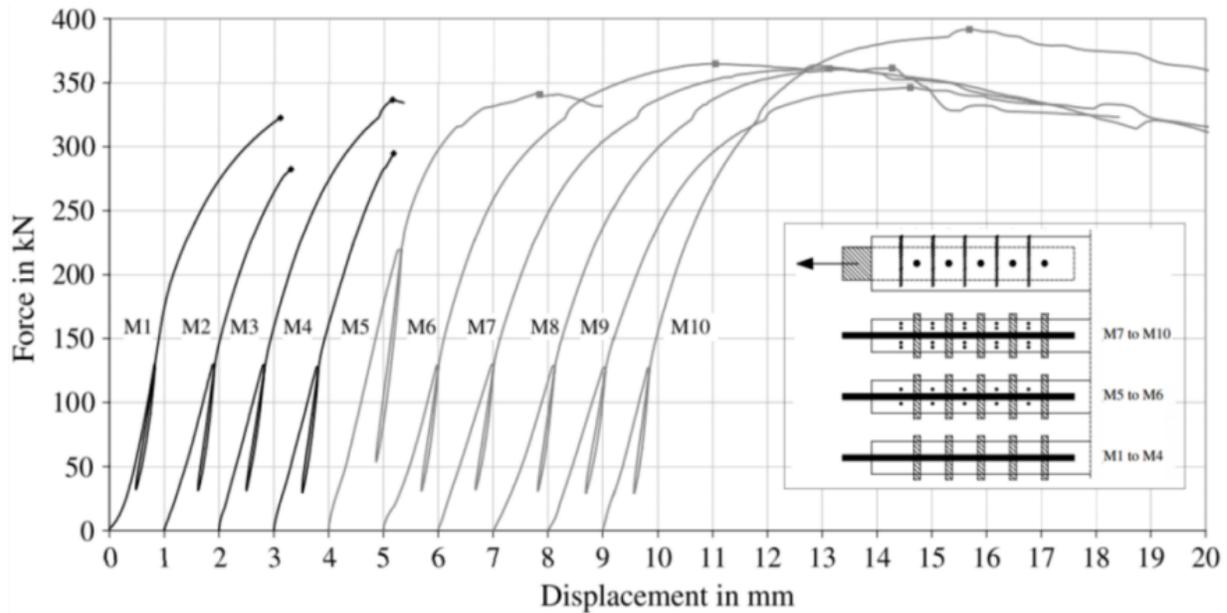
Figure 2.18 Load-Displacement curve for a beam subjected to parallel to grain tensile load (M1-M4) non-reinforced beam; (M5 to M6) reinforced beam with no contact between dowels and STS; (M6 to M7) reinforced beam with contact between dowels and STS (Adapted from Blaß and Schädle, 2011)

when twenty STS were used (M7 to M10), the beam experienced a significant increase in ductility as well as increased load-carrying capacity.

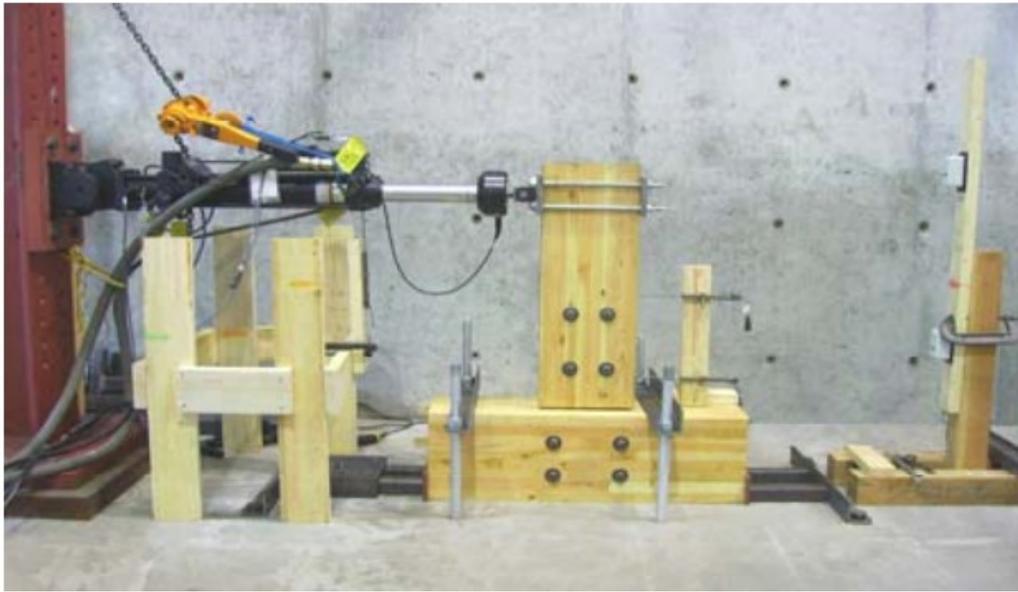
Figure 2.19 Bolted connection Test Set Up (Adapted from Lam et al., 2008).

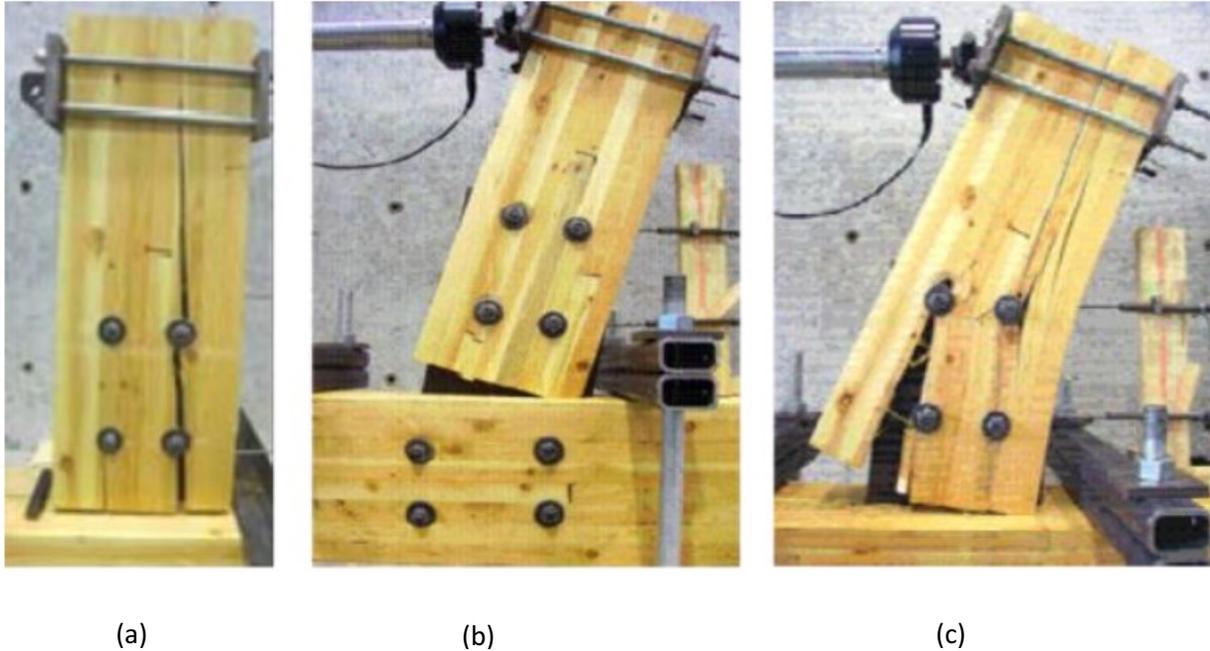
Figure 2.20 Test configurations: (a) Unreinforced beam; (b) Reinforced beam; (C) Retrofitted beam (Adapted from Lam et al., 2008).

The maximum moment resistance for the unreinforced connection was 31.49 kN.m with a maximum rotation of 2.97 °. It was observed that the beam's moment capacity quickly decreased with the formation of cracks. On the other hand, the reinforced beam had a moment capacity of 65.88 kN.m with 16.59 ° rotation, and the retrofitted beam had a moment capacity of 58.85 kN.m with 13.29 ° rotation. Therefore, the use of STS in the reinforced beam resulted in a moment capacity increase by a factor of 2.1, and the use of STS in the retrofitted beam increased the moment resistance by a factor of 1.87. Also, as evident from the maximum rotation values, the ductility of the beam was greatly improved with the use of STS. The failure mode of the unreinforced, reinforced, and retrofitted beam is illustrated in Figure 2.20.

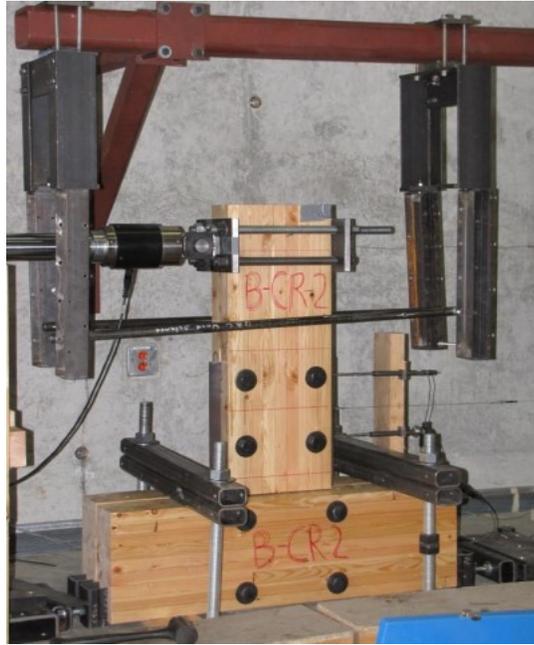
Figure 2.21 Test setup (Adapted from Lam et al., 2010).

Many codes, including the Eurocode 5, and the NBCC (2020) specify the edge distance and end distance for the bolts. However, there are no prescribed provisions for the placement of the reinforcing STS. Lam et al. (2010) investigated the effect of bolt edge distance and the placement configuration of STS on the moment carrying capacity of 24f-E Douglas Fir glulam beam to column connection. A 9.5 mm steel plate was slotted into the beam and used to connect the beam to the column. Both the beam and column had a dimension of 130 mm x 304 mm. A load was applied at the free end of the beam. Figure 2.21 shows a general setup of the test. The test was carried out with the column member placed on the ground and the load was applied horizontally.

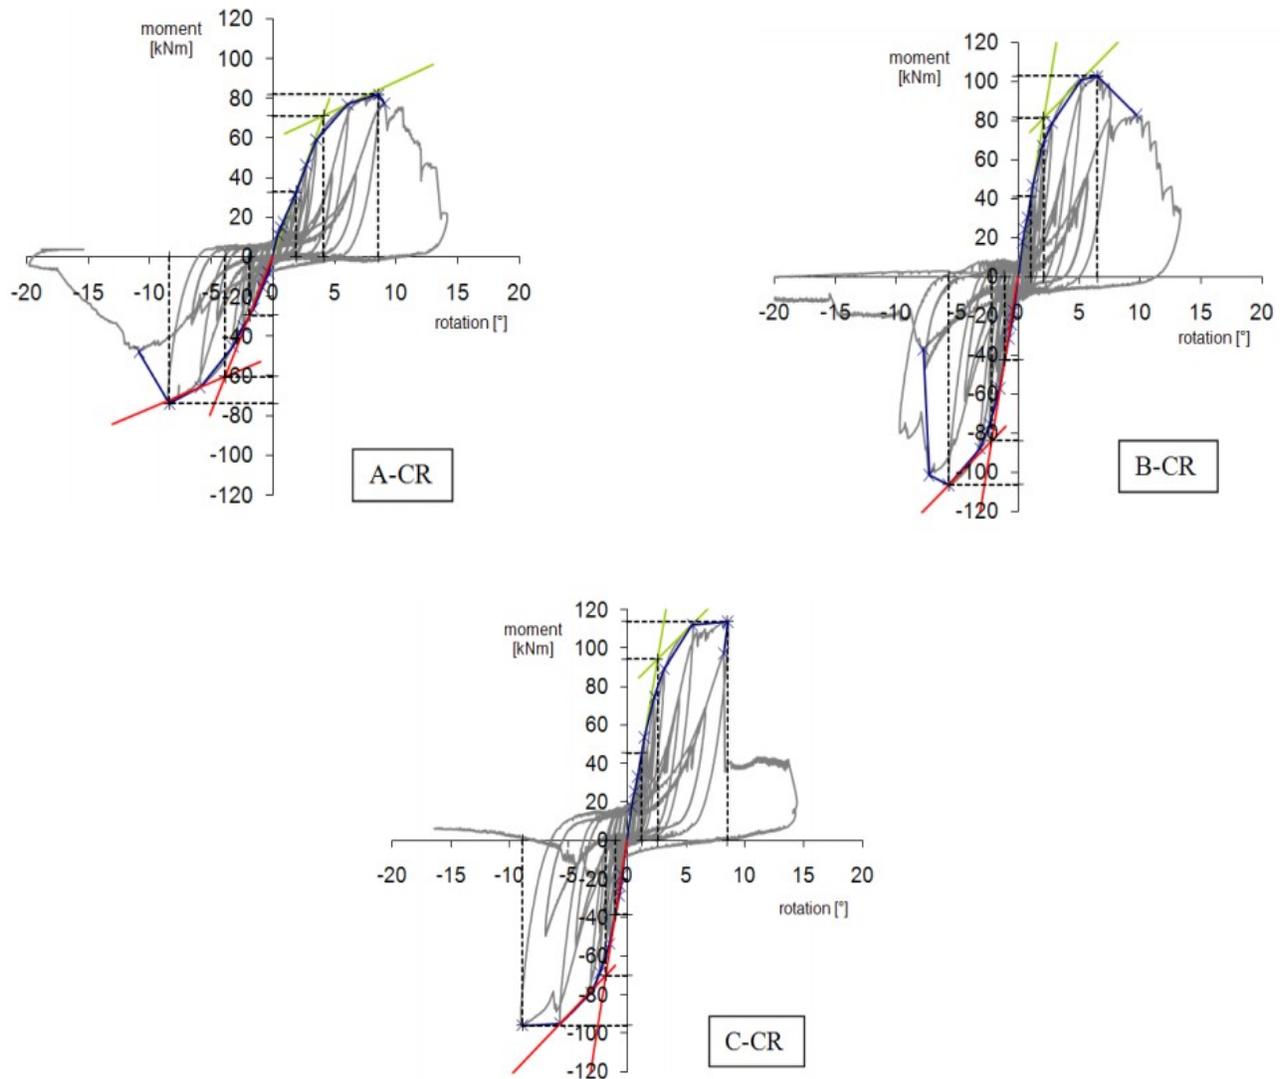
Figure 2.23 Resulted moment-rotation curves (Adapted from Lam et al., 2010).

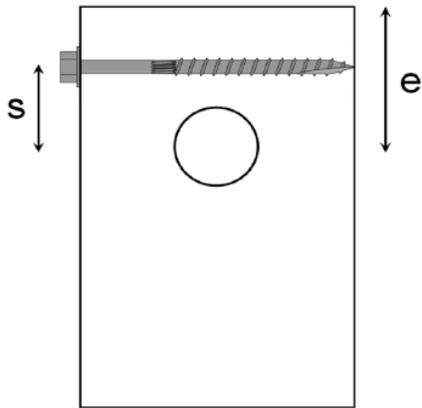
Figure 2.24 Utilized connection configuration (Adapted from Echavarría, 2007).

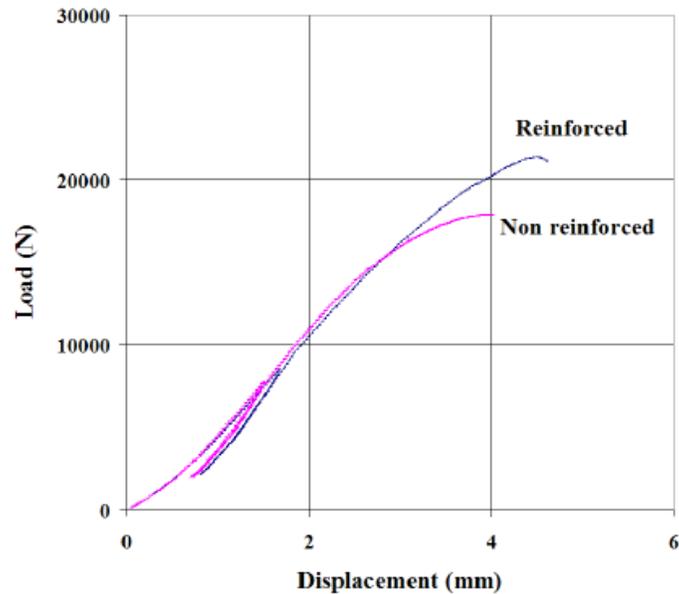
Figure 2.25 Resulted load-displacement curve (Adapted from Echavarría, 2007).

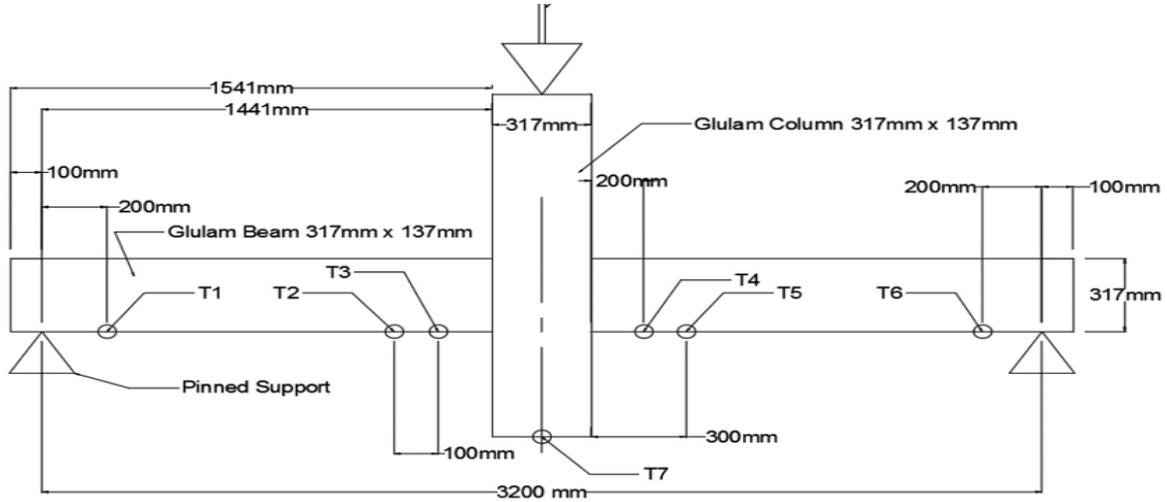
Figure 2.26 General test setup (Adapted from Petrycki and Salem, 2020)

In many design guidelines, beam-to-column connections are assumed to be pinned, and hence no moment carrying is assumed. One disadvantage of this assumption is that in case a column is damaged from a lower or above storey as a result of fire, or any other accidental event, the pinned connection will not be able to resist the extra loading as a result of this failure (Petrycki and Salem 2019). One way to mitigate this risk is to use a rigid or semi-rigid beam-column connection. In a study conducted by Petrycki and Salem (2019), the effect of STS on the moment carrying capacity, and failure mode of a glulam beam in a column removal scenario was studied. The general set up of the test consisted of two symmetrical glulam beams connected to a column placed between them. The beam-to-column connection for both beams was assumed to be perfectly rigid, and the ends of each beam were pin supported. A general setup of this experiment is shown in Figure 2.26,

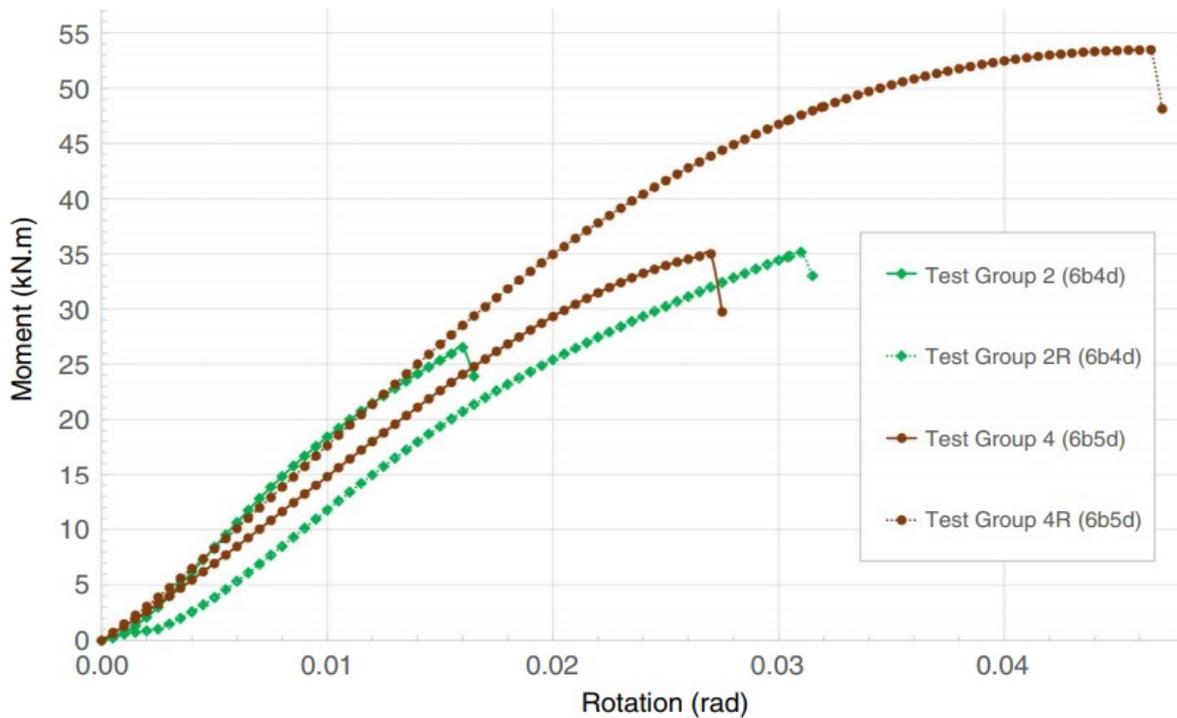
Figure 2.29 Moment-deformation graphs for reinforced connections (Adapted from Petrycki and Salem, 2020)

Also, STS provided much higher ductility as compared to unreinforced beams. The unreinforced beam exhibited cracking and brittle failure when the number of bolts was increased from 4 to 6. On the other hand, when the number of bolts increased from 4 to 6 in the reinforced connection, the beam exhibited more ductile behaviour, indicating that STS dissipated the energy of the connection that caused the brittle failure in the unreinforced beam. The unreinforced beam failed mainly by splitting along the bolt's rows, without any significant row-shear out. On the other hand, the mode of failure of STS in this experiment was primarily row-shear out. When the section was first loaded, STS prevented any premature splitting cracks from occurring. However, as the loading increased, tensile stresses were transferred to the STS, resulting in yielding and ultimate failure of the STS. The yielding of the STS imposed a high additional load on the specimen, which ultimately

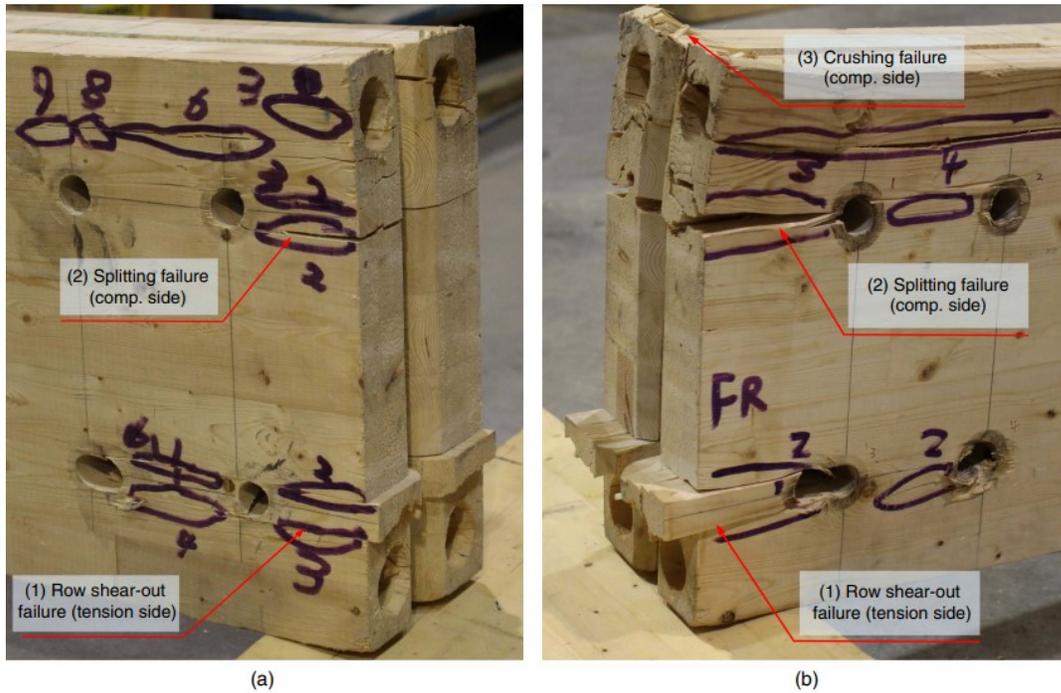
Figure 2.30 Failure modes of STS-reinforced connections: (a) 4d; (b) 5d (Adapted from Petrycki and Salem, 2020).

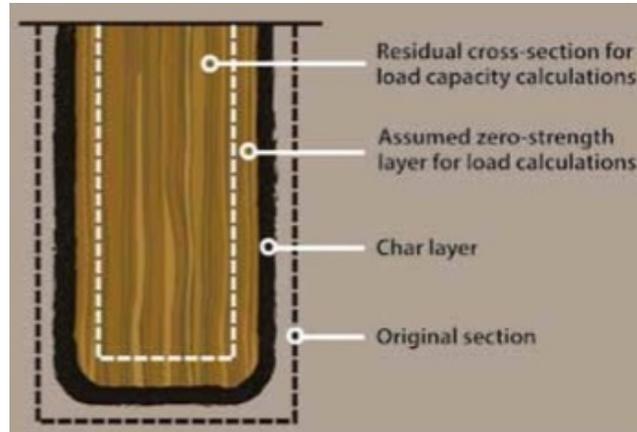
Figure 2.31 Wood Section Charring (Adapted from White and Woeste, 2013).

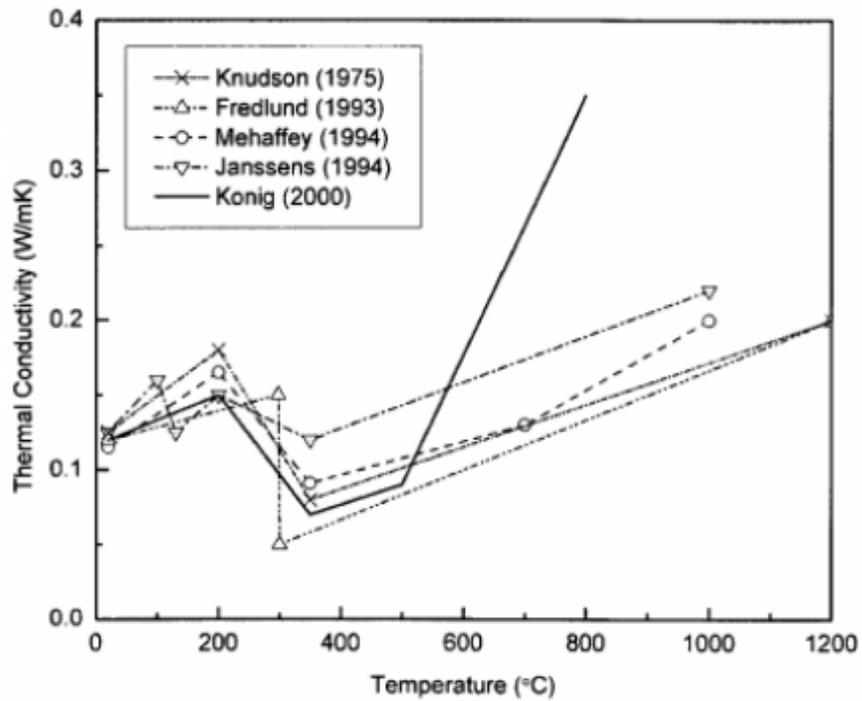
Figure 2.32 Temperature vs. thermal conductivity of wood (Adapted from Peng et al., 2011)

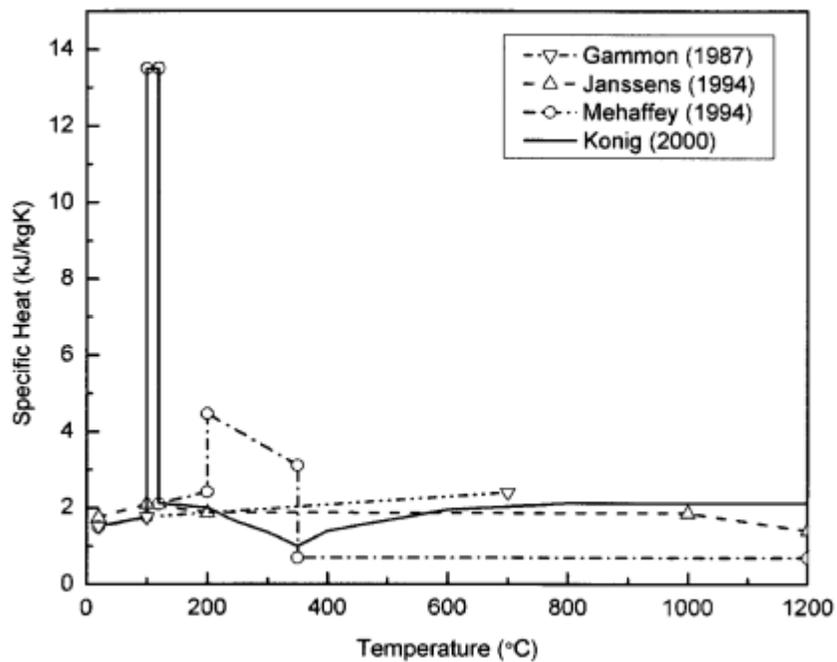
Figure 2.33 Temperature vs. specific heat of wood (Adapted from Peng et al., 2011).

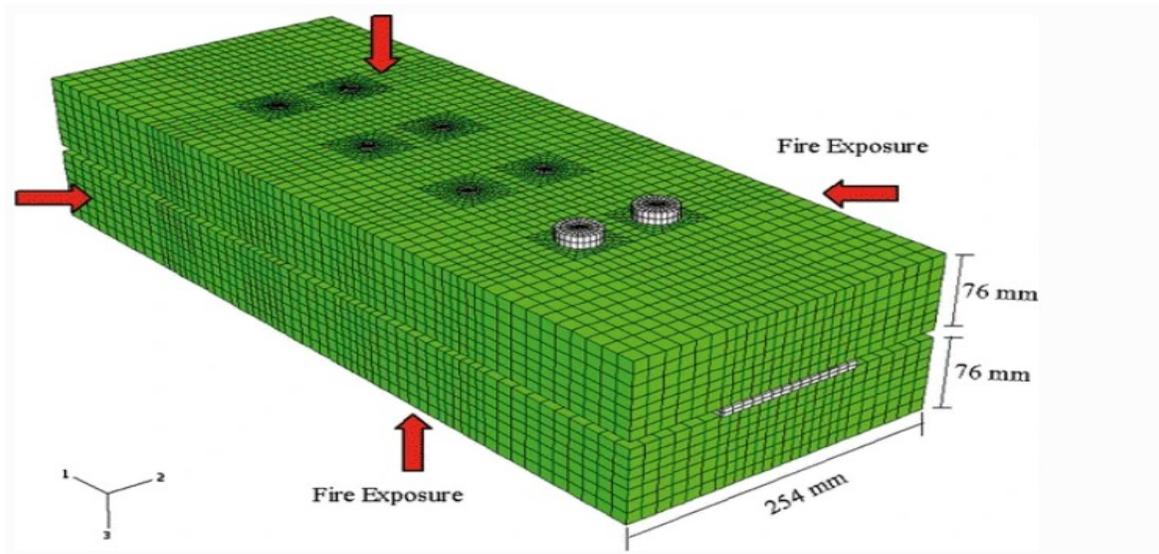
Figure 2.37 Thermal analysis finite element model (Adapted from Peng et al., 2011).

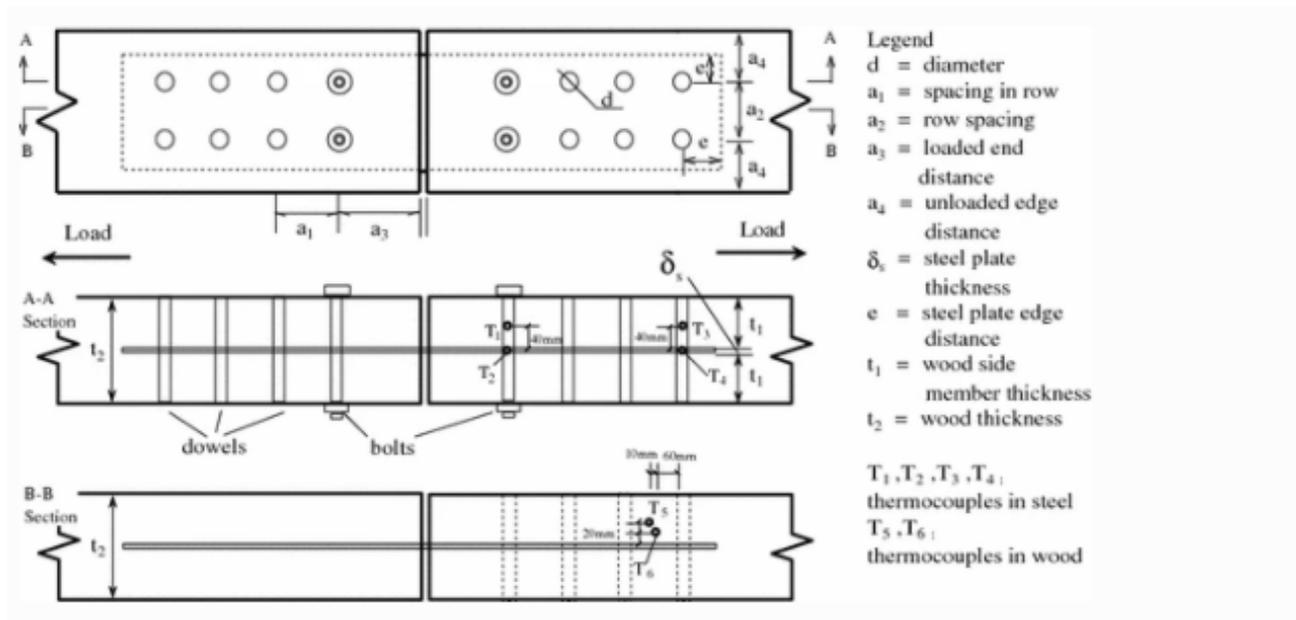
Figure 2.38 Schematic for test specimens (Adapted from Peng et al., 2011).

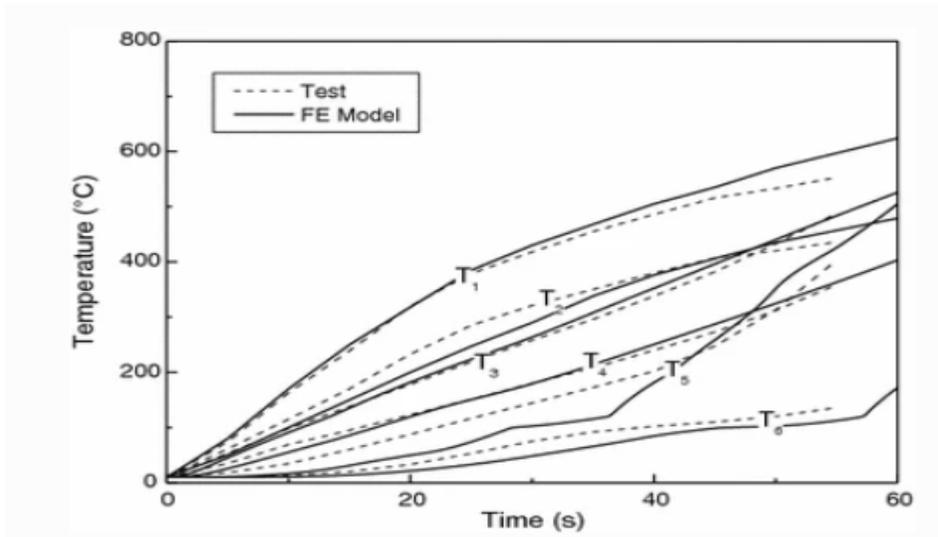
Figure 2.39 Temperature vs. time for FE model and experiments (Adapted from Peng et al, 2011)

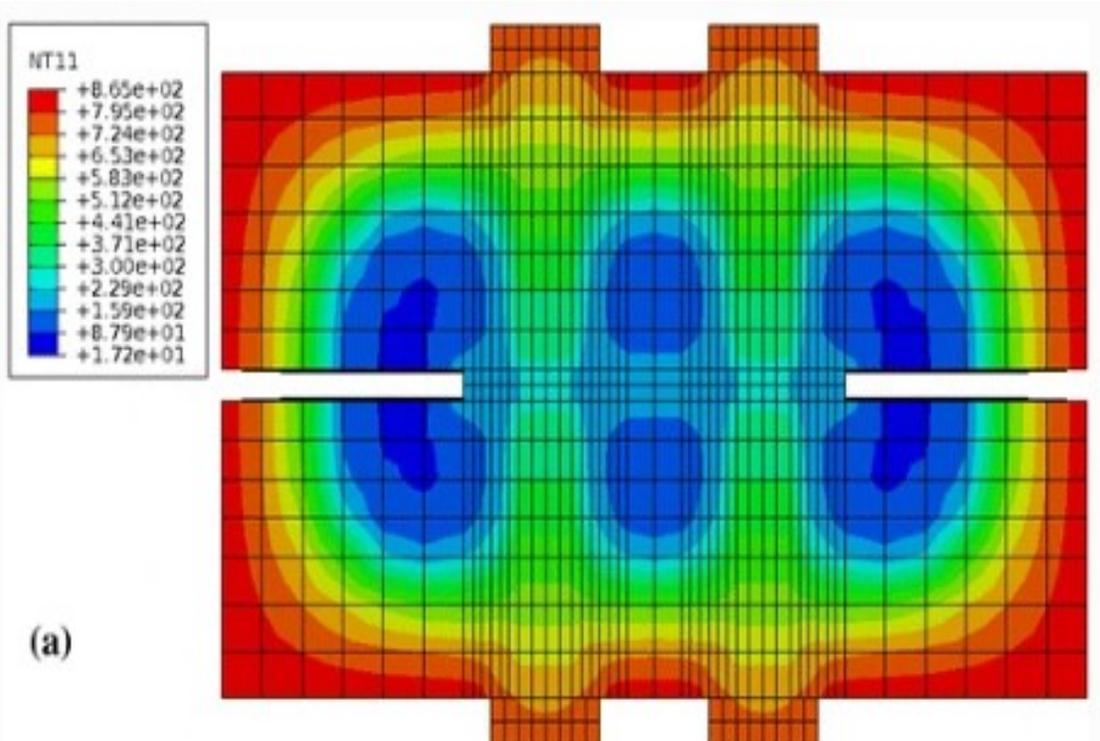
Figure 2.40 Bolt cross-section temperatures (Adapted from Peng et al., 2011).

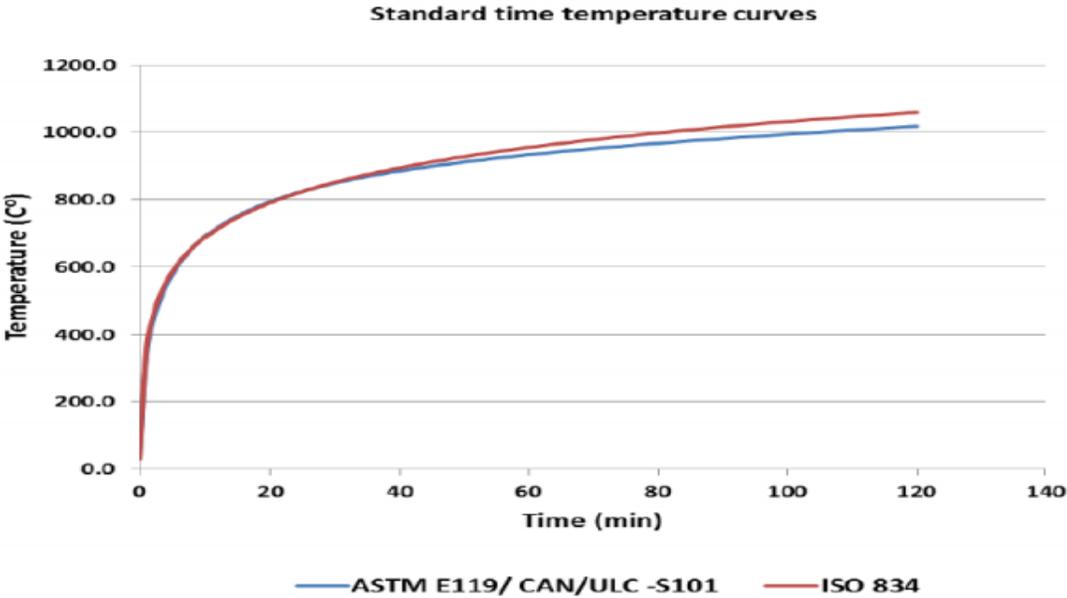
Figure 2.42 CAN/ULC-S101 and ISO 834 standard fire curves (Adapted from CAN/ULC-S101-19, 2019).

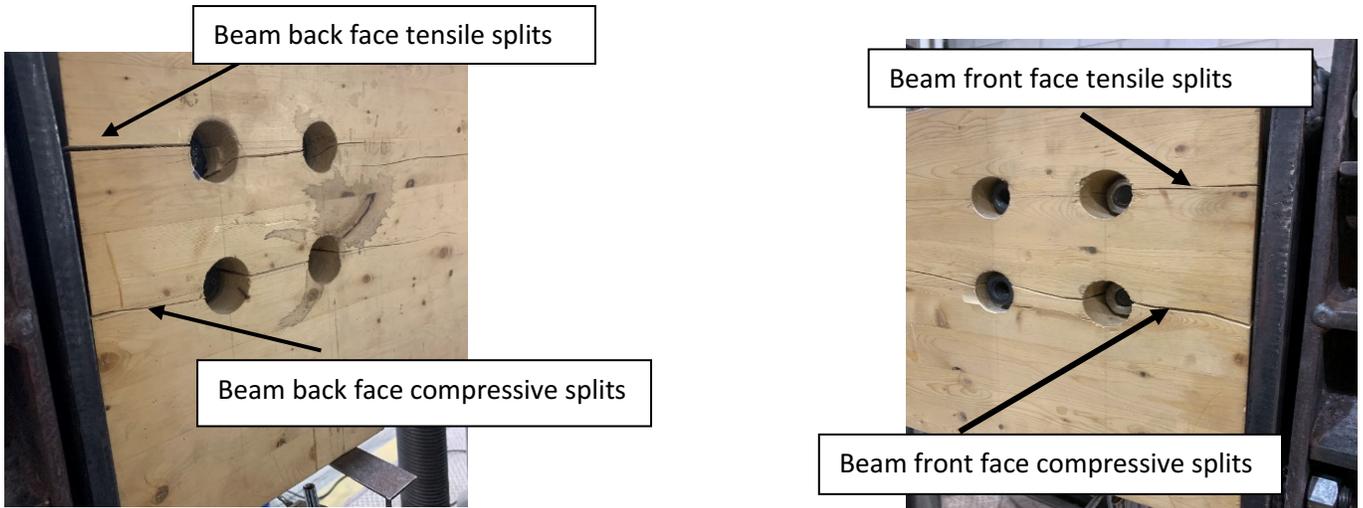
Figure 3.6 Depiction of the damage to the 4-bolt protected connections utilizing the second bolt pattern (P2) when the ambient test was terminated.

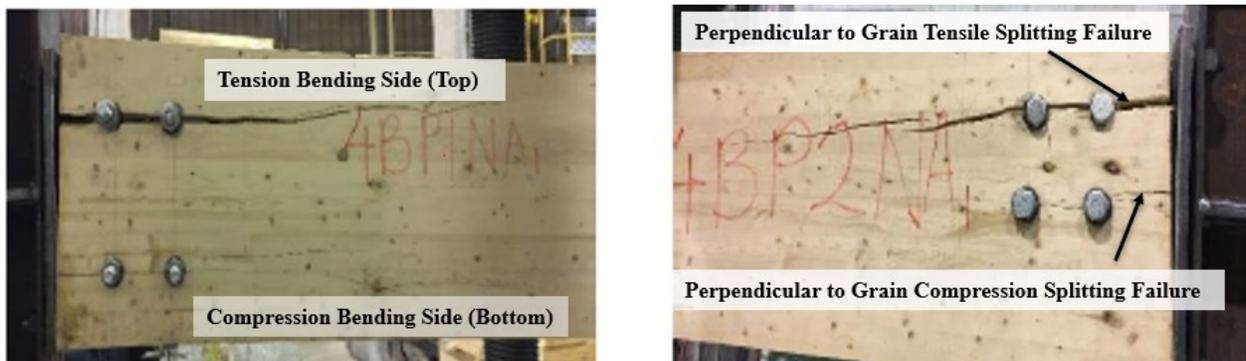
Figure 3.7 Failure modes exhibited by the 4-bolt unprotected connections utilizing the first and second bolt patterns (P1 and P2) when the tests were terminated (Adapted from Owusu, 2019).

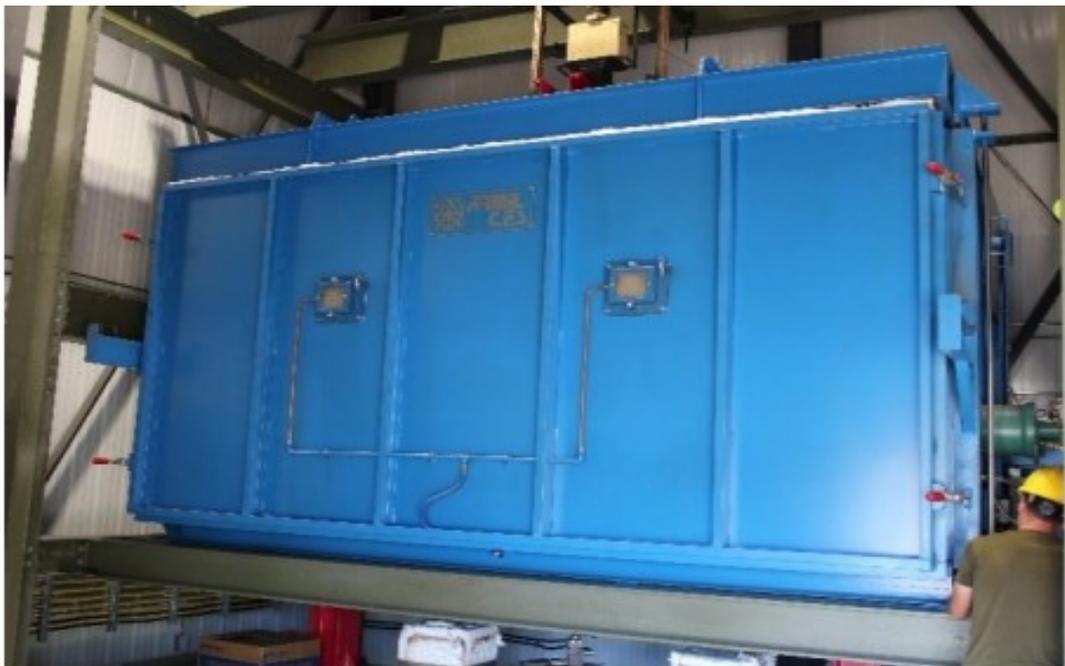
Figure 3.9 Fire testing furnace (Courtesy of Dr. Salem, 2019).
