**Experimental Fire Testing of Damaged Glulam Beam Connections
Retrofitted Using Self-Tapping Screws**

submitted to the Faculty of Graduate Studies
in partial fulfillment of the requirements for the
Degree of Master of Science

Civil Engineering

Lakehead University

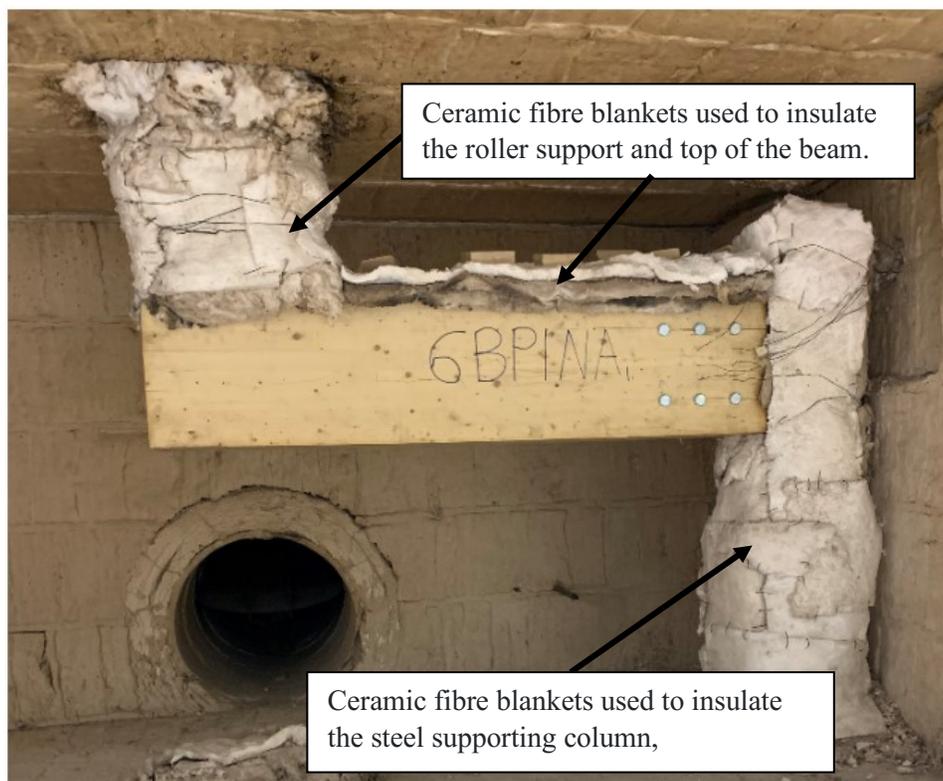
Figure 3.10 Typical fire test setup.

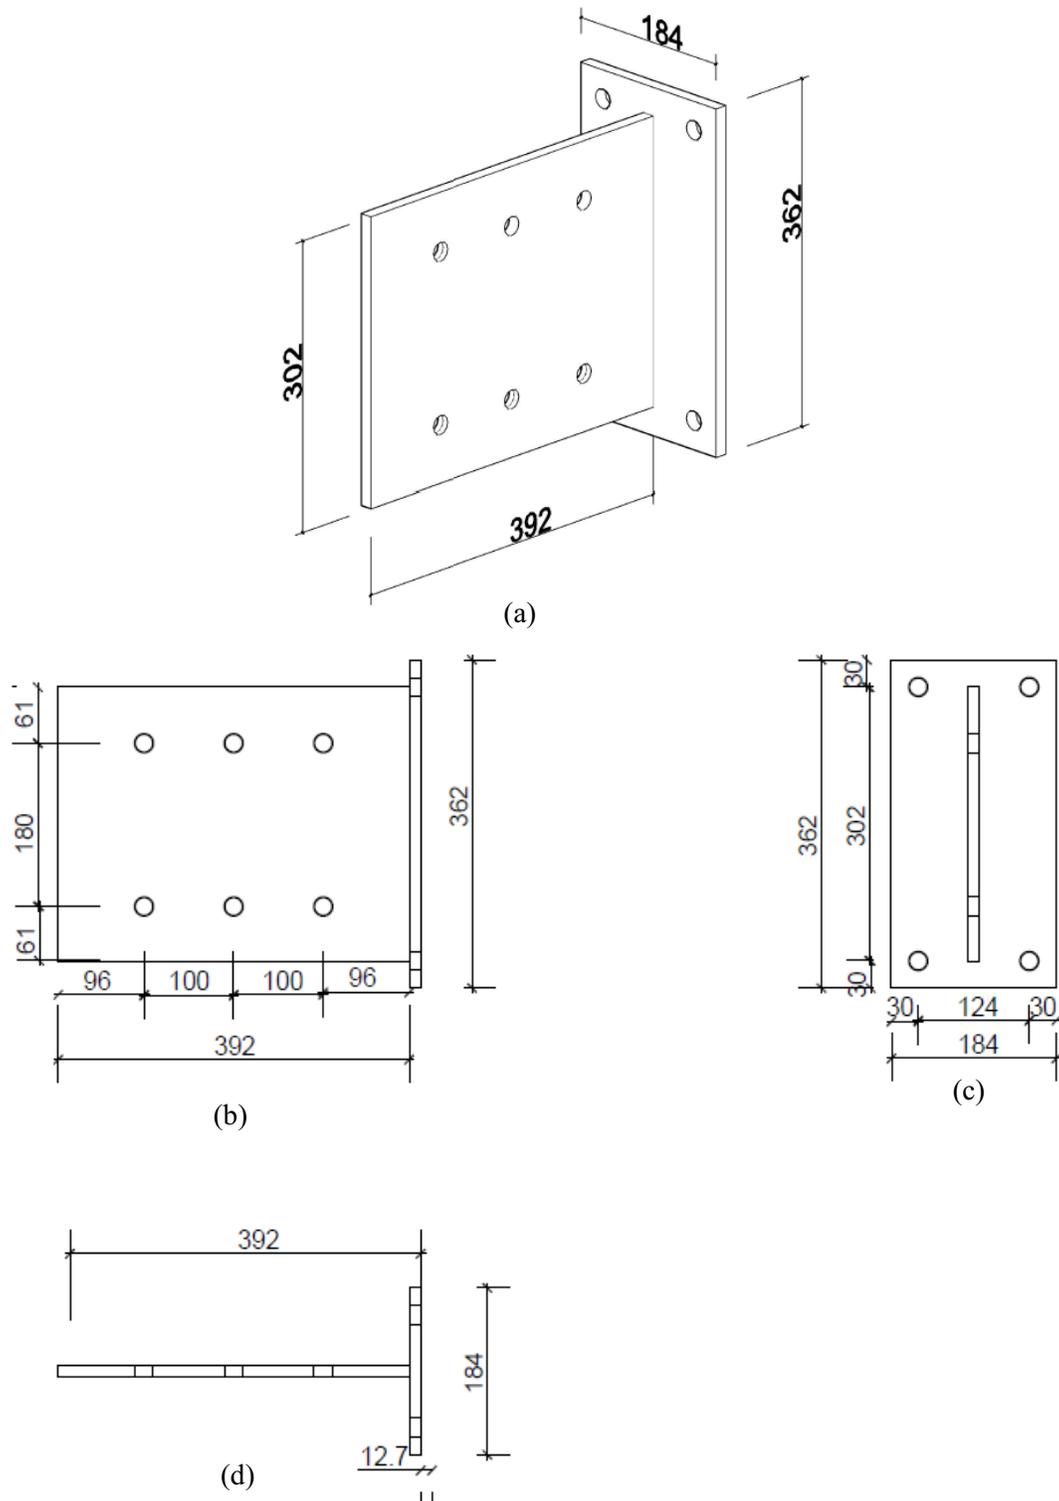
Figure 3.13 Steel T-stub connector details for the 6-bolt connection configuration with bolt pattern one (P1): (a) isometric view; (b) front view; (c) back view; (d) top view.

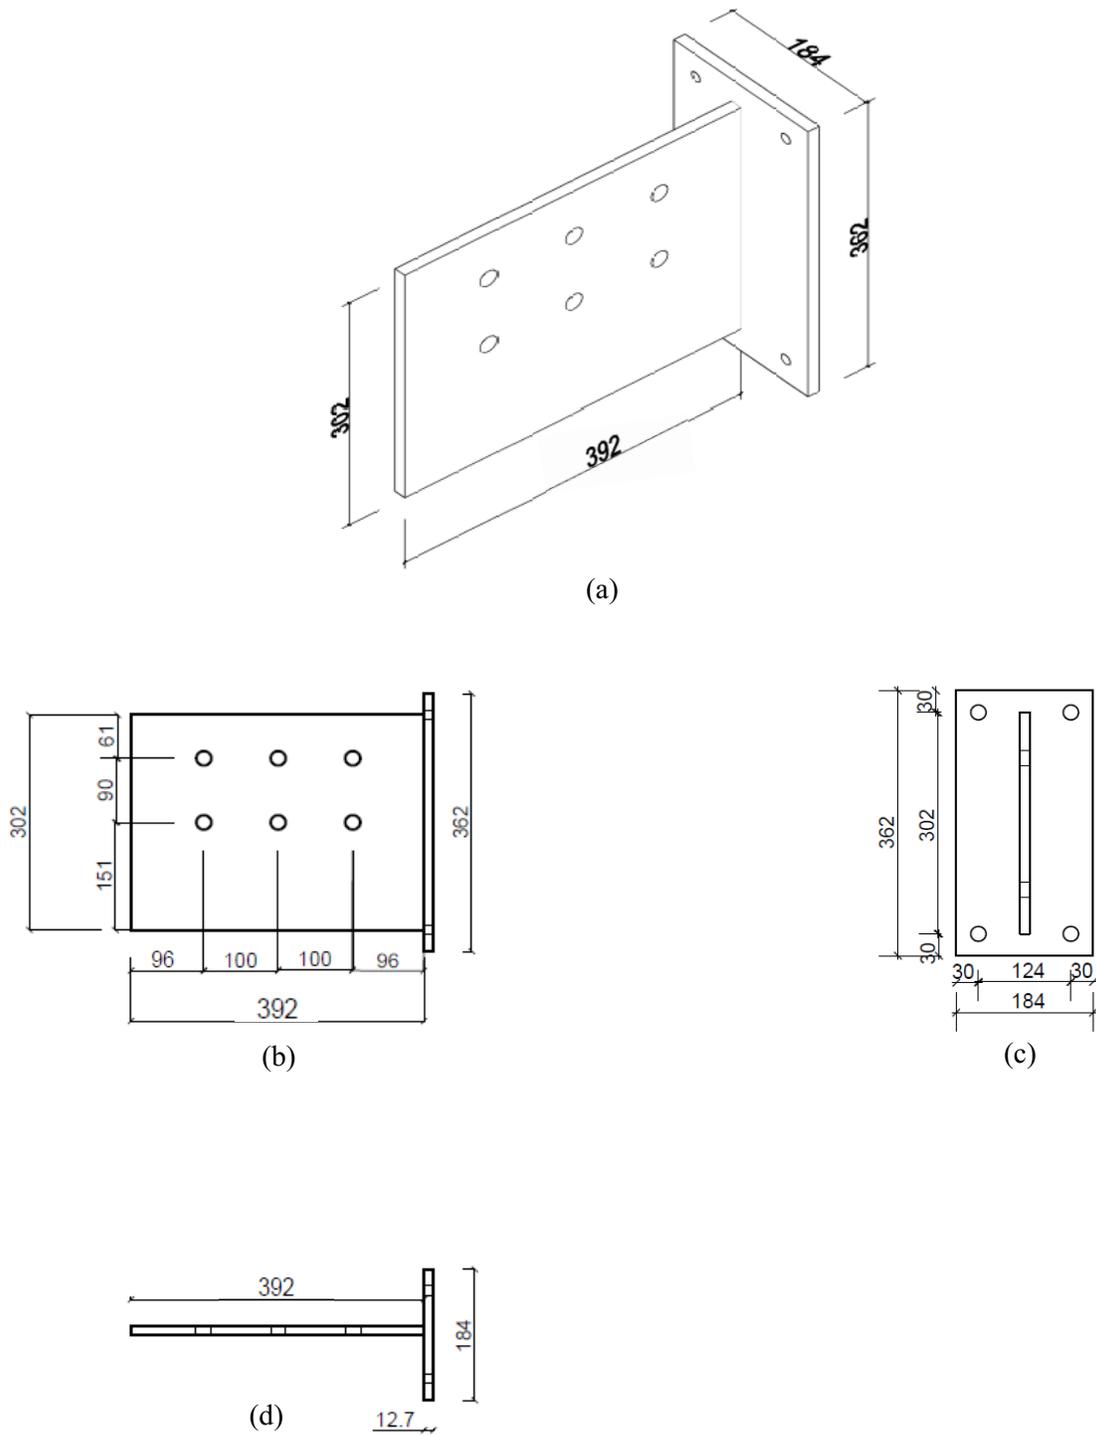
Figure 3.14 Steel T-stub connector details for the 6-bolt connection configuration with bolt pattern two (P2): (a) isometric view; (b) front view; (c) back view; (d) top view.

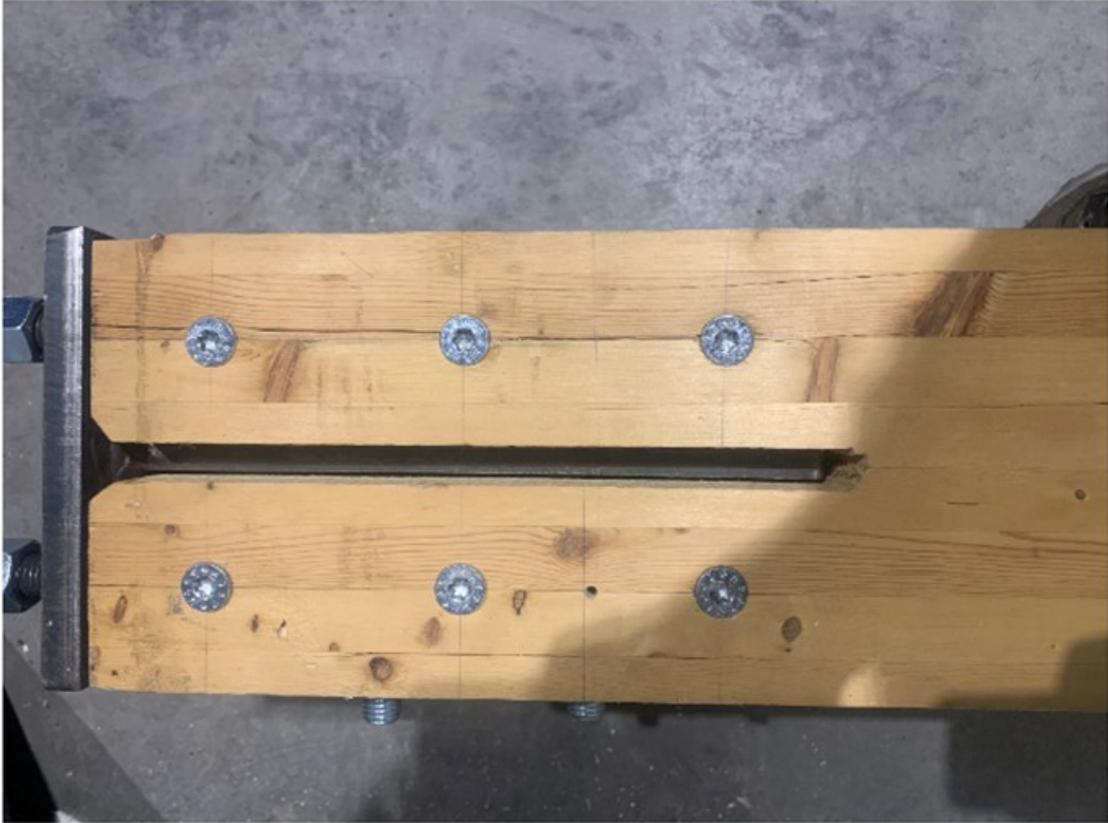
Figure 3.16 Top view of the glulam beam showing 6 STS installed.

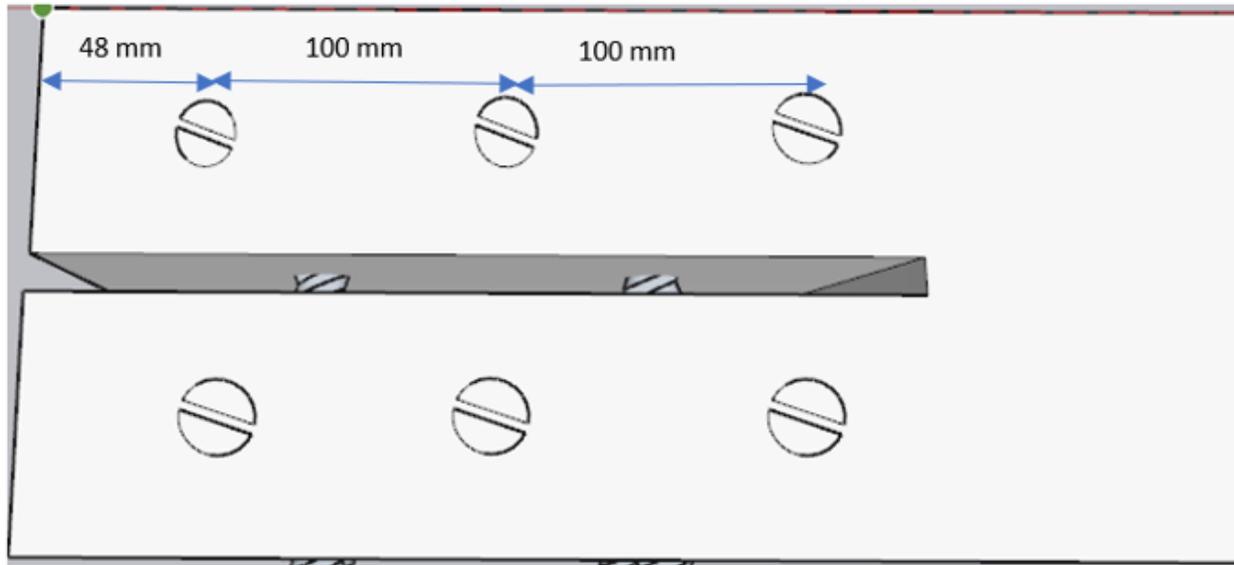
Figure 3.17 Spacing of installed STS.

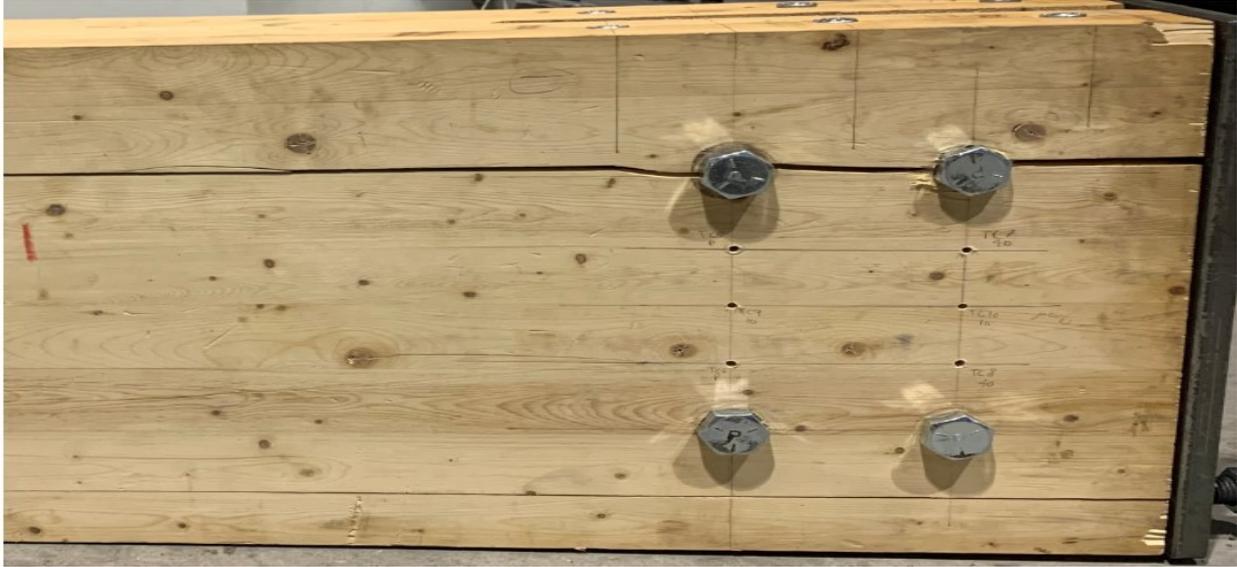
Figure 4.1 Initial state of the STS-retrofitted, unprotected connection configuration that utilized four bolts in the first bolt pattern (4BP1NP).

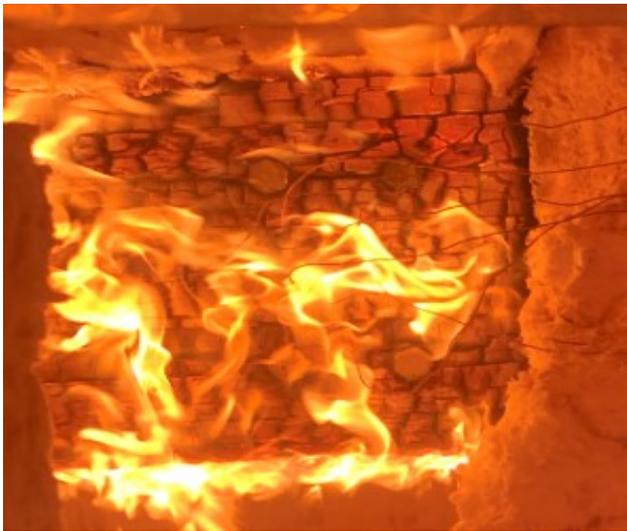
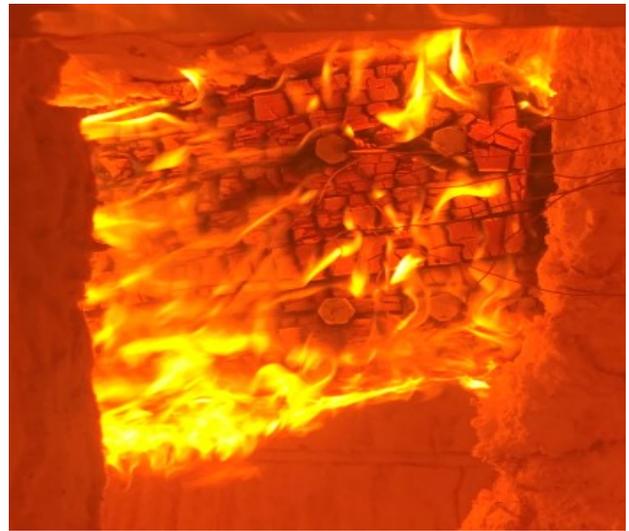
After 15 minutes

At failure (22 minutes)

Figure 4.2 Fire testing timeline for the STS-retrofitted, unprotected connection configuration that utilized four bolts in the first bolt pattern (4BP1NP).

For the STS-retrofitted connection configuration that utilized four bolts in the first bolt pattern (P1), the fire resistance time was 22 minutes. The fire resistance time of the identical undamaged, unreinforced connection tested by Owusu (2019) was 33 minutes. The retrofitted connection failed due to excessive splitting and slight row-shear out along the top row of bolts. The width of the initial main split of the connection due to ambient testing was approximately 5 mm. Figure 4.1 illustrates the initial state and splits that existed in the beam at the connection location.

During the initial 15 minutes of the fire test, it was observed that the splitting of the specimen did not propagate. However, as the fire progressed, and due to the initial extensive splitting of the specimen, the heat penetrated the wood core which eventually increased the width of the initial main split and led to the failure of the beam connection. Images of the beam during fire testing were taken at 15-minute intervals and are shown in Figure 4.2. As such, the initial splitting resulted in 11 minutes less fire resistance time as compared to the undamaged connection tested by Owusu (2019).

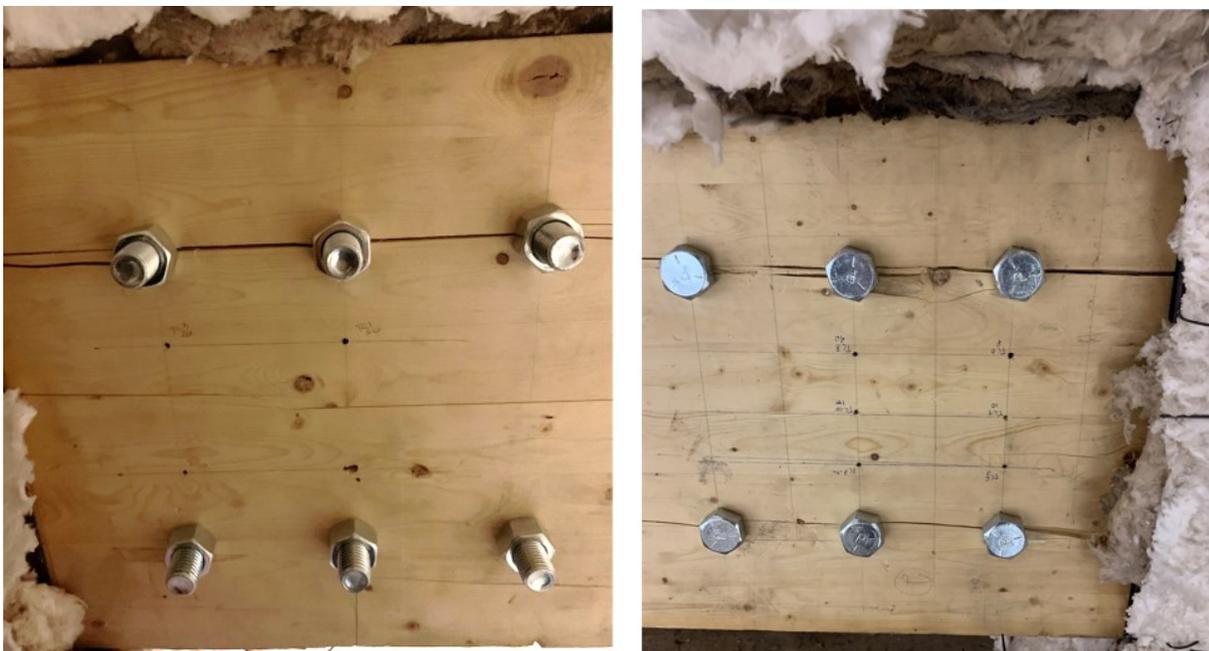
Figure 4.3 Initial state of the STS-retrofitted, unprotected connection configuration that utilized six bolts in the first bolt pattern (6BP1NP).

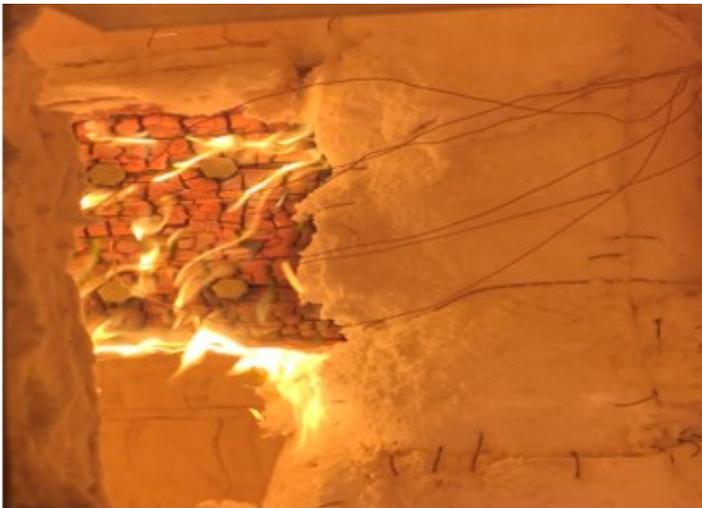
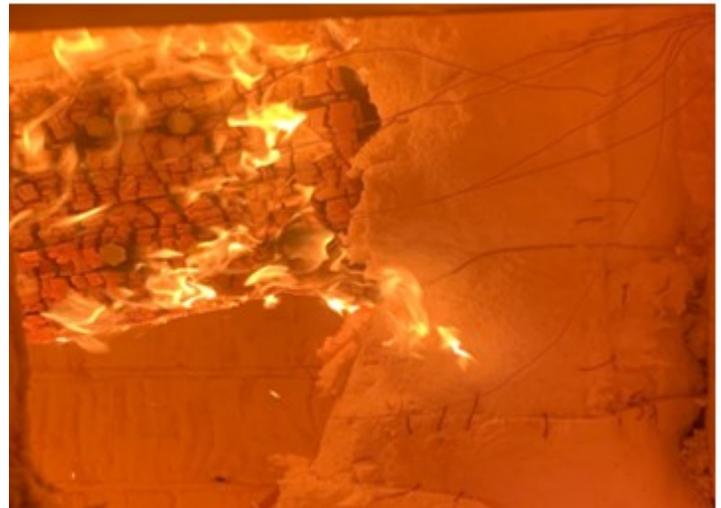
After 15 minutes

At failure (31 minutes)

Figure 4.4 Fire testing timeline for the STS-retrofitted, unprotected connection configuration that utilized six bolts in the first bolt pattern (6BP1NP).

For the STS-retrofitted, unprotected connection configuration that utilized six bolts in the first bolt pattern, the fire resistance time was 31 minutes. The beam failed due to excessive splitting along the top row of the bolts. The fire resistance time of the identical unreinforced, undamaged, and unprotected connection failed after 22 minutes only due to an unexpected glue line delamination. When using STS, the sudden glue line delamination that occurred in the unreinforced, undamaged connection did not take place. This kept the glulam beam section intact at the connection location and hence resulted in longer fire-resistant time. The initial splitting of the beam at the connection was approximately 1-2 mm. The small initial splitting width further contributed to the increased fire resistance time of this specimen as compared to the undamaged connection and the four-bolt, STS-retrofitted damaged configuration. The initial state of the STS-retrofitted, unprotected connection configuration that utilized six bolts in the first bolt pattern (P1) connection is shown in Figure 4.3.

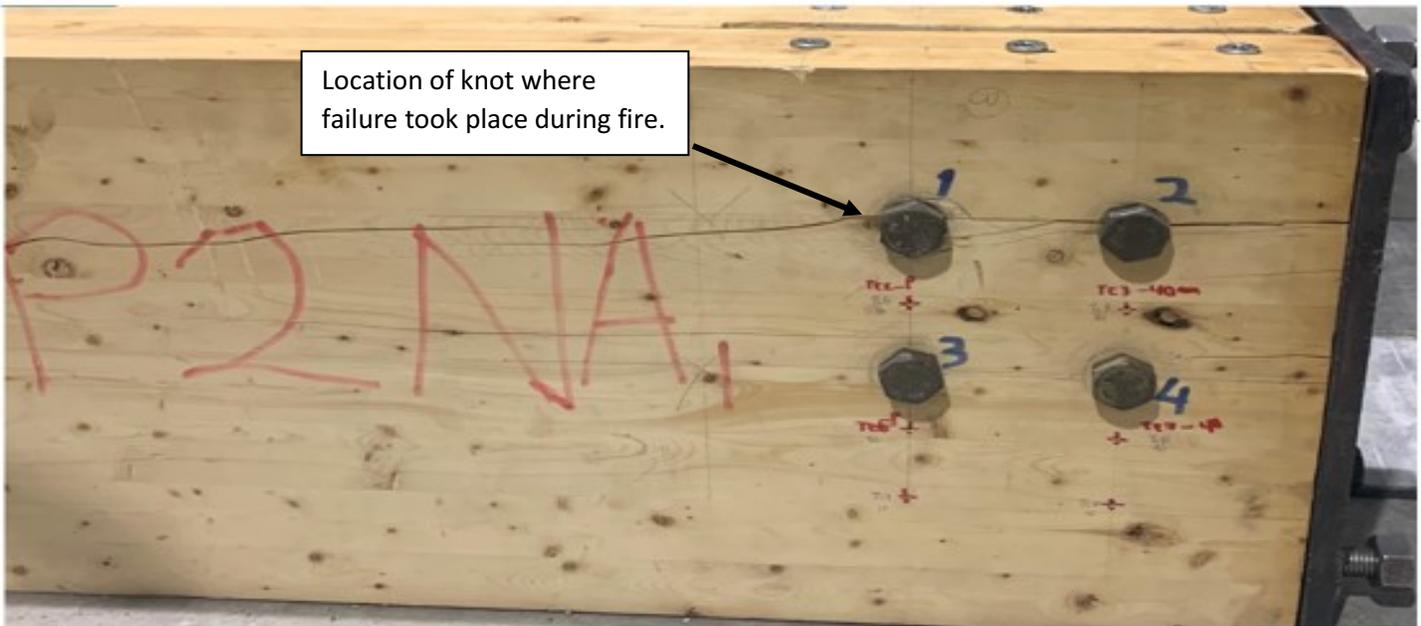
Figure 4.5 Initial state of the STS-retrofitted, unprotected connection configuration that utilized four bolts in the second bolt pattern (4BP2NP)

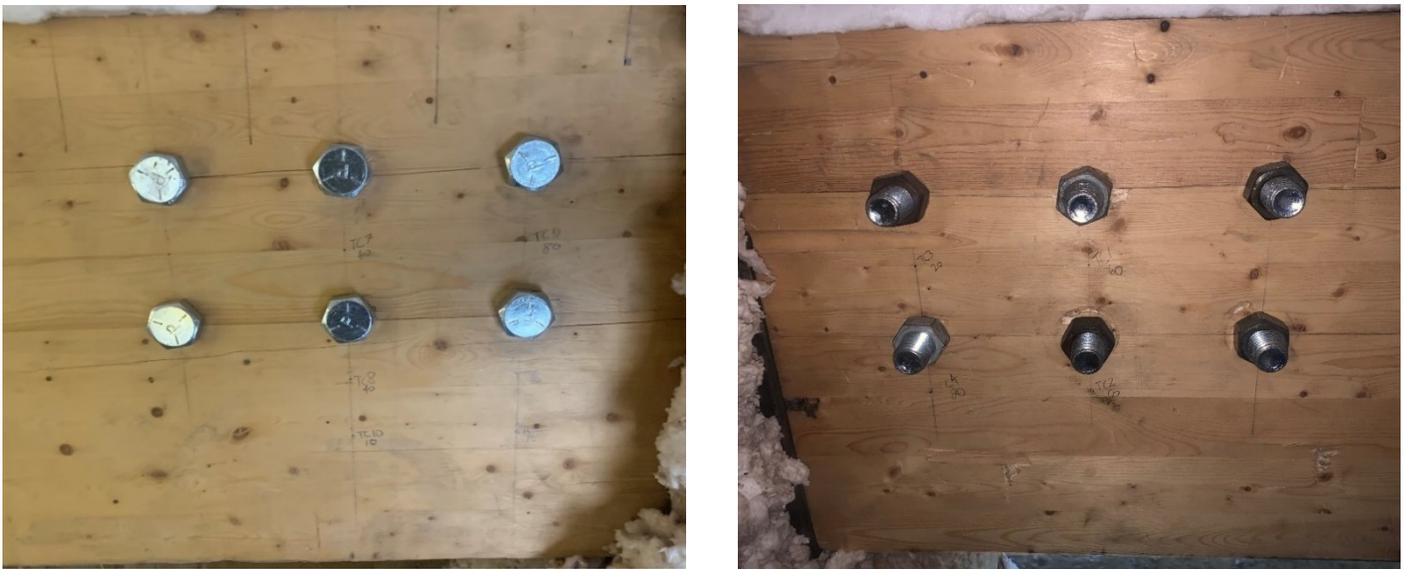
Figure 4.7 Initial state of the STS-retrofitted, unprotected connection configuration that utilized six bolts in the second bolt pattern (6BP2NP).

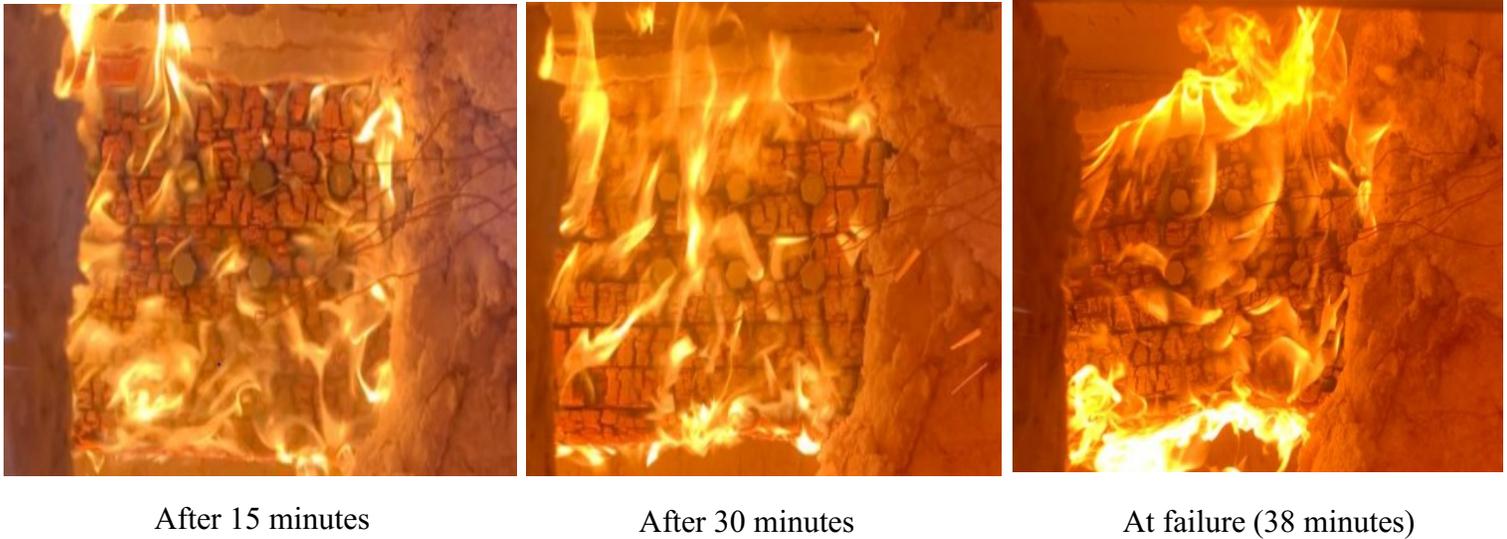
Figure 4.8 Fire testing timeline for the STS-retrofitted, unprotected connection configuration that utilized six bolts in the second bolt pattern (6BP2NP).

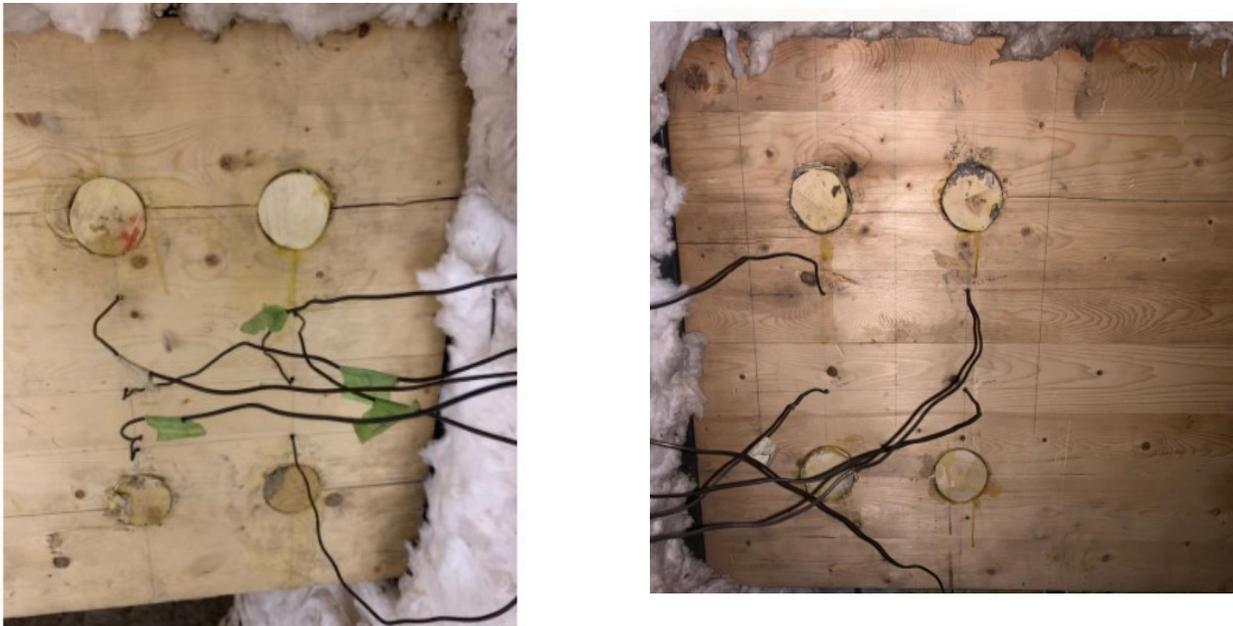
Figure 4.9 Initial state of the STS-retrofitted, protected connection configuration that utilized four bolts in the first bolt pattern (4BP1P).

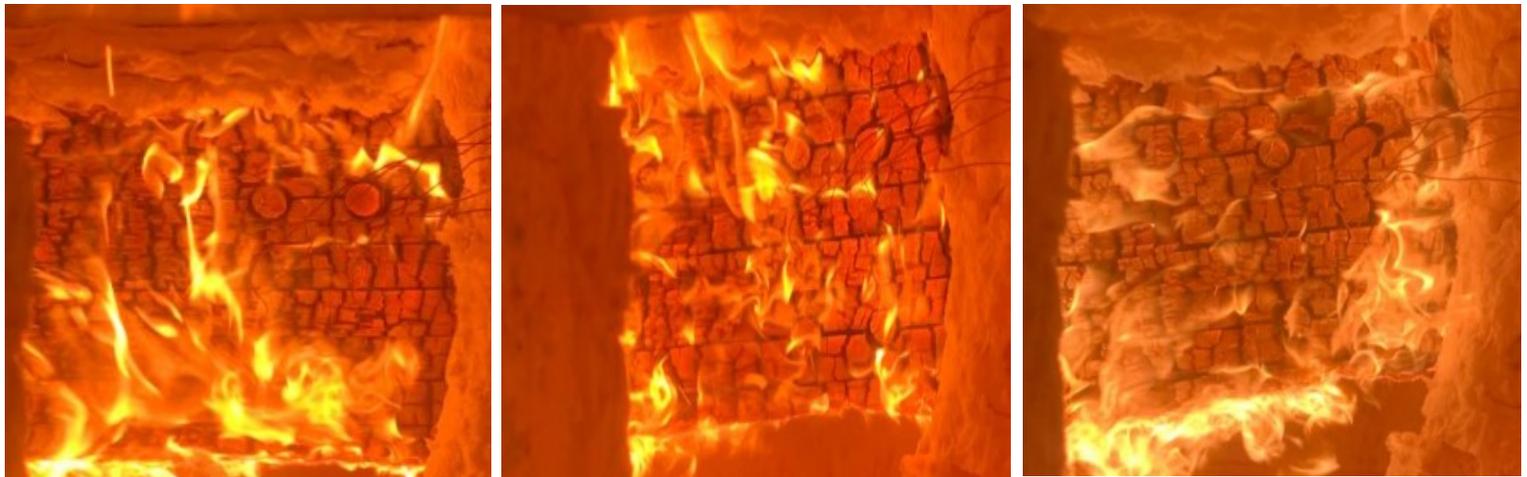
After 15 minutes

After 30 minutes

For the STS-retrofitted, protected connection configuration that utilized four bolts in the first bolt pattern (P1), the fire resistance time was 43 minutes. The initial split of the beam formed along the top row of bolts had a width of approximately 3 mm (Figure 4.9). The STS-reinforced beam connection failed due to a reduction in the strength because of charring. The identical undamaged, unreinforced connection tested by Owusu (2019) was tested twice. The fire resistance times were 56 and 42 minutes (average of 49 minutes). The 14 minutes less fire resistance time of the connection examined in the second fire test compared to the same connection examined in the first test can be attributed to wood splitting that occurred at a glue line due to delamination. Therefore, the damaged, STS-retrofitted connection achieved a lower fire resistance time by 13 minutes compared to the undamaged, unreinforced connection which did not experience glue line delamination. It also had a 1-minute greater fire resistance time than that of the identical undamaged, unreinforced connection in which the glue line delamination caused the earlier failure.

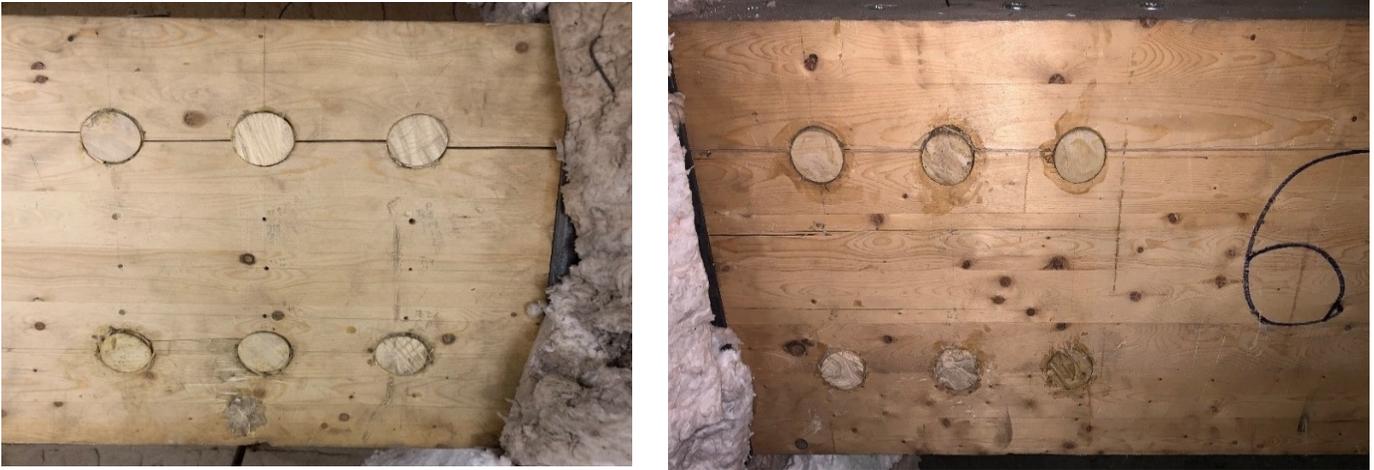
Figure 4.11 Initial state of the STS-retrofitted, protected connection configuration that utilized six bolts in the first bolt pattern (6BP1P).

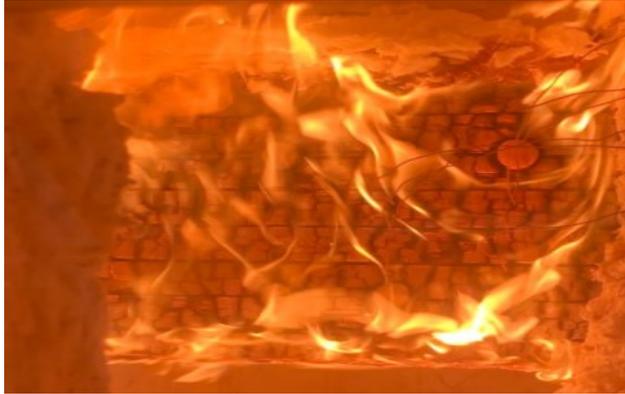
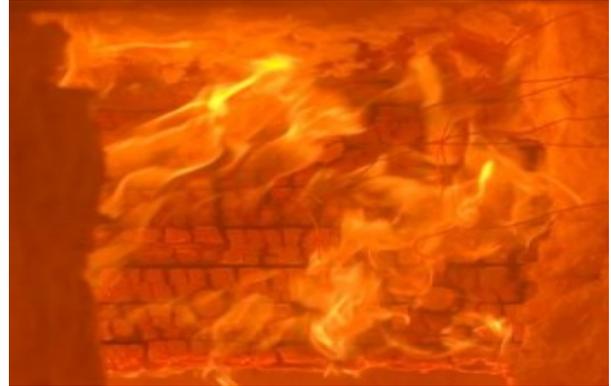
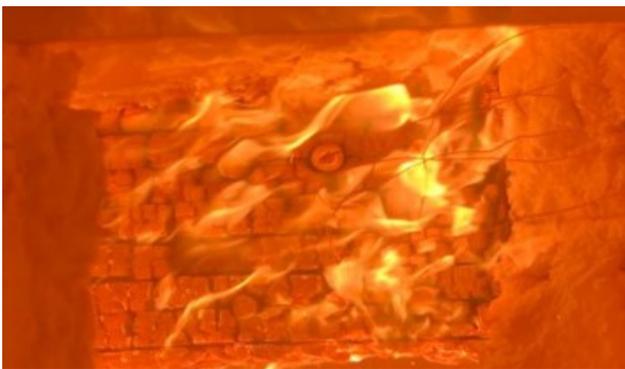
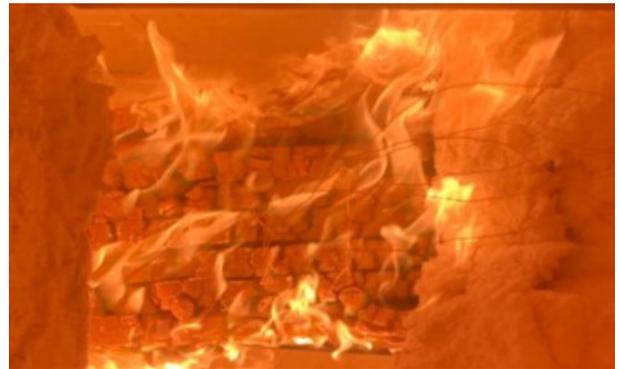
After 15 minutes

After 30 minutes

After 45 minutes

At failure (60 minutes)

Figure 4.12. Fire testing timeline for the STS-retrofitted, protected connection configuration that utilized six bolts in the first bolt pattern (6BP1P).

For the STS-retrofitted, protected connection configuration that utilized six bolts in the first bolt pattern (P1), the fire resistance time was 60 minutes. The initial split had a width of approximately 3 mm and thus, the connection failed due to excessive charring localized mainly along the top row of bolts, where the main split existed. It was also observed after failure (Figure 4.12) that the beam section was severely charred at the bottom as well. Glue line delamination was observed to happen in the STS-reinforced connection between the top and bottom rows of bolts; however, this did not result in any accelerated failure of the connection. Conversely, in the identical undamaged, unreinforced connection tested by Owusu (2019), the fire resistance time was only 48 minutes and the connection failed suddenly mainly due to glue line delamination that occurred along the top row of bolts. When the test was repeated for this connection configuration by Owusu (2019), the connection was able to sustain the applied loads for 62 minutes, since no glue line delamination took place. Therefore, the fire test results of the STS-retrofitted connection show that the presence of the STS prevented the glue line delamination and enhanced the fire resistance time of the

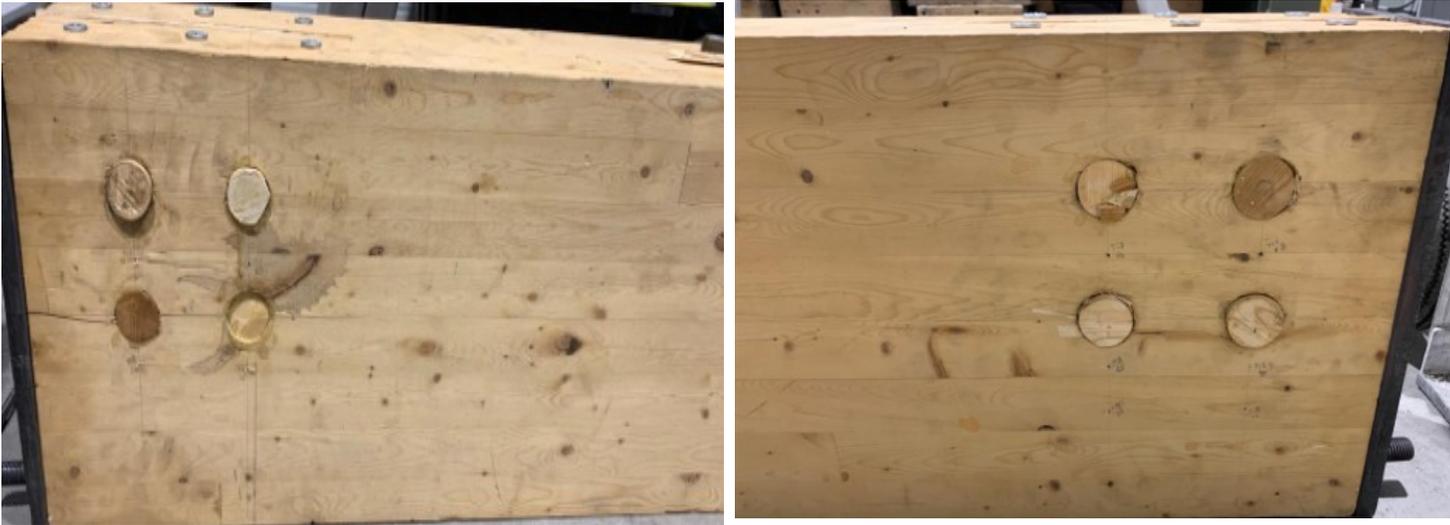
Figure 4.13 Initial state of the STS-retrofitted, protected connection configuration that utilized four bolts in the second bolt pattern (4BP2P).

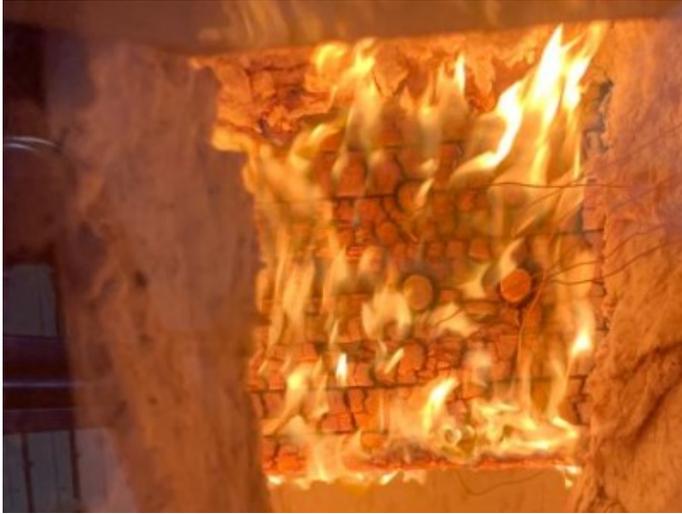
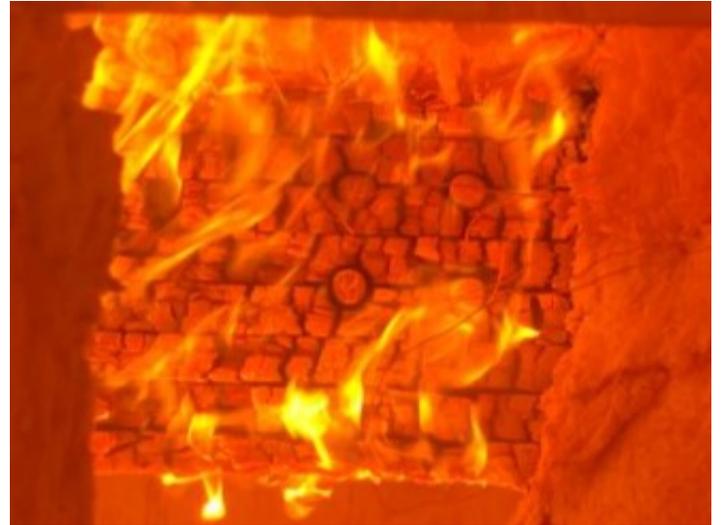
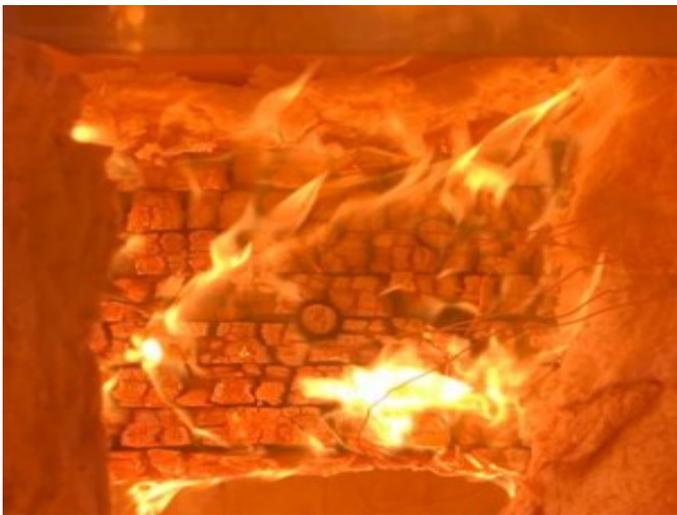
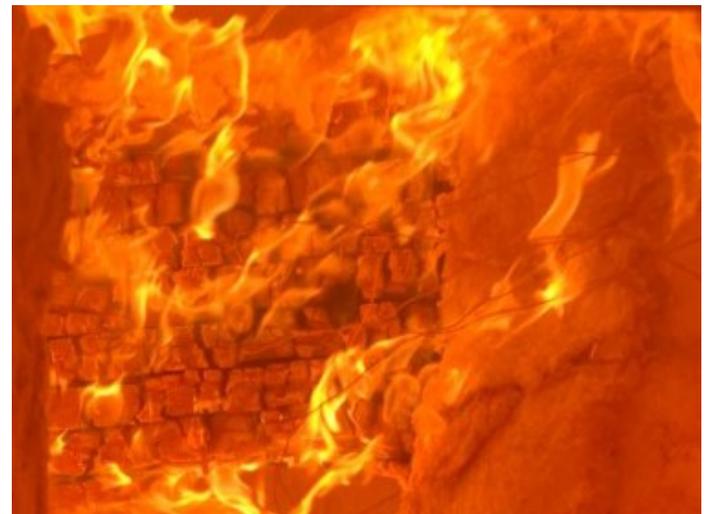
After 15 minutes

After 30 minutes

After 45 minutes

At failure (58 minutes)

Figure 4.14 Fire testing timeline for the STS-retrofitted, protected connection configuration that utilized four bolts in the second bolt pattern (4BP2P).

For the STS-retrofitted, protected connection configuration that utilized four bolts in the second bolt pattern (P2), the fire resistance time was 58 minutes. The initial split exhibited by the connection had a width of less than 1 mm (Figure 4.13). Thus, the beam connection failed due to excessive reduction in its strength as a result of charring, and not due to any glue line delamination (Figure 4.14).

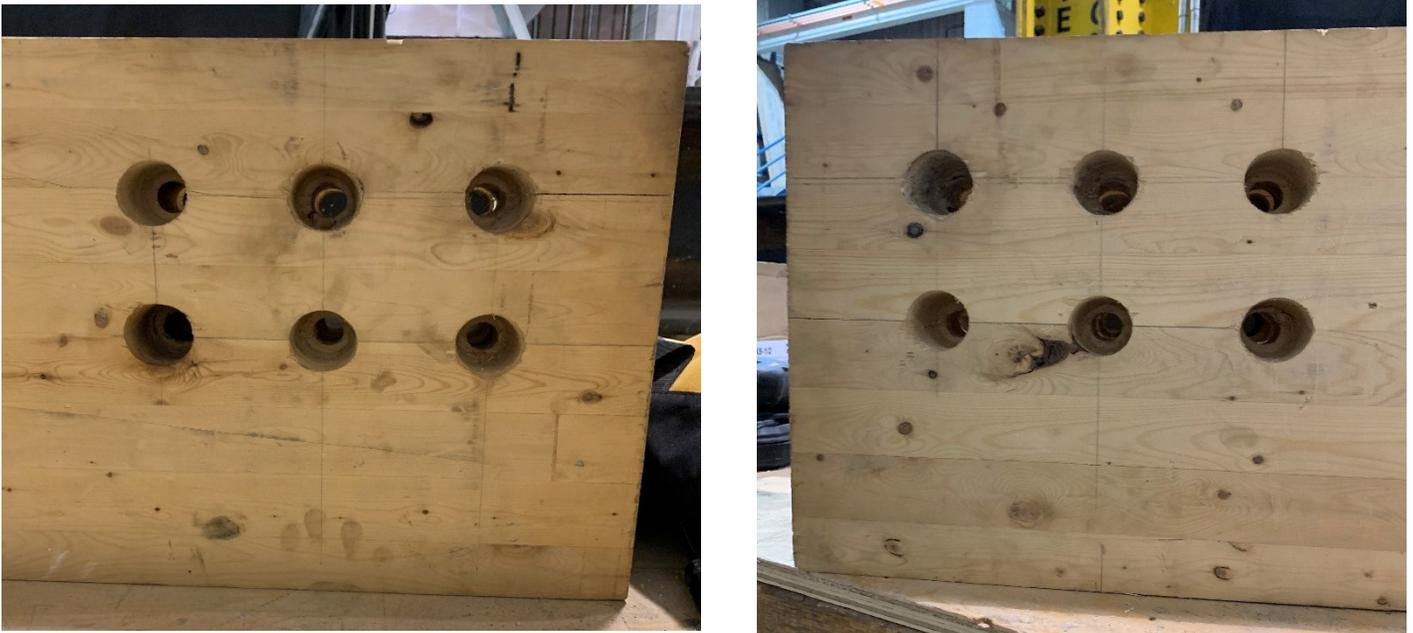
Figure 4.15 Initial state of the STS-retrofitted, protected connection configuration that utilized six bolts in the second bolt pattern (6BP2P).

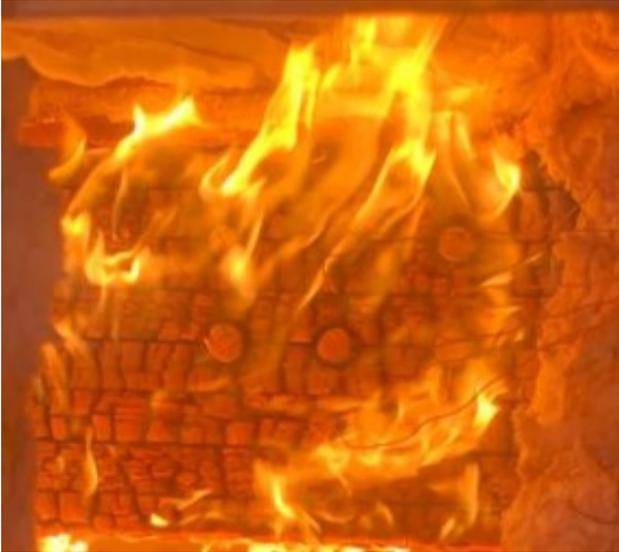
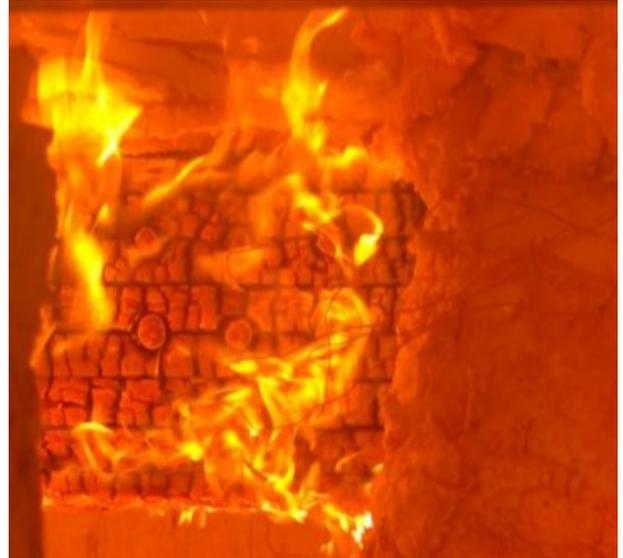
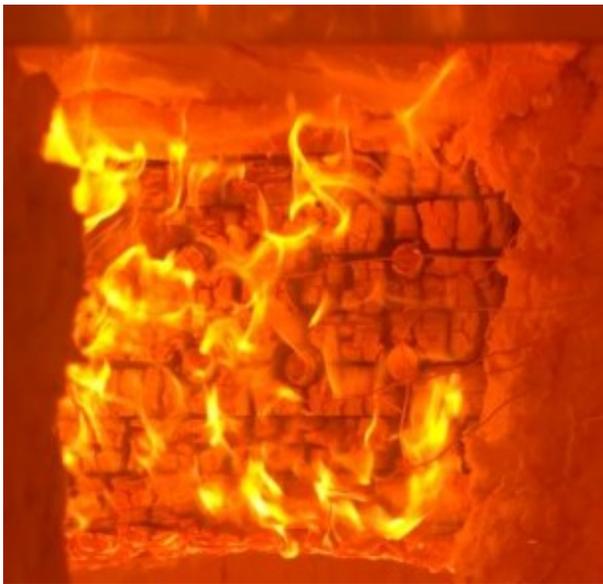
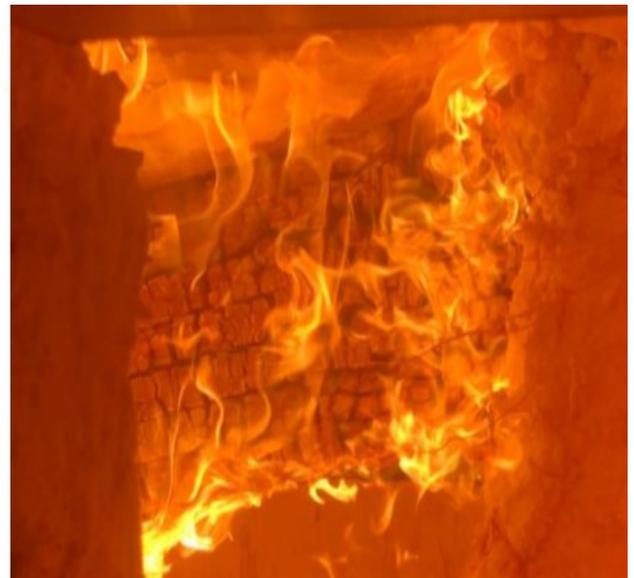
After 15 minutes

After 30 minutes

After 45 minutes

At failure (57 minutes)

Figure 4.16 Fire testing timeline for the STS-retrofitted, protected connection configuration that utilized six bolts in the second bolt pattern (6BP2P).

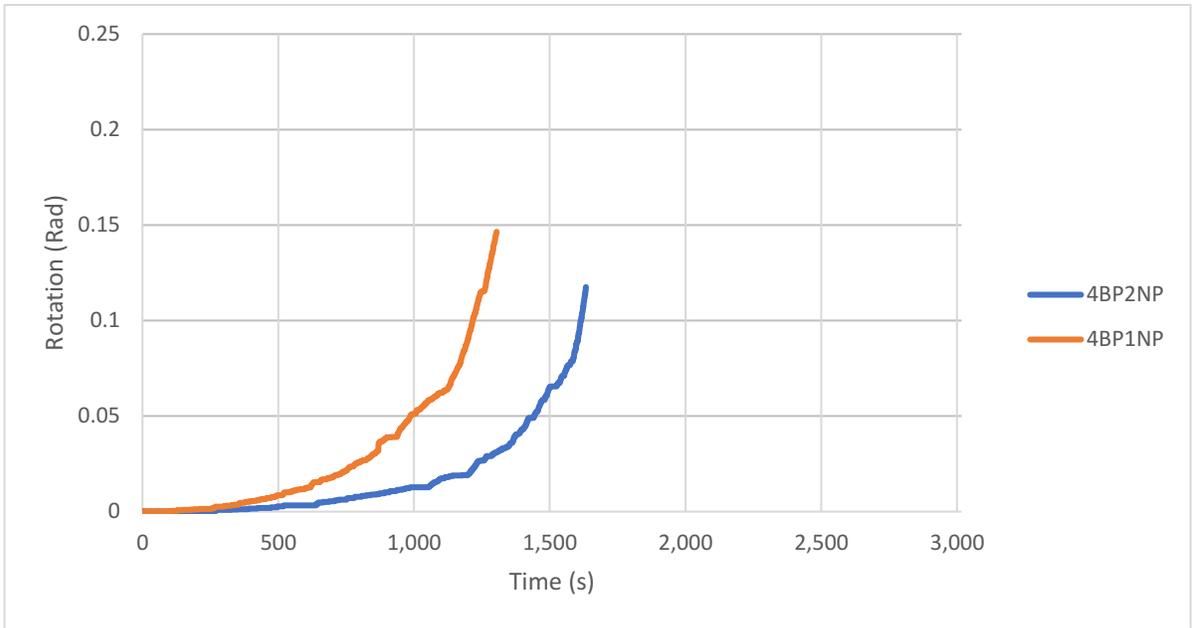
Figure 4.17 Time-rotation relationships of the STS-retrofitted, unprotected connection configurations that utilized four bolts in the first (4BP1NP) and second bolt patterns (4BP2NP).

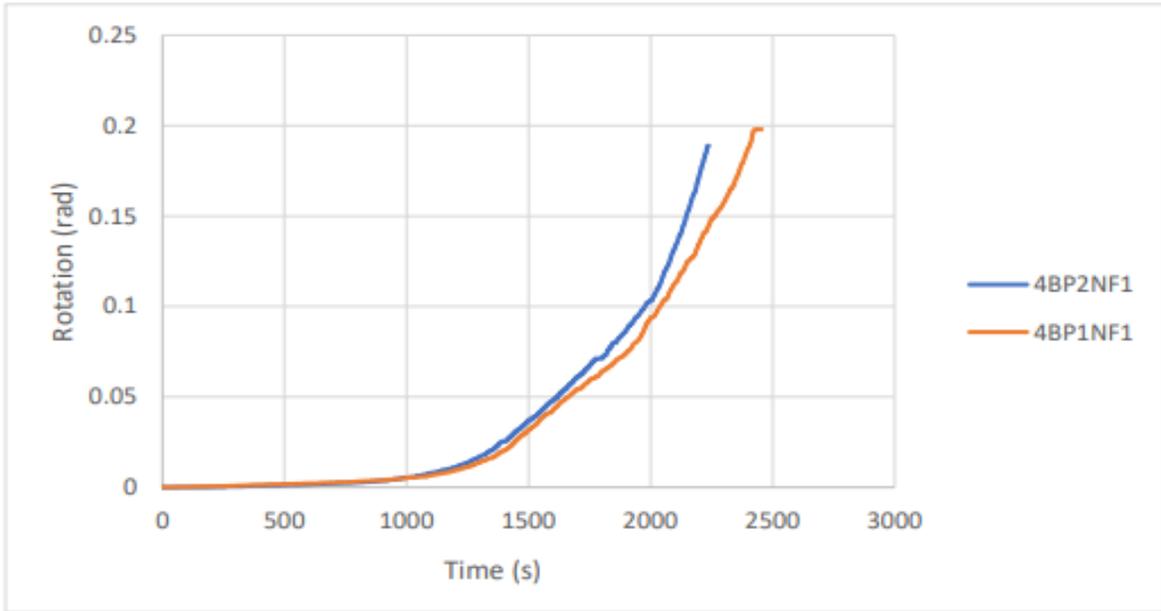
Figure 4.18. Time-rotation relationships of the undamaged, unreinforced and unprotected connection configurations that utilized four bolts in the first (4BP1NF1) and second bolt patterns (4BP2NF1) (Adapted from Owusu, 2019).

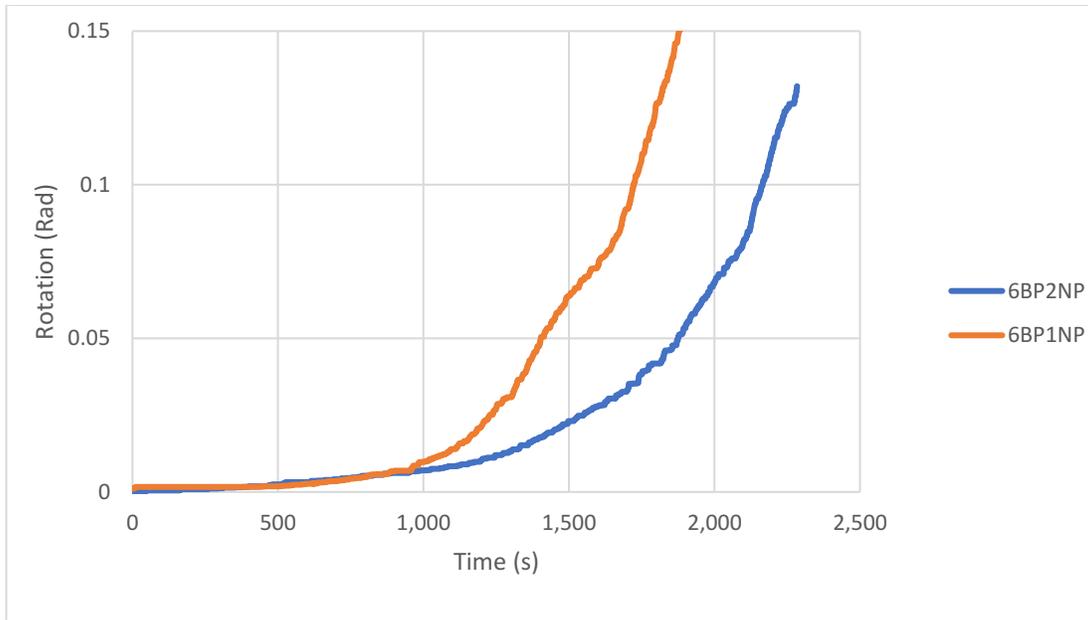
Figure 4.19 Time-rotation relationships of the STS-retrofitted, unprotected connection configurations that utilized six bolts in the first (6BP1NP) and second bolt patterns (6BP2NP).
