**Experimental Fire Testing of Damaged Glulam Beam Connections
Retrofitted Using Self-Tapping Screws**

submitted to the Faculty of Graduate Studies
in partial fulfillment of the requirements for the
Degree of Master of Science

Civil Engineering

Lakehead University

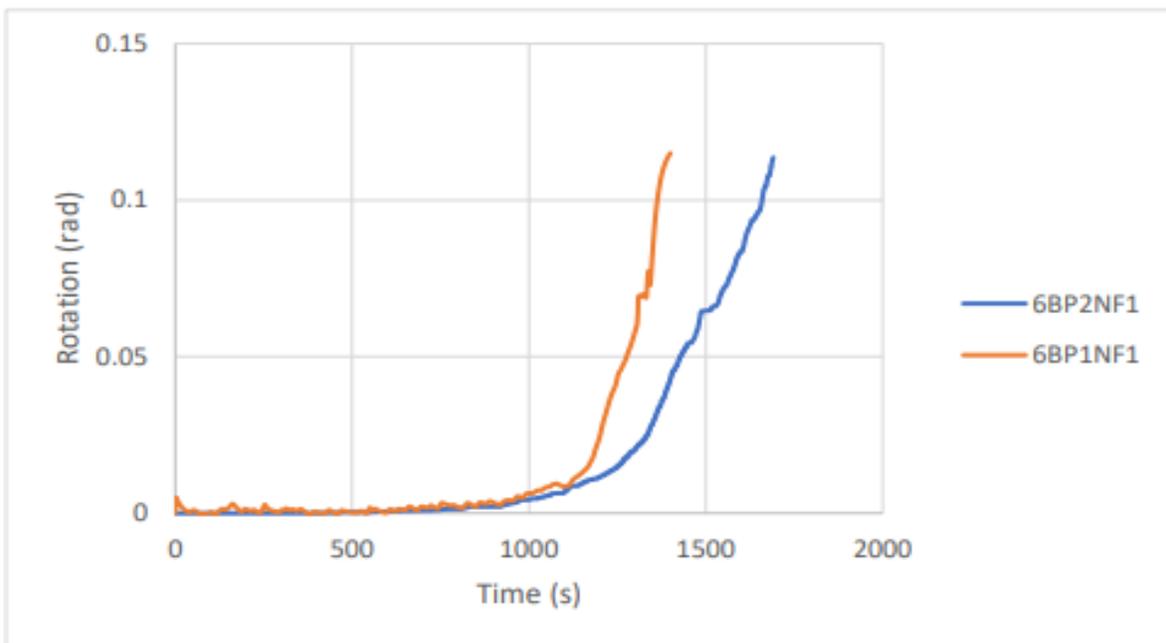
Figure 4.20 Time-rotation relationships of the undamaged, unreinforced, and unprotected connection configurations that utilized six bolts in the first (6BP1NF1) and second bolt patterns (6BP2NF1) (Adapted from Owusu, 2019).

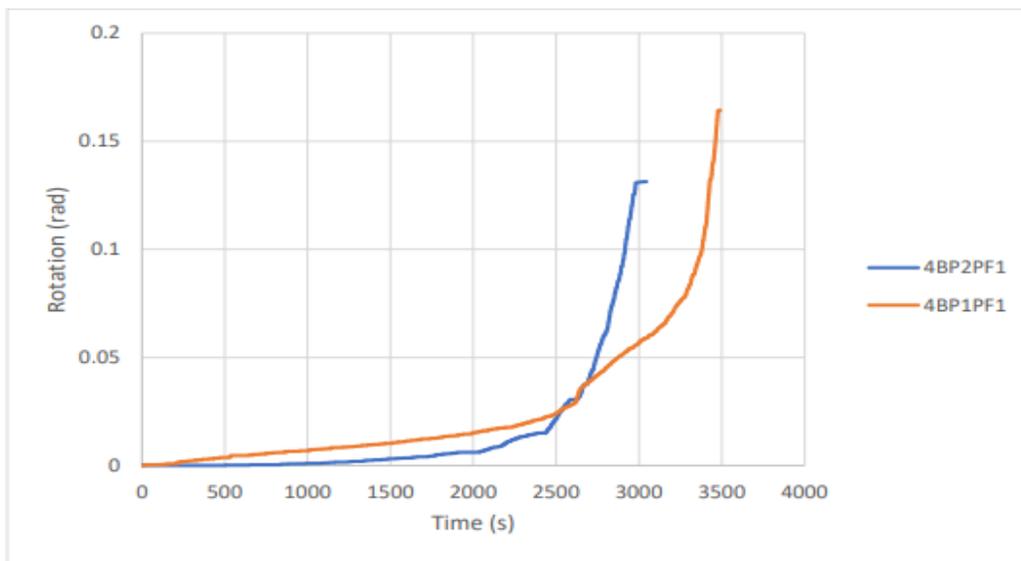
Figure 4.22 Time-rotation relationships of the undamaged, unreinforced, and protected connection configurations that utilized four bolts in the first (4BP1PF1) and second bolt patterns (4BP2PF1) (Adapted from Owusu, 2019).

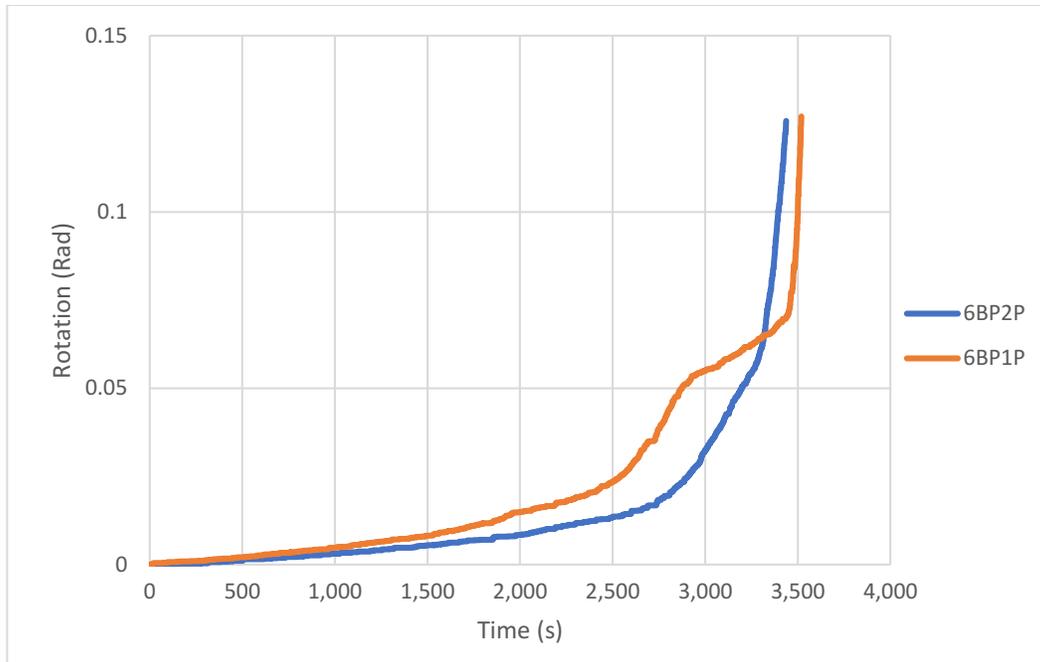
Figure 4.23 Time-rotation relationships of the STS-retrofitted, protected connection configurations that utilized six bolts in the first (6BP1P) and second bolt patterns (6BP2P).

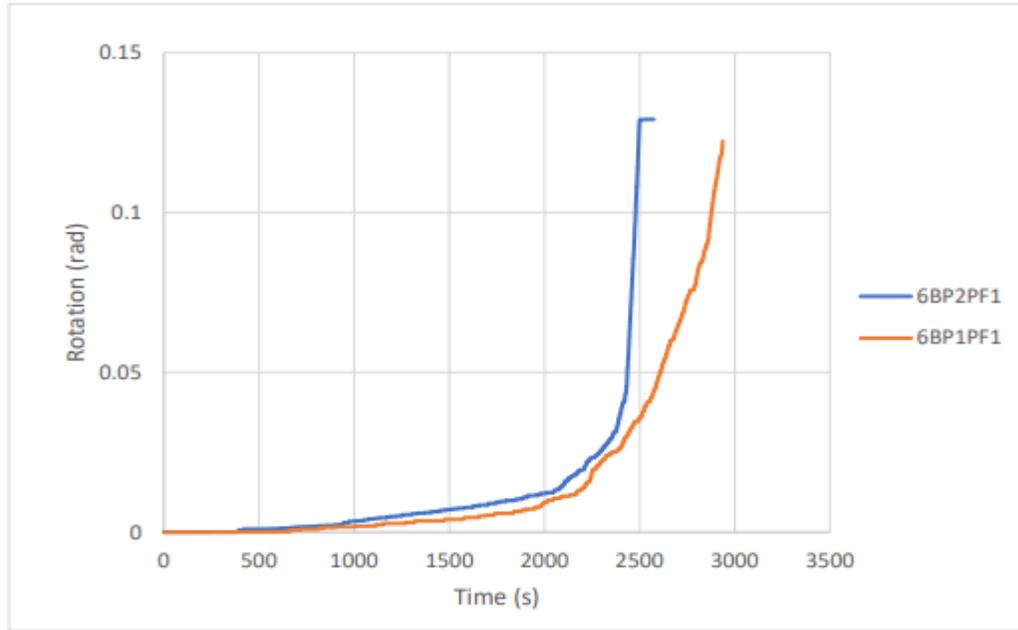
Figure 4.24 Time-rotation relationships of the undamaged, unreinforced, and protected connection configurations that utilized six bolts in the first (6BP1PF1) and second bolt patterns (6BP2PF1) (Adapted from Owusu, 2019).

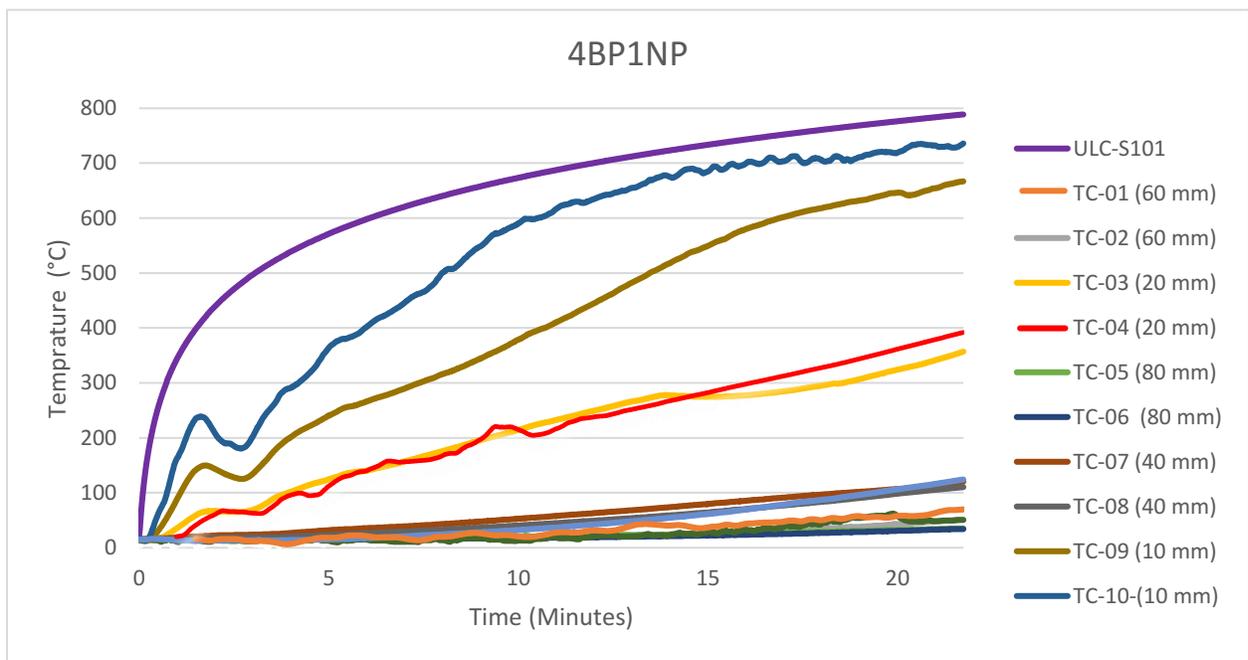
Figure 4.25. Time-temperature relationships of the STS-retrofitted, unprotected connection configurations that utilized four bolts in the first bolt pattern (4BP1NP)

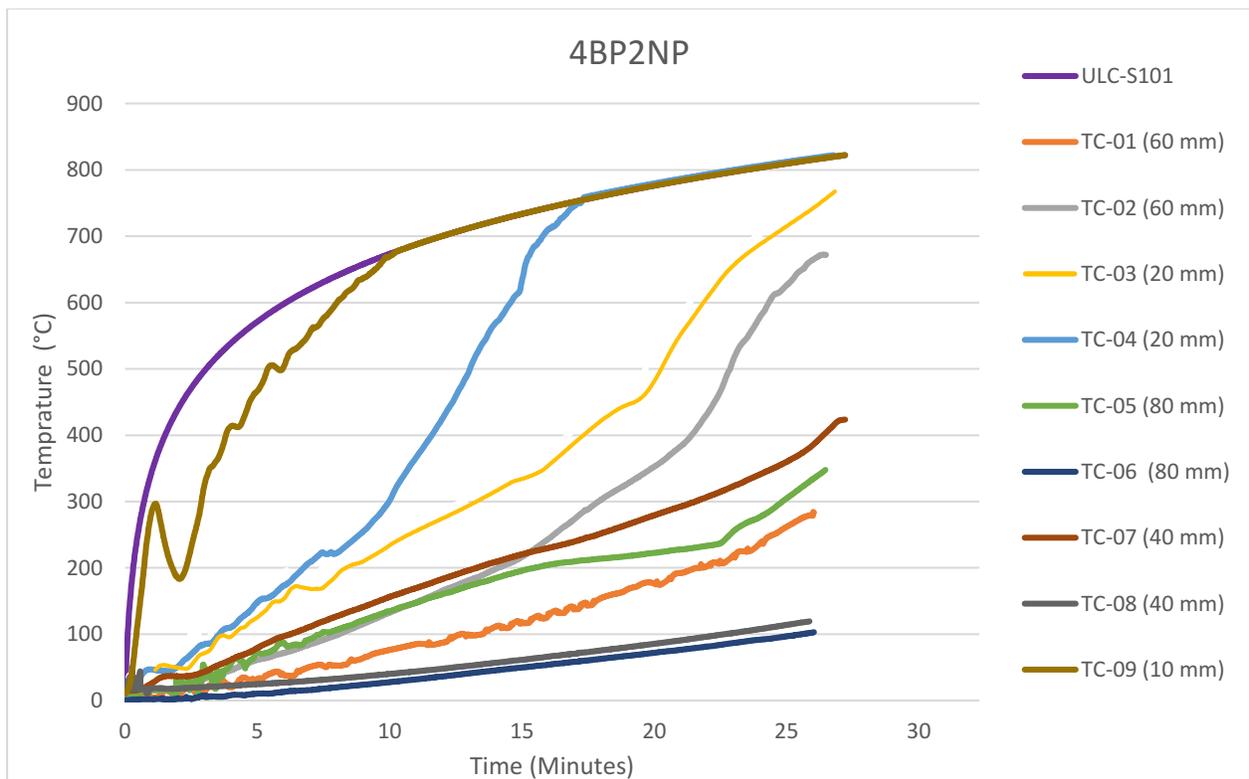
Figure 4.26 Time-temperatures relationships of the STS-retrofitted, unprotected connection configurations that utilized four bolts in the second bolt pattern (4BP2NP)

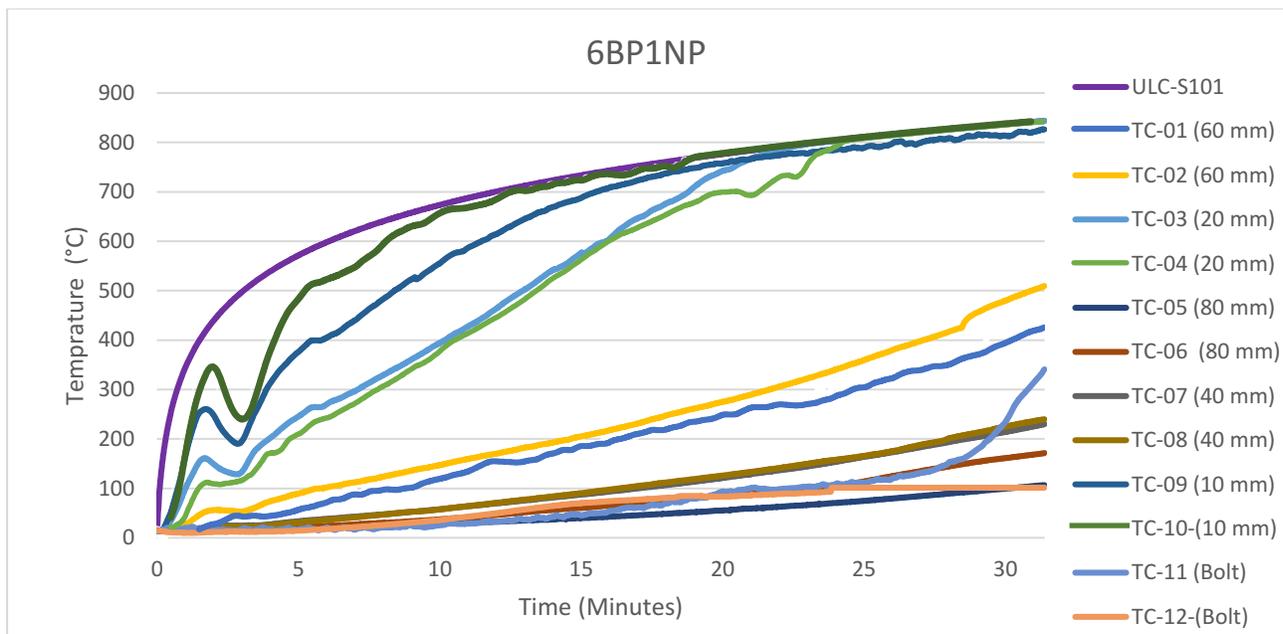
Figure 4.27 Time-temperatures relationships of the STS-retrofitted, unprotected connection configurations that utilized six bolts in the first bolt pattern (6BP1NP)

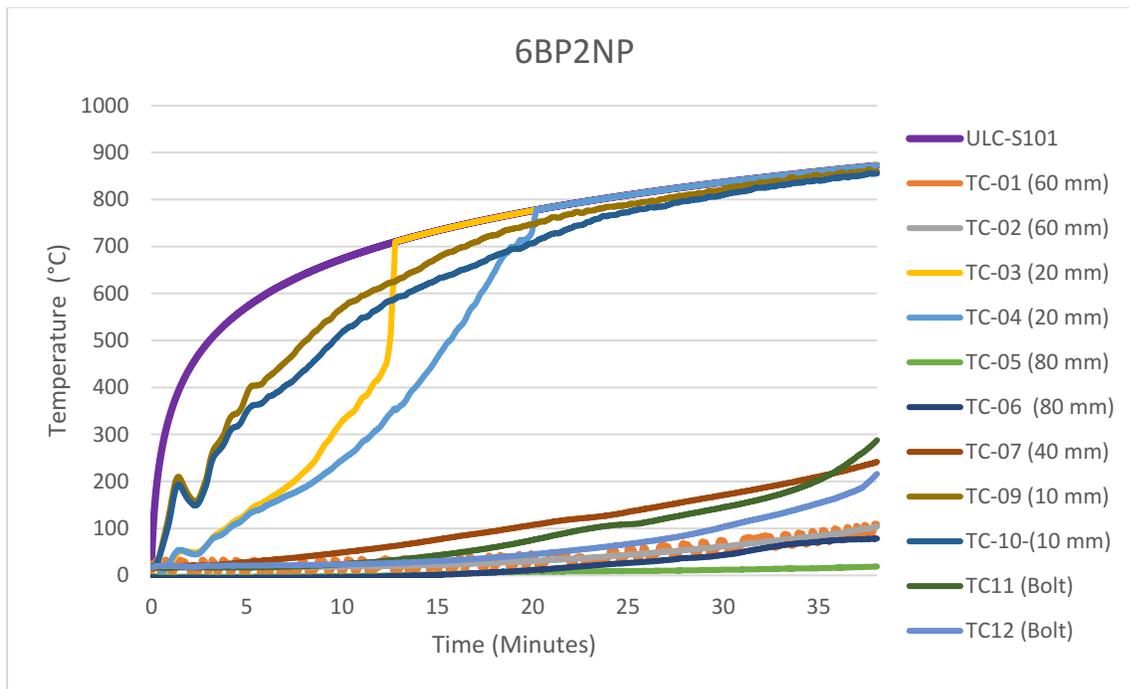
Figure 4.28 Time-temperatures relationships of the STS-retrofitted, unprotected connection configurations that utilized six bolts in the second bolt pattern (6BP2NP).

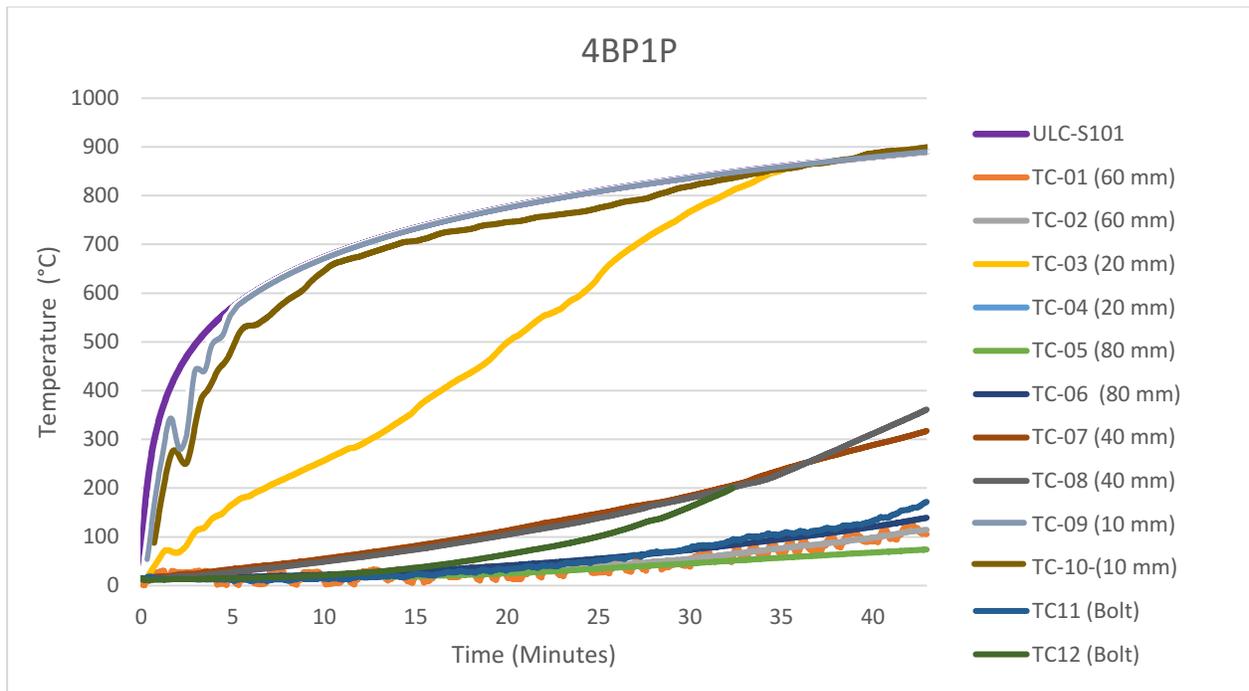
Figure 4.29 Time-temperatures relationships of the STS-retrofitted, protected connection configurations that utilized four bolts in the first bolt pattern (4BP1P)

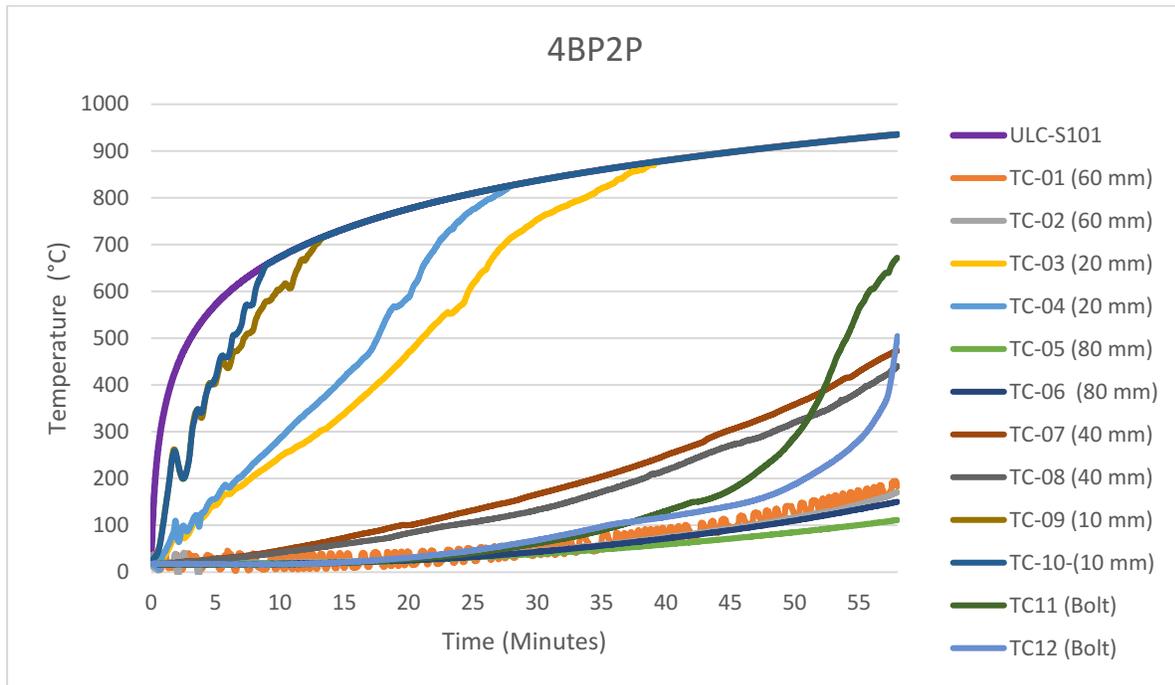
Figure 4.30 Time-temperatures relationships of the STS-retrofitted, protected connection configurations that utilized four bolts in the second bolt pattern (4BP2P)

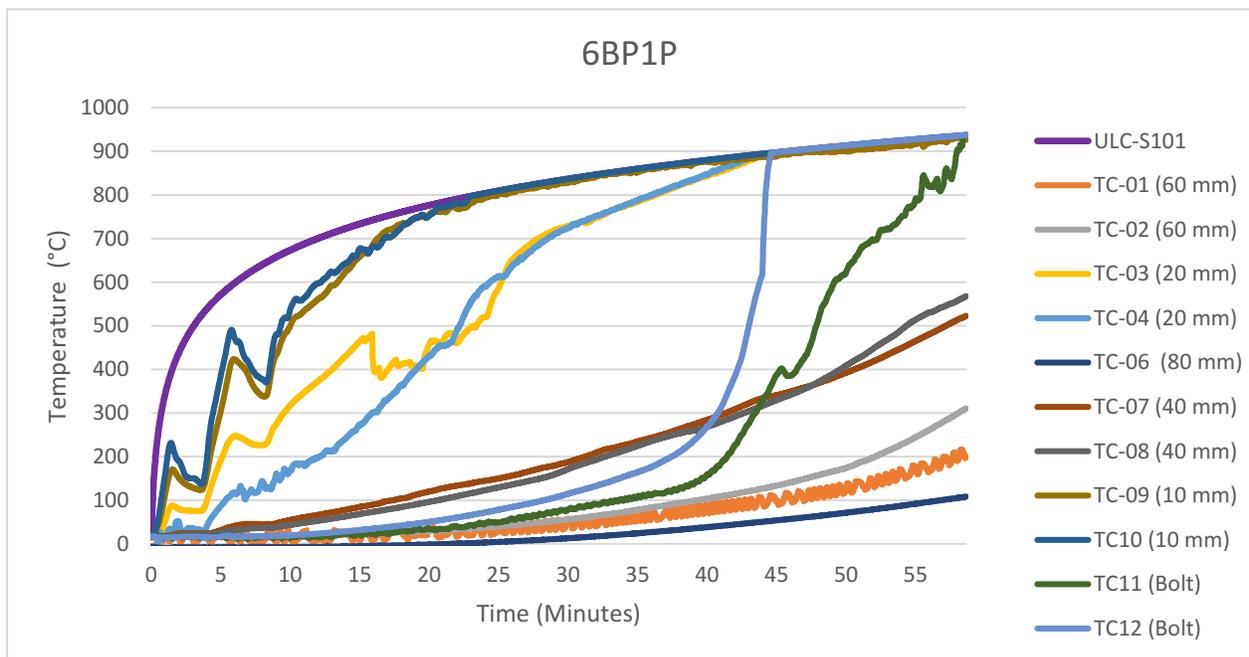
Figure 4.31 Time-temperatures relationships of the STS-retrofitted, protected connection configurations that utilized six bolts in the first bolt pattern (6BP1P)

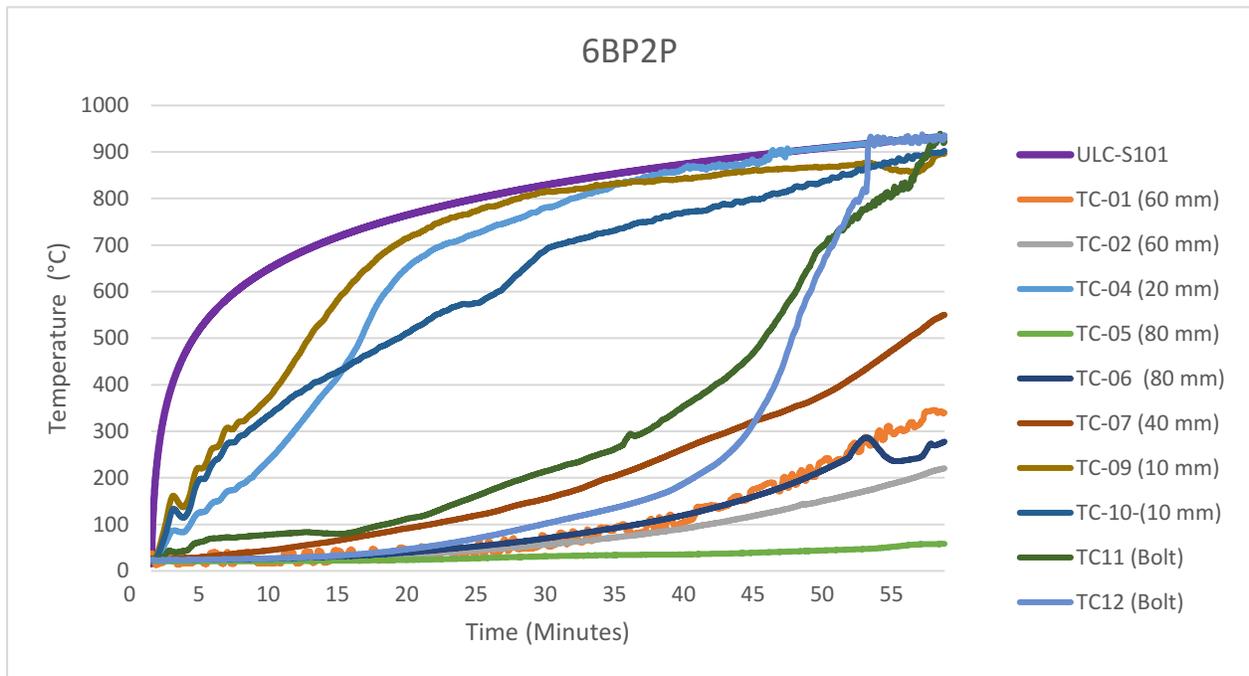
Figure 4.32 Time-temperatures relationships of the STS-retrofitted, protected connection configurations that utilized six bolts in the second bolt pattern (6BP2P)

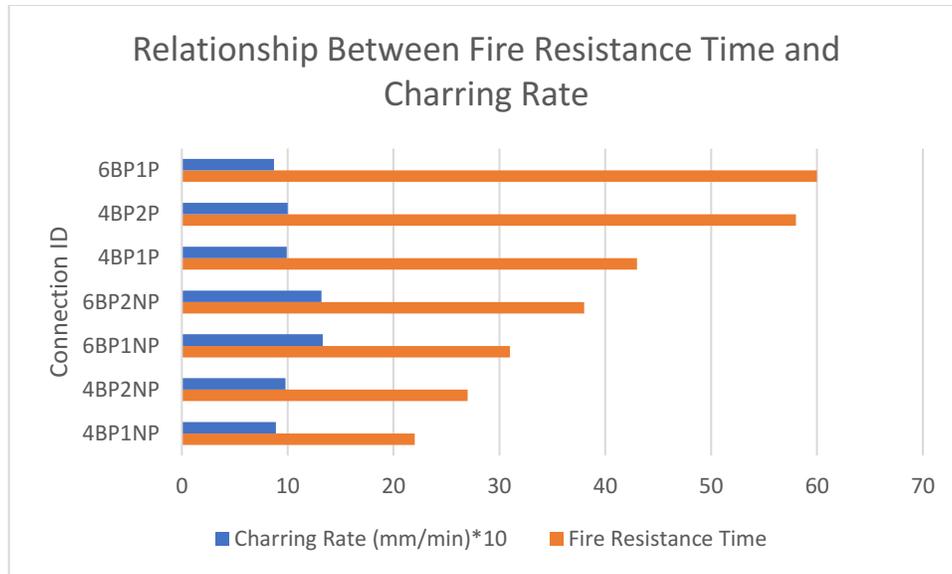
Figure 4.33 Relationship between the calculated charring rate and fire resistance time of the eight STS-retrofitted connection configurations tested.
