**IDENTIFYING AND ADDRESSING ROUNDABOUT ACCESSIBILITY  
ISSUES CONFRONTING PERSONS WITH VISION LOSS IN CANADA: A  
PILOT STUDY**

**A thesis submitted in conformity with the requirements**

**Department of Civil Engineering**

**Lakehead University**

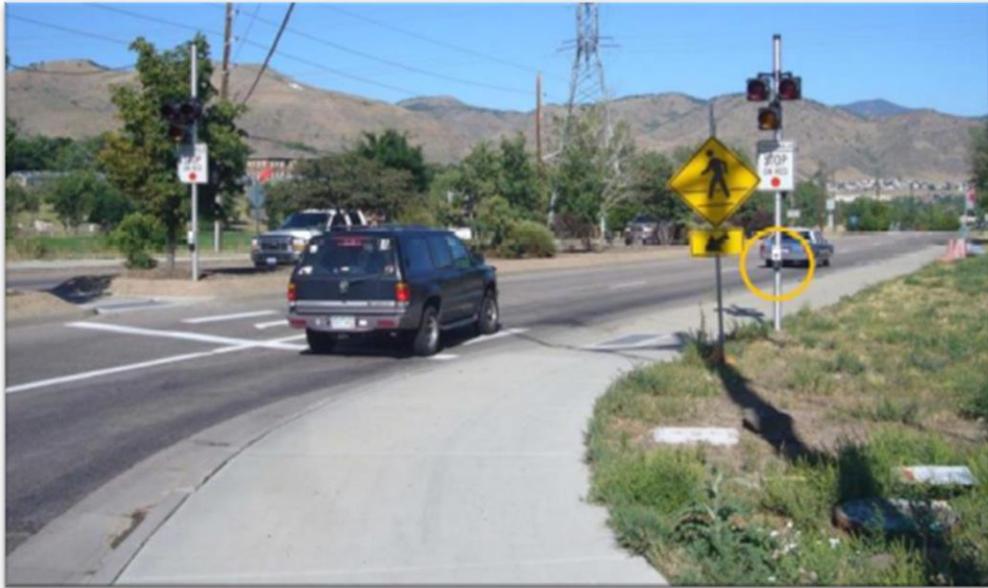
**Figure 11: Accessible Pedestrian Signal [12]**

This sub-section goes a little more in depth than the previous on Rectangular Rapid Flashing Beacon (RRFB). The RRFBs are amber lights that activate when the button to control is pushed on the pole at the beginning of the crosswalk, triggering the Accessible Pedestrian Signal (APS). Figure 11 below shows an example of these devices. The APS responds by saying a couple of times, “Amber light is flashing; vehicles may not stop immediately.” Once the RRFB is activated and begins to flash, it should last between 20 and 30 seconds. When the APS systems that are installed on opposite approaches of the same leg on the roundabout are activated at the same time by different people intending to cross the same road in opposite direction, the system is designed to operate without interference of sound generated when the APS is activated on opposite sides of the same road. In addition to meeting accessibility standards, specifications and requirements set by the MUTCD or the authorities in the jurisdiction where the roundabout is located, there is also need to follow instructions contained in TAC’s Pedestrian Crossing Control Guide (2018) for devices [22]. Finally, to complement everything discussed so far on accessibility, and as part of their advocacy work, the Canadian National Institute for the Blind (CNIB) expects agencies to become acquainted with requirements stated in the Clearing our Path Document, consider and implement such for roundabout accessibility [23][16].

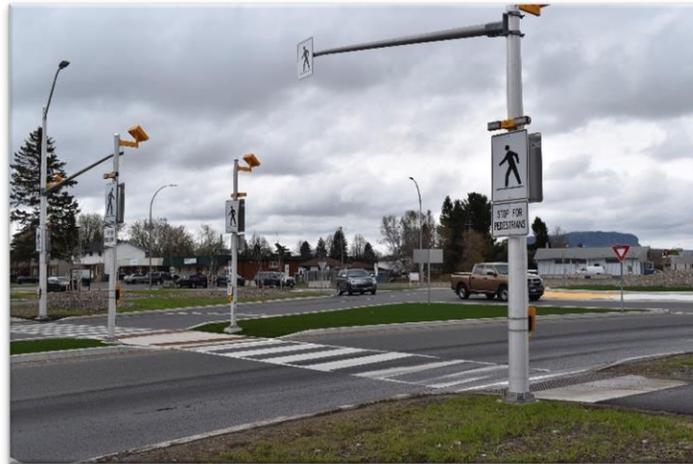
**Figure 12: Standard Pedestrian Crosswalk Sign [24]**

Roundabouts are required to have signs by each crosswalk indicating that pedestrians are using these locations to cross. By law, a standard pedestrian crosswalk sign with Manual of Uniform Traffic Control Devices (MUTCD) identification number RA-4 guarantees the right of way for the pedestrian. The sign must indicate that the pedestrian is walking just as symbolized relative to the middle of the road. The sign in Figure 12 below has numbers RA-4R for the right-hand side. Conversely, RA-4L must be used as the left-hand version. As illustrated in Figure 13 below, signs must be placed along the roadsides, indicating where the crosswalk is positioned. If the road is two-way, back-to-back symbols are used on both sides. As shown in Figure 14 below, a Pedestrian Crosswalk Ahead sign, code number WC-2, should be installed if and when visibility is limited [24].

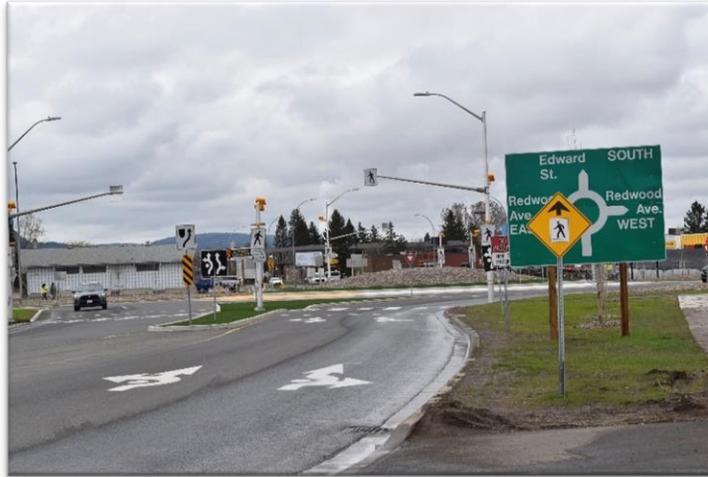
**Figure 13: The Roundabout in Thunder Bay with the “Pedestrian Crosswalk” sign**

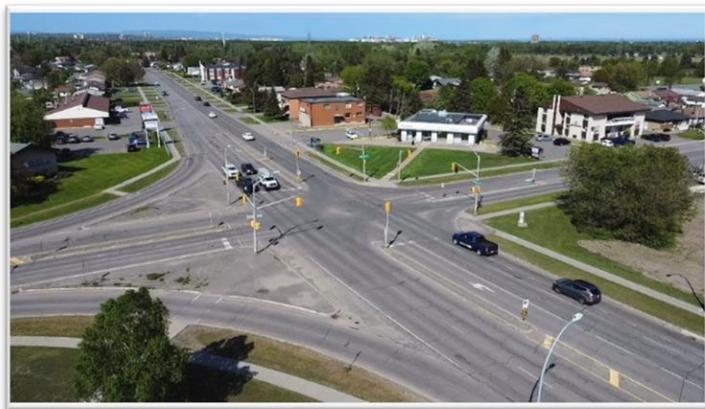
**Figure 15: Intersection at Edward Street and Redwood Avenue on June 3, 2021- North is the top-left corner of the photo [44]**

The site selected is the only one in Thunder Bay meeting the set criteria. The roundabout situated at the intersection of Edward Street and Redwood Avenue in Thunder Bay, was built between June and September of 2021. The facility is shown in Figure 15 and Figure 16 below. Positioned in the Northwest is Oasis Family Dental Clinic, in the Northeast is Janzen's Pharmacy, in the Southwest is a Shopping Mall's Parking Lot, and in the Southeast is a cleaning company (Supreme Cleaners).

The roundabout has four legs, two on Edward Street (2-lane road) and the other two on Redwood Avenue (1-lane road). The crosswalks on Edward Street, the busier one of the two streets, has RRFBs with APS that responds when triggered, saying, "Amber light is now flashing; vehicles may not stop immediately." The posted speed for both roads intersecting on the roundabout is 60 KPH, which reduces to 40 KPH on the roundabout.

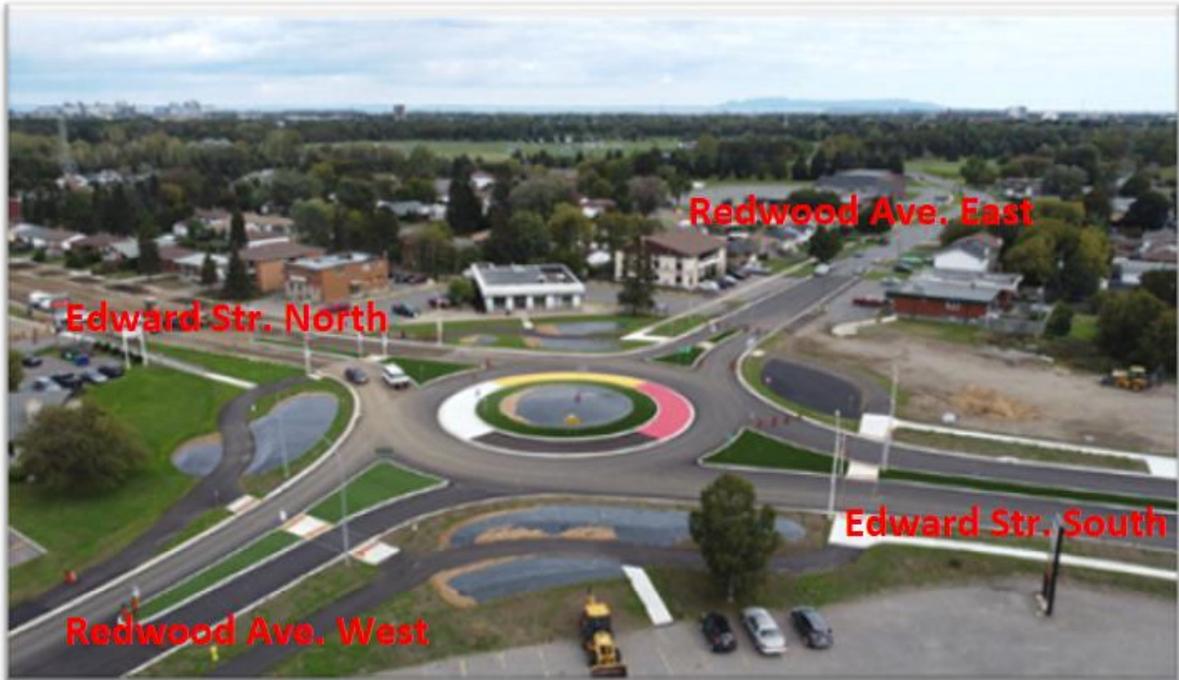
**Figure 16: Intersection at Edward Street and Redwood Avenue on September 9, 2021 - North is the top-left corner of the photo [45]**

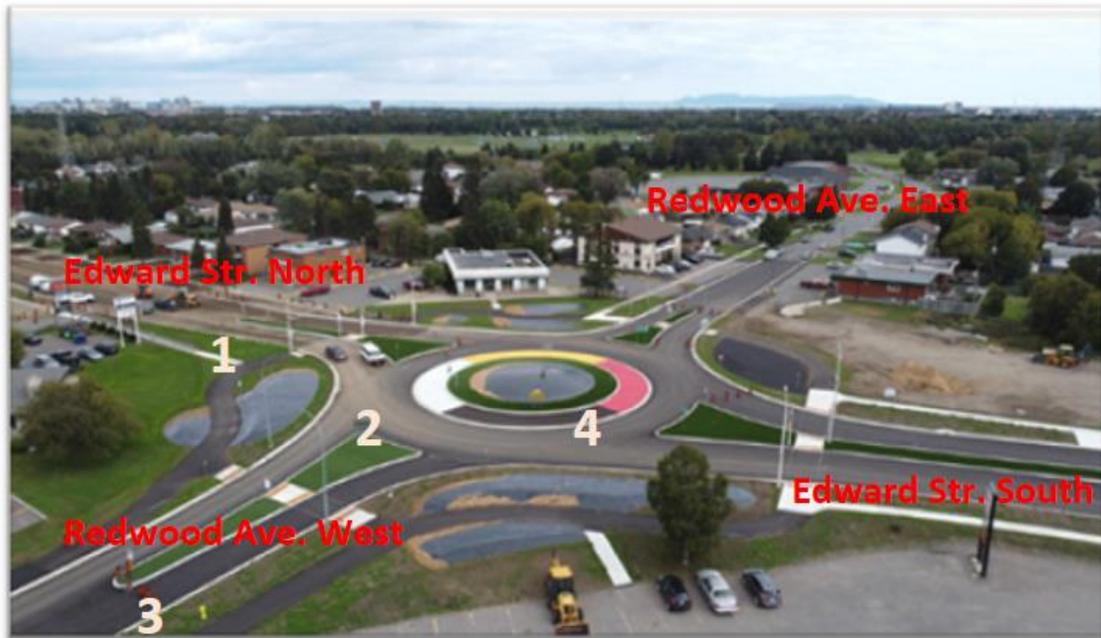
The research effort will focus on specific on-site approaches, shown in Figure 17 below, since this is a pilot study. Approach 1 is Edward Street North going Southbound into the roundabout, Approach 2 is Redwood Avenue West going Westbound exiting the intersection, Approach 3 is Redwood Avenue West going Eastbound towards the roundabout, and Approach 4 is Edward South Street going Southbound leaving the roundabout.

**Figure 17: Focused on Approaches 1 to 4 - North is the top-left corner of the photo [45]**

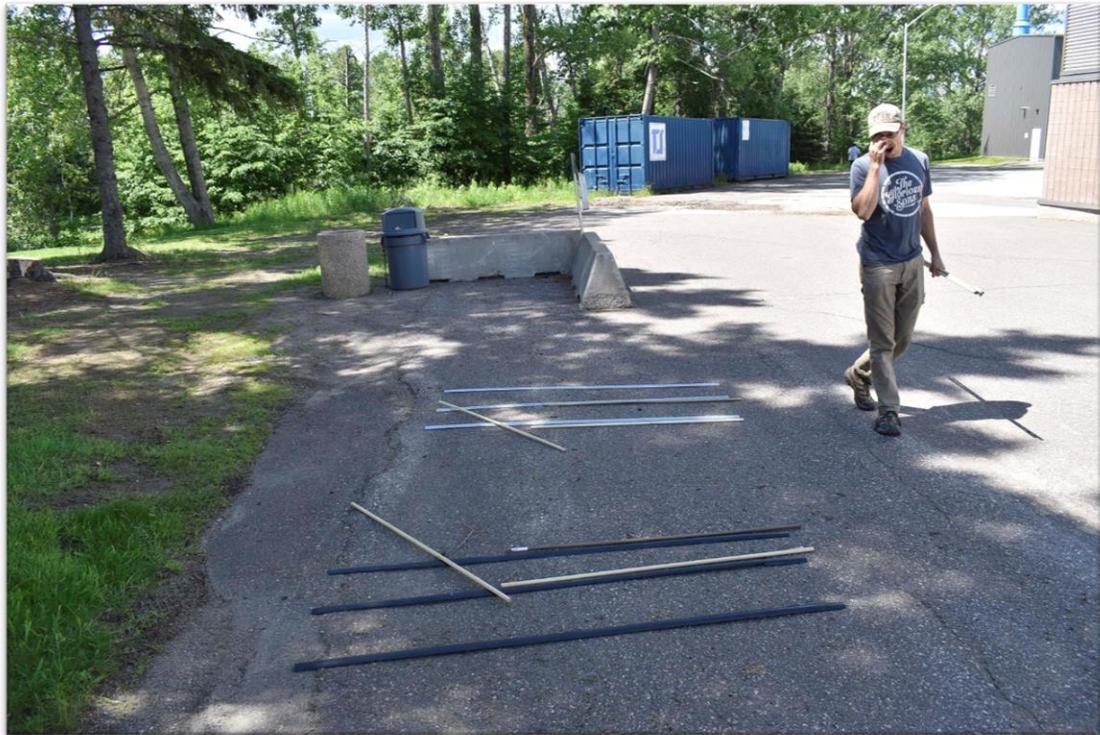
**Figure 18: Fabricated strips and dowel on display at LU campus**

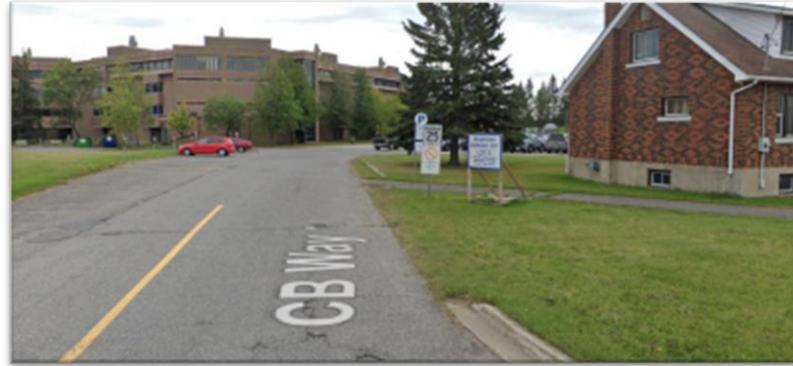
**Figure 19: Entrance driveway to Parking Lot 5 and the Centennial Building from Oliver Road. (Photo Credit: Google Maps)**

Weather permitting, steps were taken to have the strips installed on campus. First, the location of the strips was selected on the entrance driveway such that it was not too close to the nearby Oliver Road entrance or to the parking area in Lot 5. Then, the pavement surface was swept clean removing debris and moisture. Once the area was ready, the strips made of the PVC - ABS materials with the dowel beneath were plastered to the pavement near the entrance of LU Parking Lot 5 as shown in Figure 19 and Figure 20 below. For this process, the dowel was first laid down then the PVC or ABS strip went on top, and the Eterna Bond tape of 4 inches wide in size was applied. For safety reasons, an orange and black striped tape was stuck to the top of the strips to forewarn drivers of what is on the road surface.

As rehearsal for data collection on the roundabout, two rows of sound strips placed in the university was an opportunity for assessing the “click-clack” sound generated by vehicles that were moving through the driveway into the parking lot at the maximum allowed speed - 25 KPH, or less. The space between adjacent rows of strips was measured to sufficiently accommodate a vehicle from axle to axle in between the two rows of strips.

The test was performed not only to prepare for the installation of the sounds strips and check that it will work without any problems, but to determine if the sound produced by the strips is clear and how far away it could be transmitted from source. For this purpose, the test was monitored by listening to the sound generated when vehicles drove over the rows of strips and hearing the sound intensity to gauge how it decays as the observer stood progressively and incrementally away from the source of the sound, on the way to the Faculty of Engineering Centennial Building situated nearby.

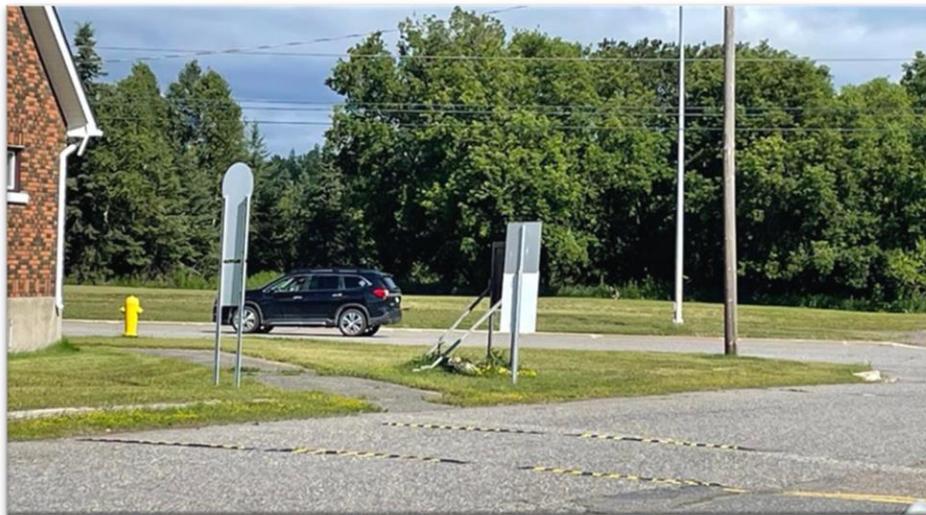
**Figure 20: Strips installed at the entrance driveway of Parking Lot 5**

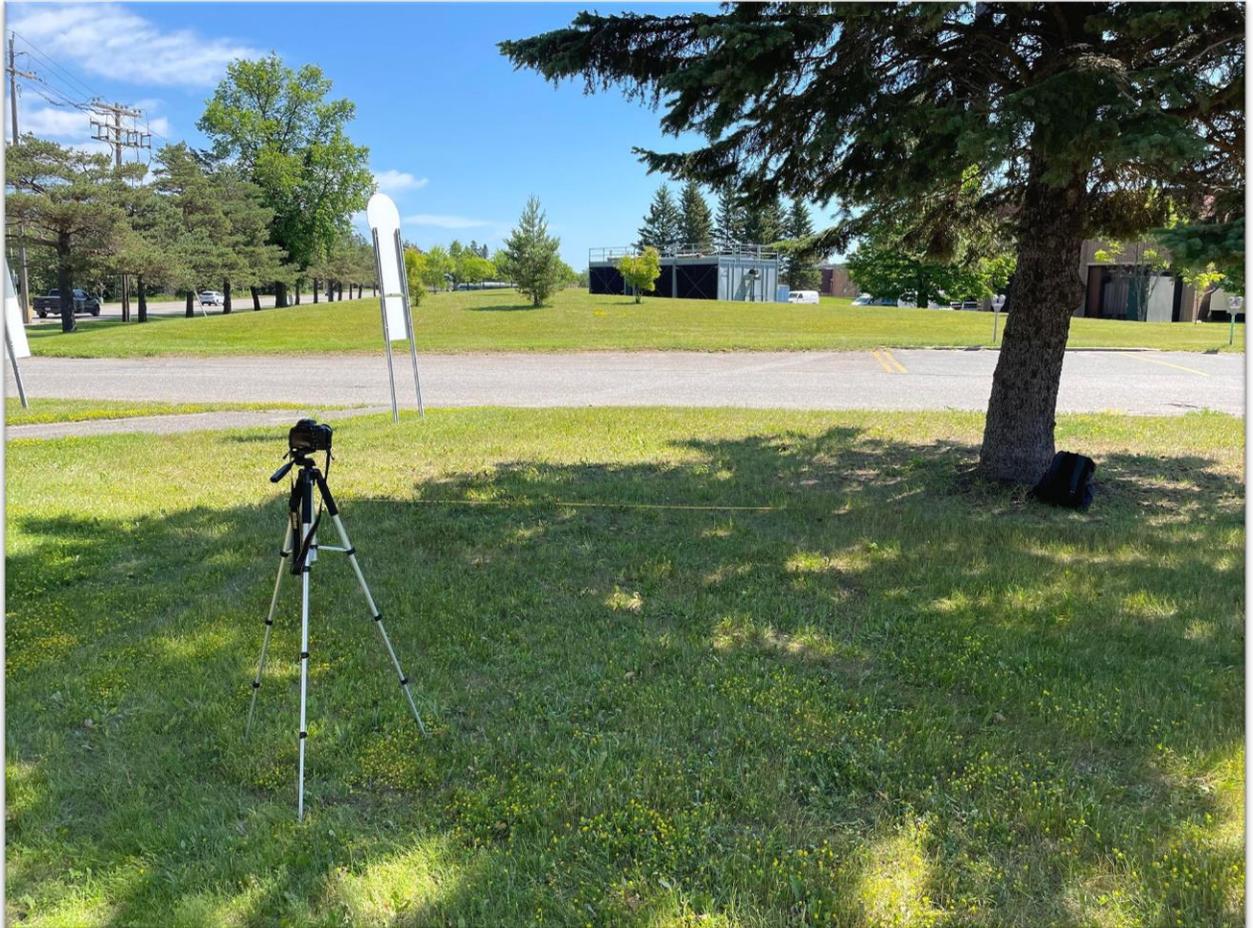
distance between the two rows of strips was predetermined and the amount of time each vehicle took to traverse between the two adjacent rows of strips could be estimated.

**Figure 21: Nikon D3500 Camera mounted to monitor the zone for traffic**

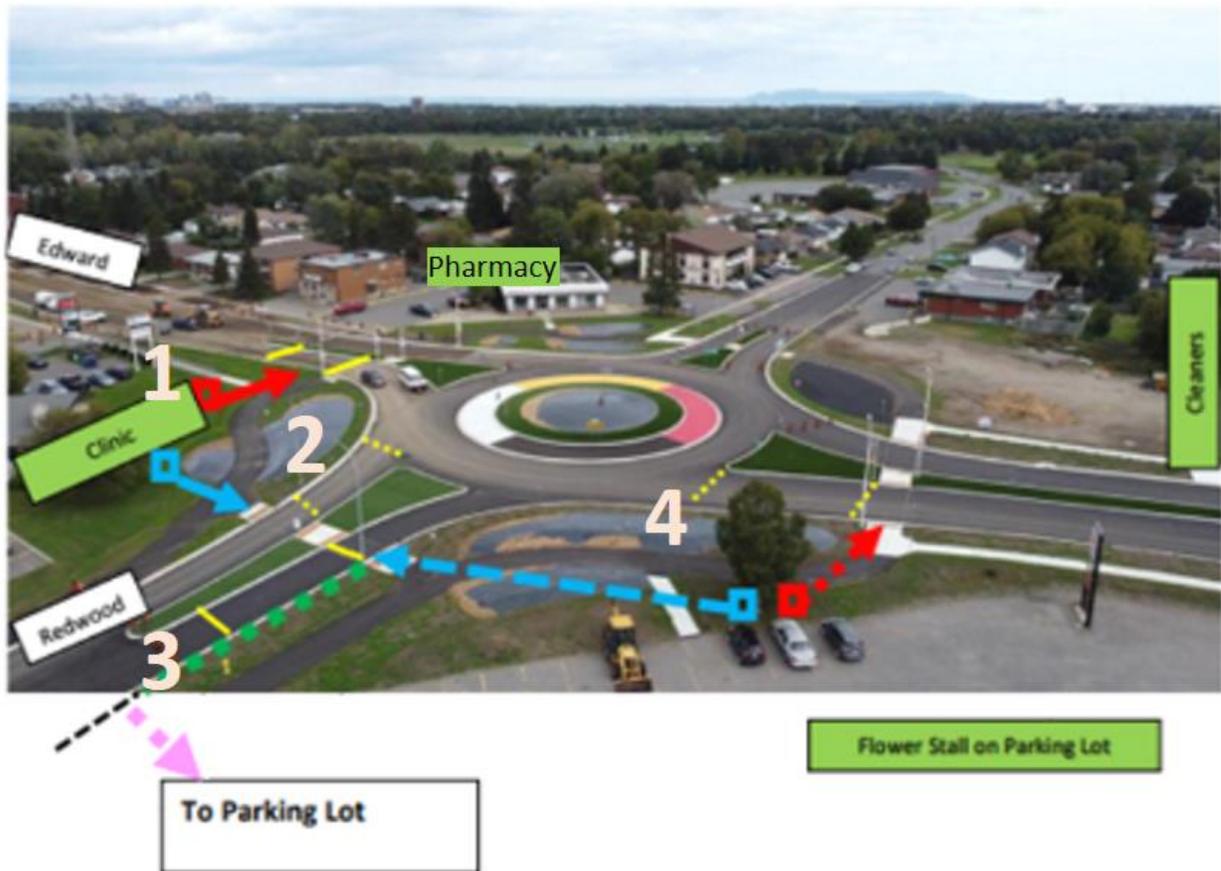
**Figure 22: Showing where the camera and strips were positioned. North is the top-left corner of the photo [45]**

Numbers 1, 2, 3, and 4 shown in Figure 22 are the four approaches being monitored on the roundabout (as indicated previously). The camera is represented by the rectangular box with an arrowhead pointing towards the crosswalk on each approach. The red-colored rectangular box with an arrowhead depicts the camera that is pointing towards the major road, and the blue - colored rectangular box with an arrowhead depicts the camera pointing towards the minor road. The solid blue and red lines with arrowheads are in the first quadrant, while the broken blue and red lines with arrowheads are in the second quadrant of the roundabout. Two rows of strips, represented by yellow lines, are to be placed on the pavement on each approach. Also, the solid yellow lines on the road pavement indicate where inbound vehicles enter the roundabout. While the broken yellow lines on the road pavement show exit points for outbound vehicles.

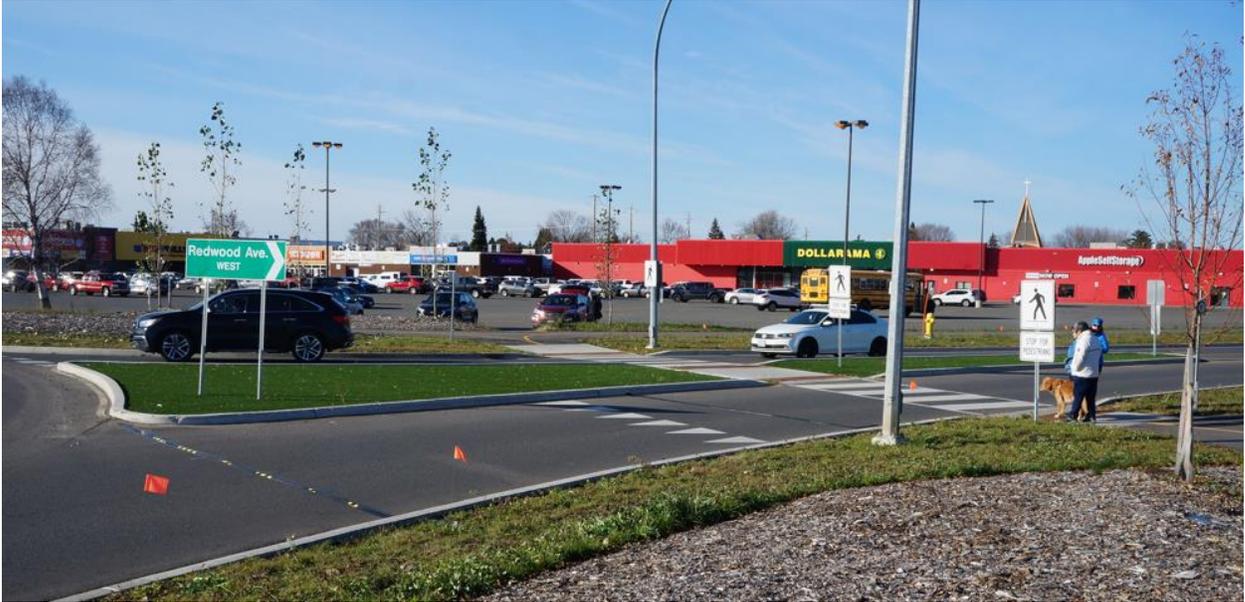
Before laying down the strips, the road was swept clean of dirt at the location for each row of strips. Also, a blowtorch was used to remove moisture from the pavement surface. Moreover, the strips were wiped dry before applying the adhesive tape to plaster the strips and dowel to the surface of the road.

Furthermore, the orange and black striped tape was placed on each row of strips for motorists' safety and precaution. Appendix Figure A13, Figure A14, and Figure A15 show some of the scenes on site as installation work progressed. An example of the rows of strips on site after installation is shown in Figure 25 below with fully installed rows of strips on Approach 2 along Redwood Avenue West going Westbound. The picture indicates Flag 1 as the first of three flags, located the farthest from the crosswalk. Flag 2, coinciding with the position of the first row of strips as if going downstream with traffic. Lastly, the position of Flag 3, coinciding with the position of the second row of strips as if going downstream with traffic, is nearest to the crosswalk. The flags put in place make the tracking of moving vehicles in the area less challenging for the naked human eyes.

**Figure 25: Fully Installed Strips on Approach 2 at Redwood Avenue West going Westbound**

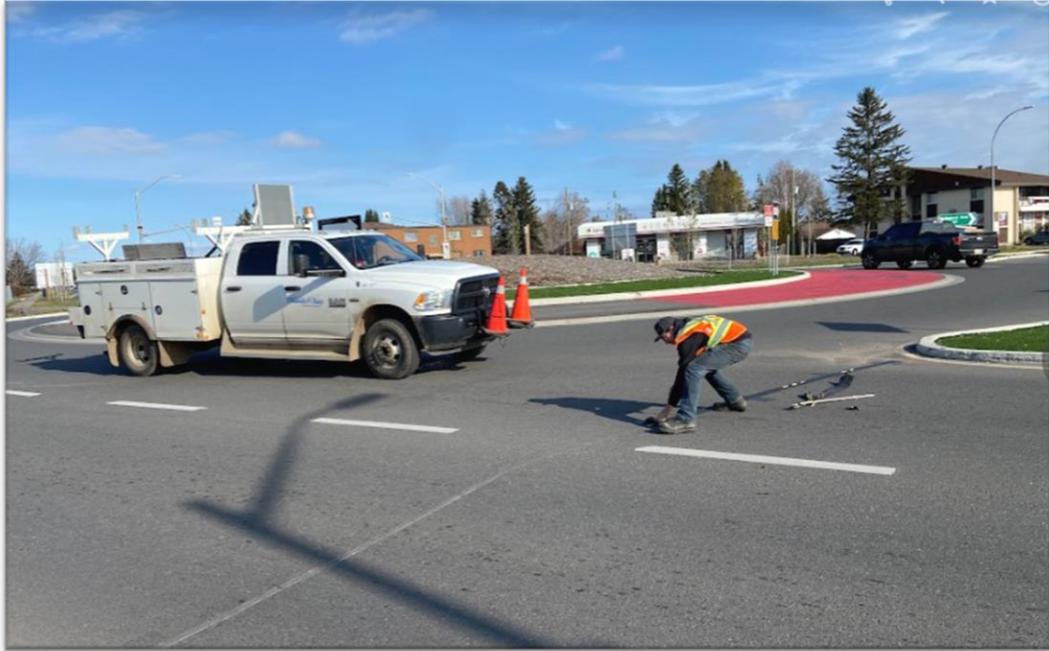
**Figure 26: Strips being removed from the road**

Later in the afternoon, after the data collection session finished and all volunteers left, it was time to remove the strips from the road. The pavement treatment was only allowed onsite while the data collection exercise was conducted. To facilitate the removal exercise, as shown in Figure 26 below, the City of Thunder Bay had one of its traffic control vehicles drive-through blocking off the road to protect people who were doing the removal and cleaning up the road. This process took about 30 minutes, with a team of 3 people from the university quickly peeling off the strips and pieces of dowel from the pavement. The surrounding area was also cleaned, and all waste materials were packed properly and disposed of appropriately.

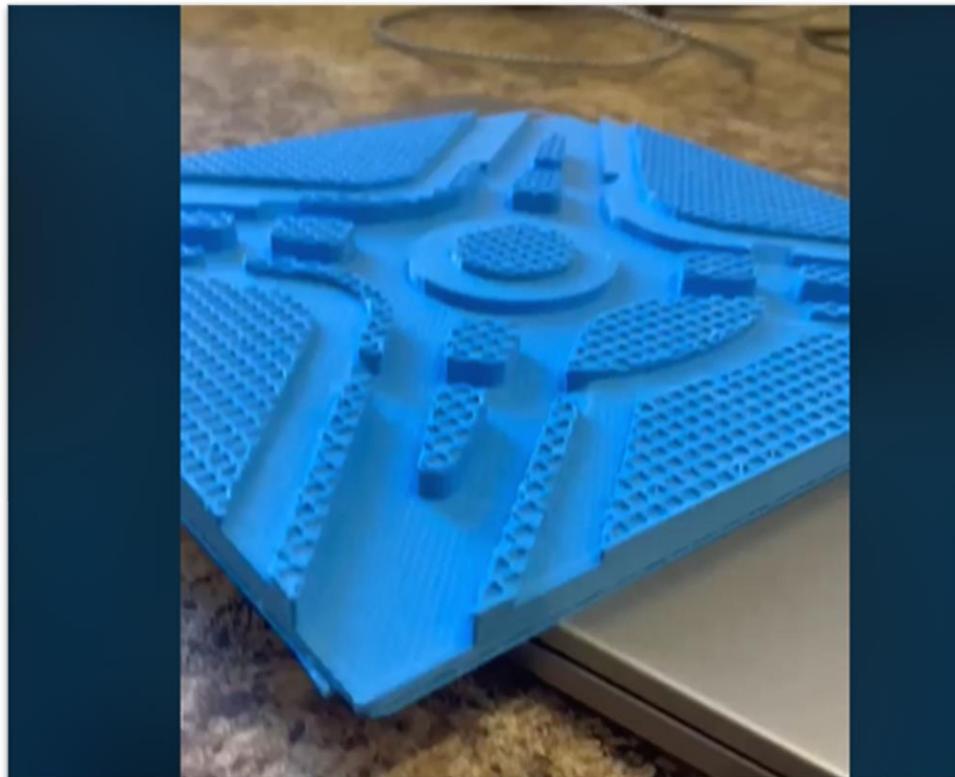
A 3D model of some random roundabout was used in illustrating to PWVL how the roundabout is configured. Figure 27 below shows this 3-Dimensional roundabout model printed in blue. This model consists of three different topographical levels. The lowest topographical level on the model indicates the surface where vehicles pass on the roundabout; the next level up is where pedestrians walk, while the highest level is neither for pedestrian nor vehicle traffic.

**Figure 27: Showing the three layers of the 3-Dimensional model**

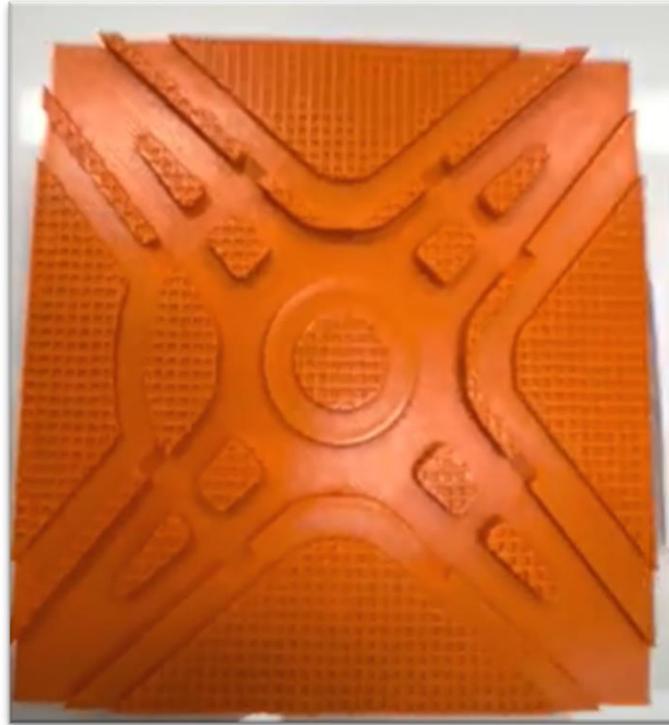
**Figure 28: Showing a model in orange color**

With the 3D model, some information related to the roundabout were conveyed to the volunteers, who felt the model by touch and thus making some sense of the roundabout. Also, printing in brighter colors makes it more useful for PWVL who could see better bright colors than regular colors. Figure 28 below shows the orange 3D model used in this research project.

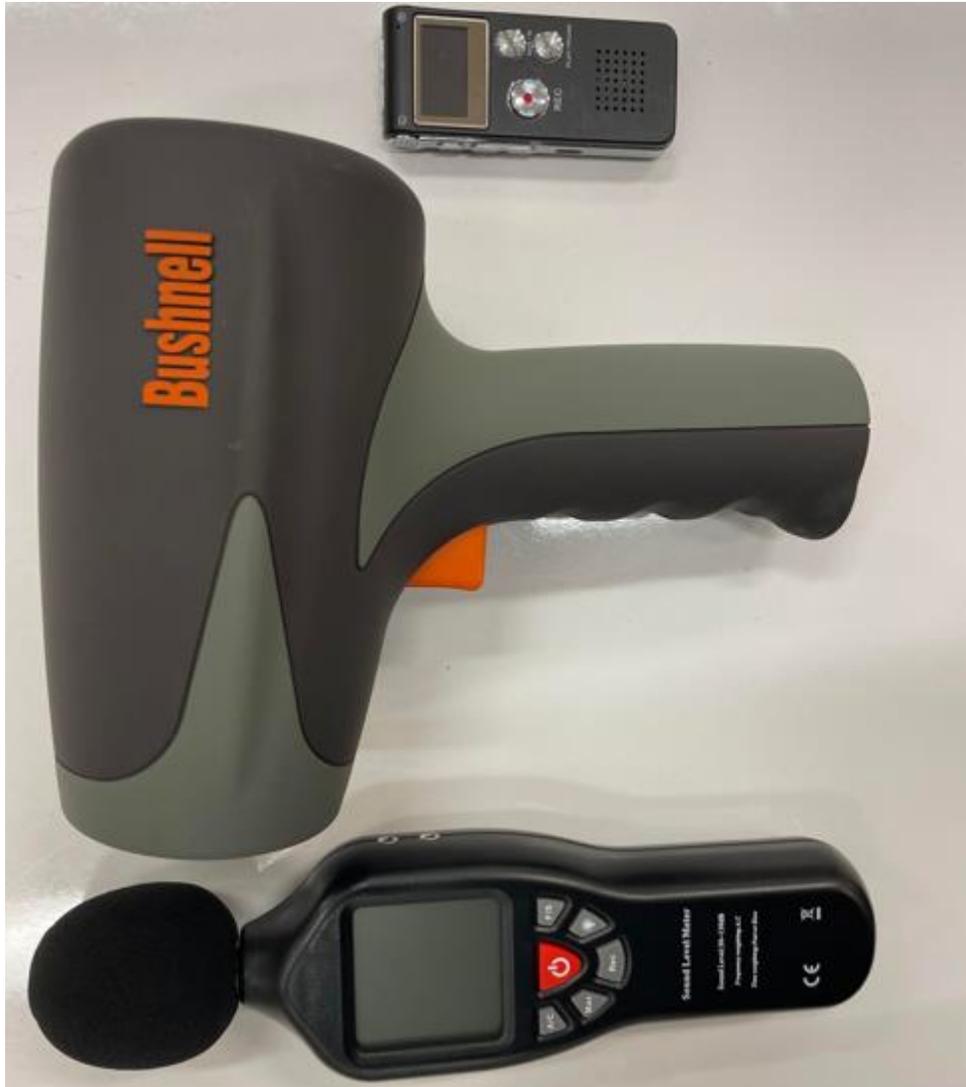
**Figure A6: Some of the electronic equipment tried for data collection. The voice recorder is at the top of the page, the speed radar gun is in the middle, and the decibel meter is at the bottom**

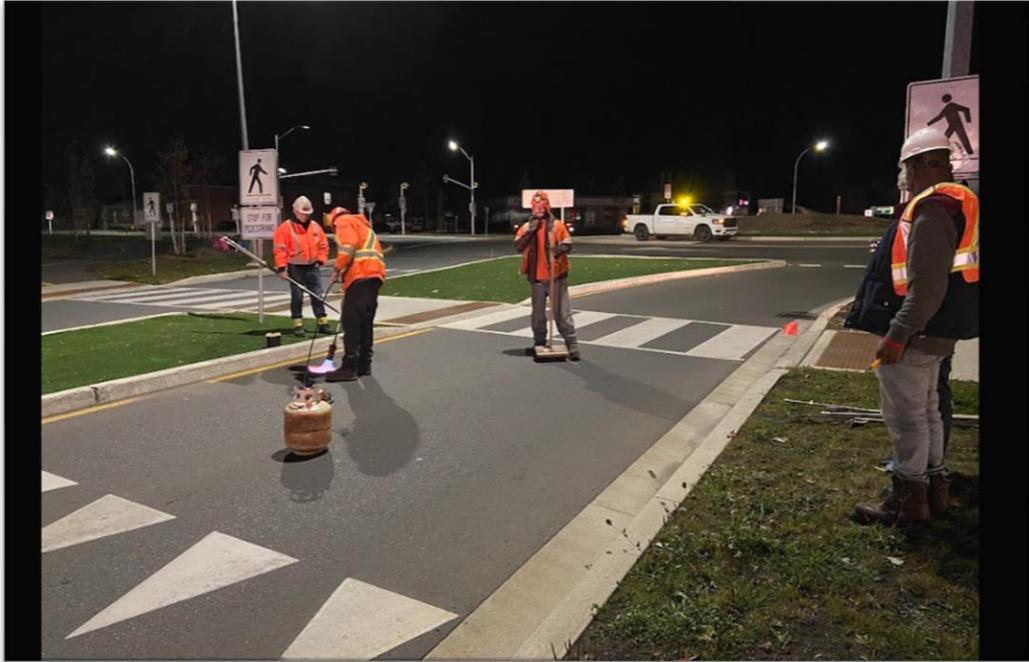
**Figure A13: Cleaning the surface with a broom, followed by drying the surface with a blow torch before installing the strips at about 5 am local time on Thursday, October 27, 2022**

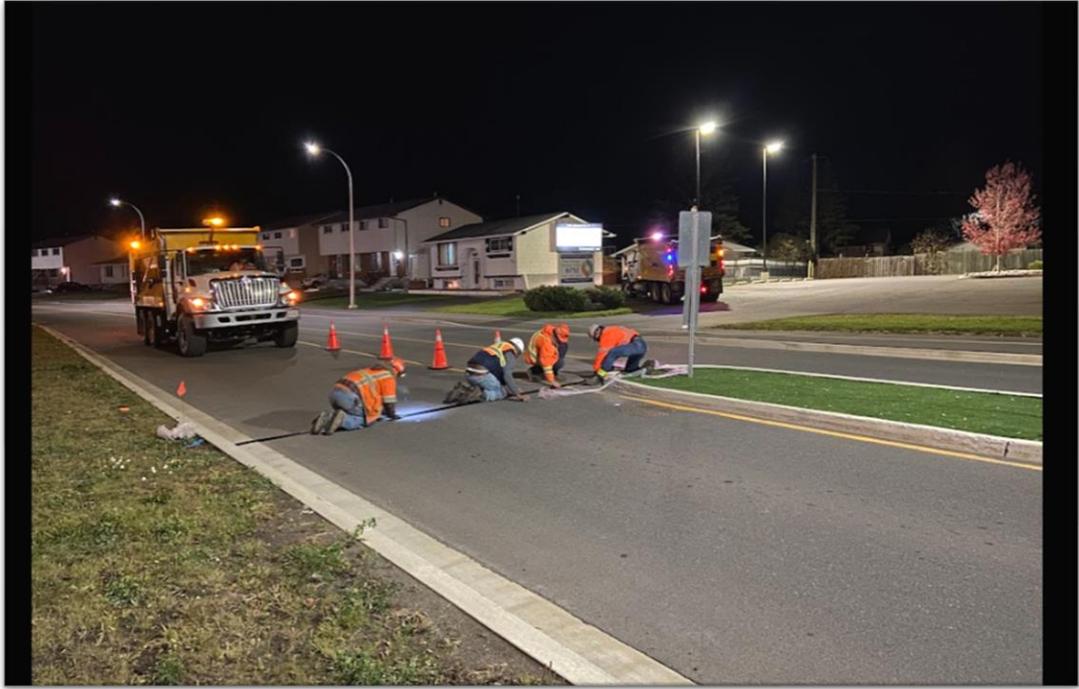
**Figure A14: Installing the strips on the pavement.**
