KAMA CREEK CULVERT RESTORATION:
AN ASSESSMENT OF LONG-TERM REMEDIATION SUCCESS

Brent Straughan

April 2018

An Undergraduate Thesis Submitted in
Partial Fulfillment of the Requirements for the
Degree of Honours Bachelor of Environmental Management

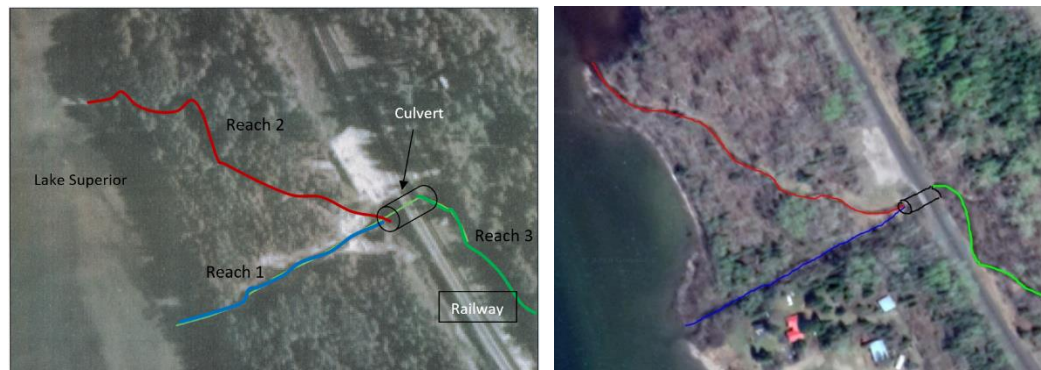
Source: Left, Kaurin (2015). Right, Google maps
 Figure 1: Kama Creek reach locations. Blue, reach 1 is post 1962 channelization and pre 2011 remediation. Red, reach 2 is pre 1962 channelization (historic condition) and post 2011 remediation. Green, reach 3 is the stream above the culvert crossing.

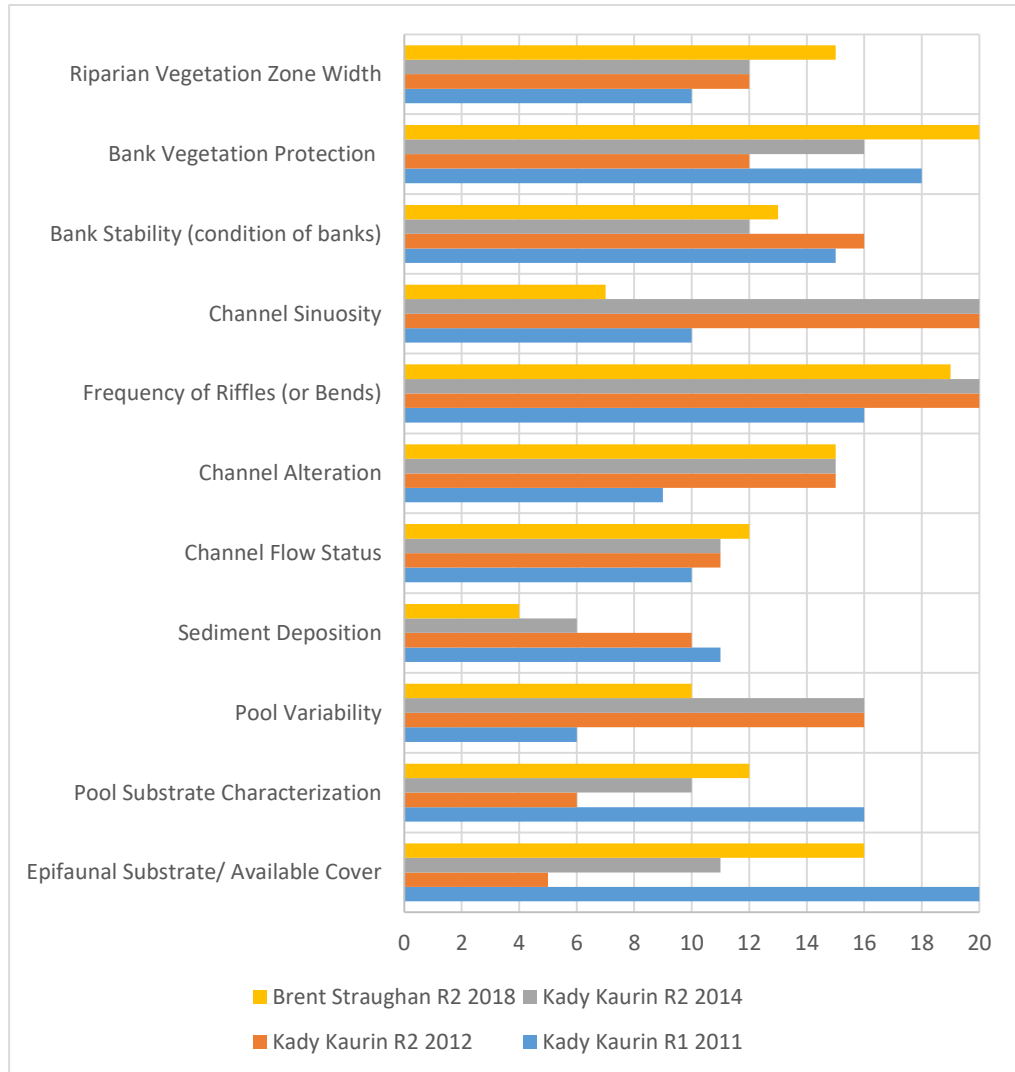
Figure 5: Total observation values from Kama Creek Habitat Assessments in Reach 1 and Reach 2

Throughout all assessment years', individual condition scores often varied from year to year, but the total scores of Kama Creek were statistically indifferent. The total score of Kama Creek remained in the suboptimal class across all study times.

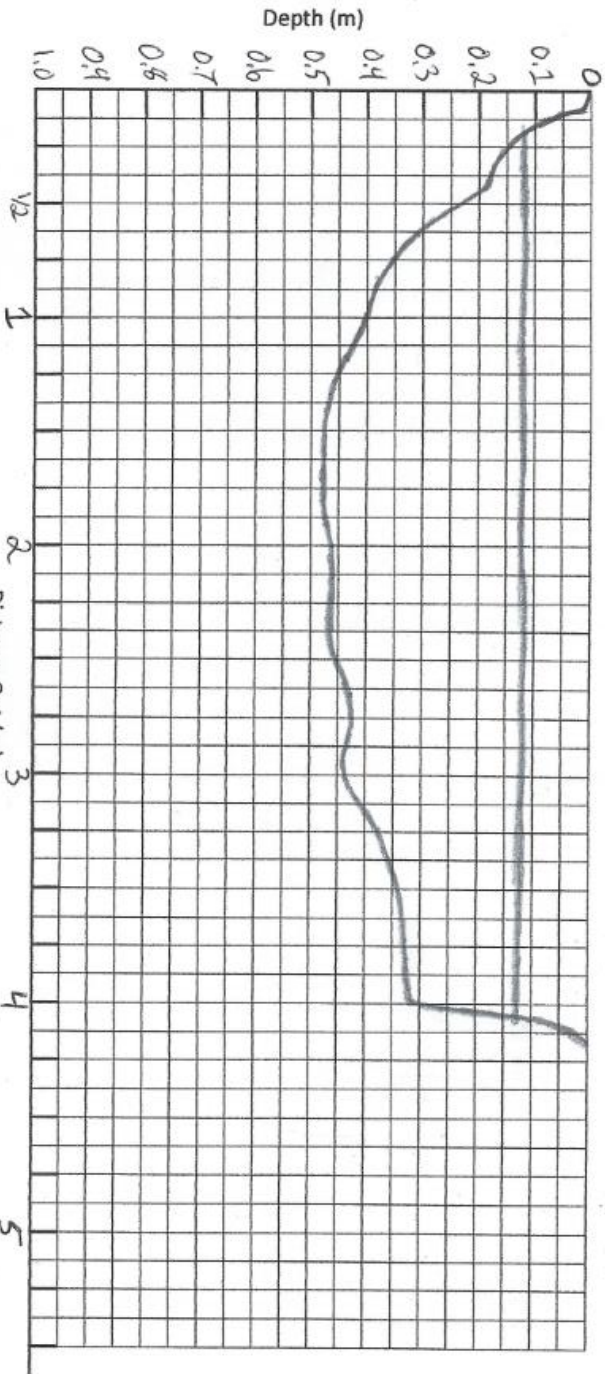
Cross-Sectional Profile and Discharge Calculation for Kama Creek
 Date: Nov. 4, 2018 Site ID: Kama 1 UTM Easting: 0425854 UTM Northing: 5425787

Total Discharge (Q) = 0.1214 m³ s⁻¹
